# Engine failure involving Cirrus SR22, VH-DCB

28 km east of Nyngan, New South Wales, on 24 January 2025

Aviation Occurrence Investigation (Short)

AO-2025-004

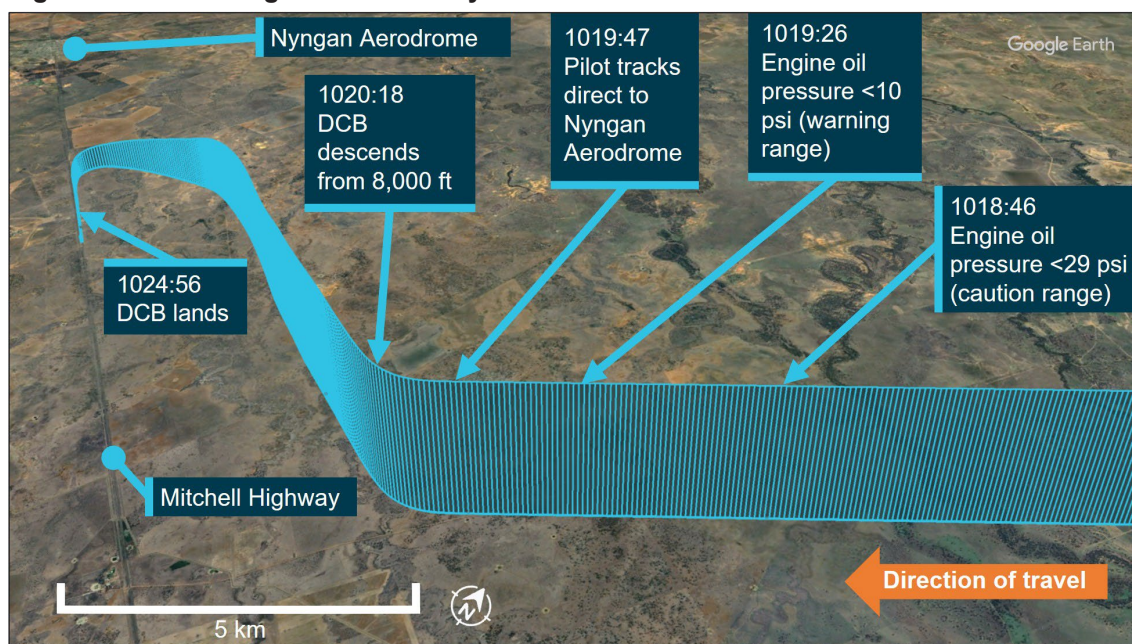
**Figure 1: VH-DCB flight track and key events taken from recorded data**

At 1018, while cruising at an altitude of about 8,000 ft above mean sea level (AMSL), the engine oil pressure decreased below the normal operating limits for the engine, 30 pounds per square inch (psi), and the pilot recalled an engine oil pressure alert. The pilot identified that Nyngan Aerodrome was the nearest aerodrome, about 15 NM (28 km) to the west. At 1019, the pilot diverted directly to Nyngan with the aid of the autopilot (Figure 1).

At 1020 the pilot began a controlled descent towards Nyngan and the Mitchell Highway (Figure 1), and they selected idle power, mixture to cut off and turned off the fuel pump. They attempted to switch the fuel selector lever to off, but they were unable to, recalling that they required both hands to do so. At this time their forward visibility became partially obscured by engine oil on the windscreen.

The pilot recalled that the fire appeared to extinguish as the aircraft descended through 4,000 ft and reported they were able to switch the fuel selector off at about 3,250 ft. However, they recalled smoke began to enter the cockpit at about 3,000 ft as the aircraft continued to descend. The pilot selected the first stage of flap and lined up on a section of the Mitchell Highway in a south-easterly direction. On final approach, the pilot had to adjust the emergency landing flightpath to avoid 2 motor vehicles on the highway and safely conducted the emergency landing, vacating the highway onto a dirt access road at about 1024 (Figure 2).

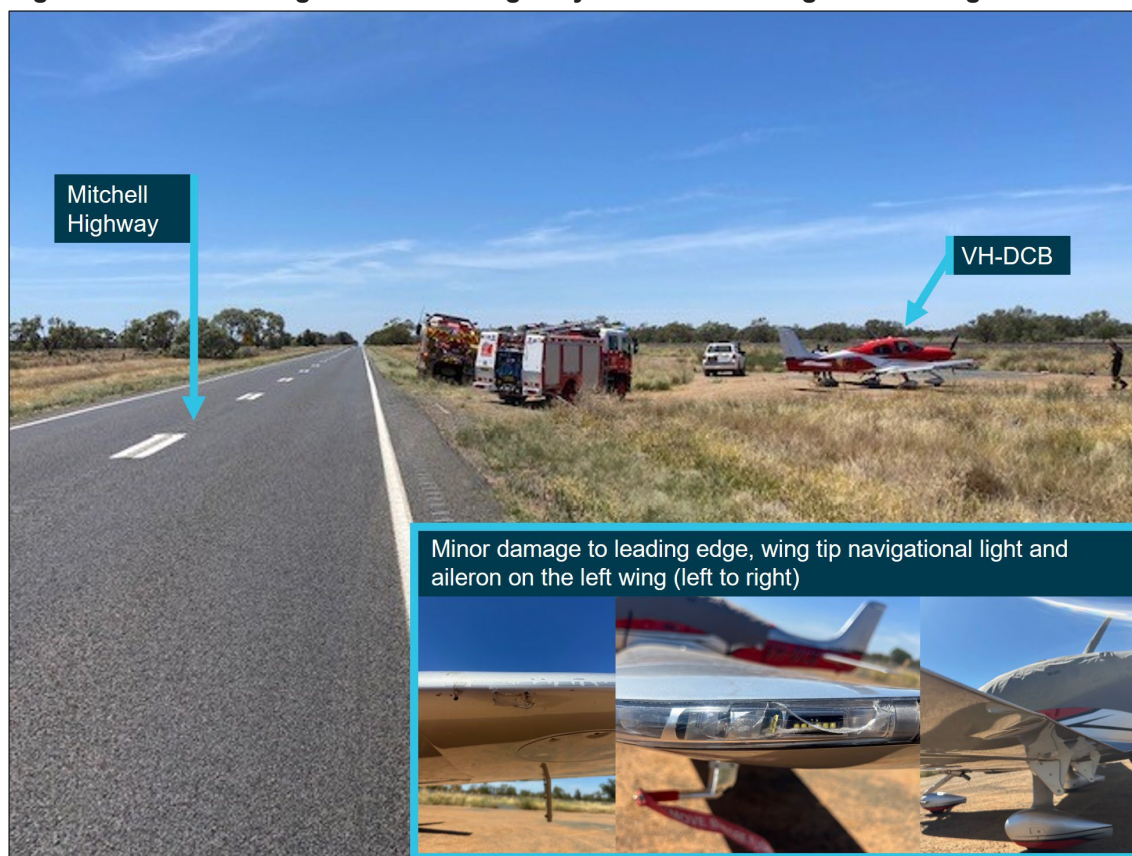
**Figure 2: VH-DCB alongside Mitchell Highway and minor damage to left wing**

The aircraft sustained minor damage to several components on the left wing as a result of colliding with roadside guideposts during the landing roll (Figure 2 right insert) and the pilot and passenger were uninjured. The New South Wales rural fire service attended the scene shortly after the aircraft had safely landed.

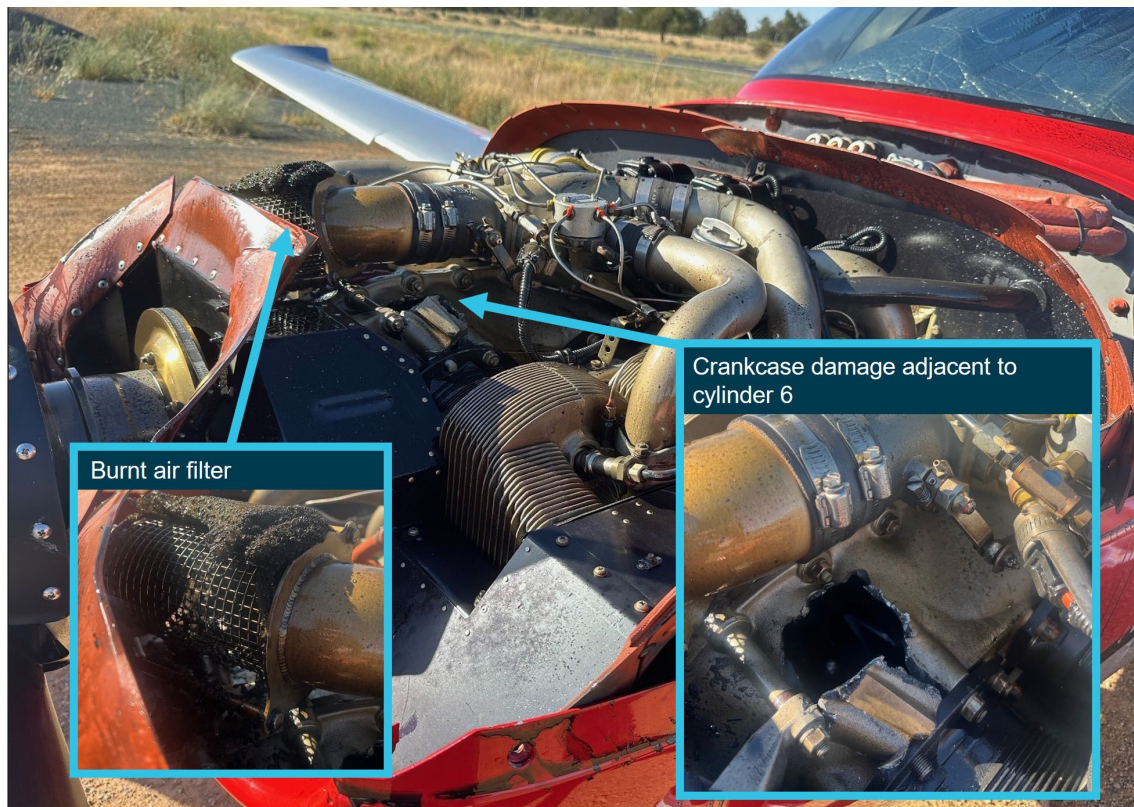
**Figure 3: VH-DCB engine bay and damage to the air filter and crankcase**

The pilot inspected the aircraft engine after the serious incident and found the crankcase had ruptured adjacent to cylinder 6 (Figure 3 right insert) below the induction duct assembly. They recovered a connecting rod that had separated from the crankshaft (Figure 4) and identified that the air filter was visibly damaged as a result of a fire (Figure 3 left insert). The pilot recalled performing a post-landing dipstick check and observed that about 6 quarts of oil remained in the engine.

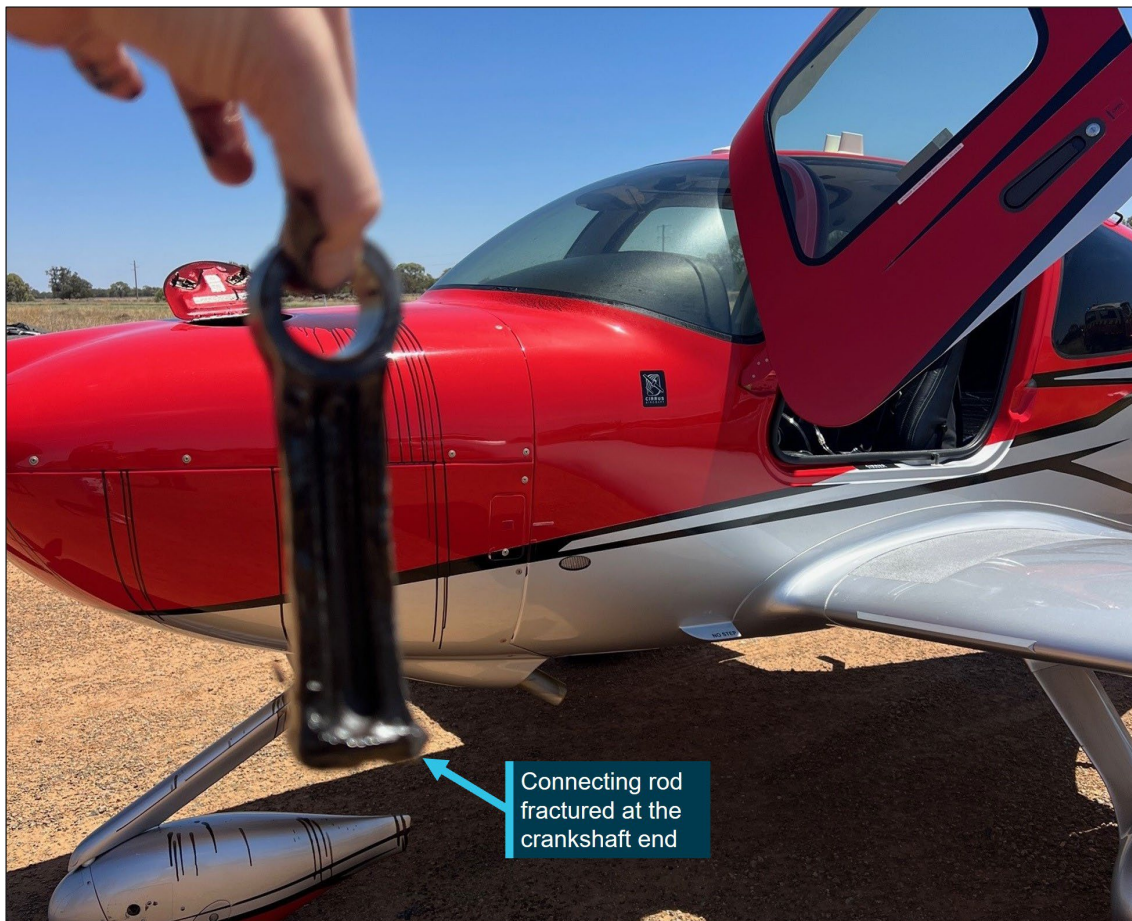
**Figure 4: Fractured connecting rod recovered from VH-DCB**

Due to the remoteness of the location, the aircraft was secured on a nearby property and the engine was retained with the fuselage until a replacement was fitted to the aircraft. Following the subsequent removal of the engine, a disassembly and inspection had not been conducted at the time of publication of this report. As a result, the ATSB was unable to determine the root cause for the loss of oil pressure or the mechanical failure of the engine.

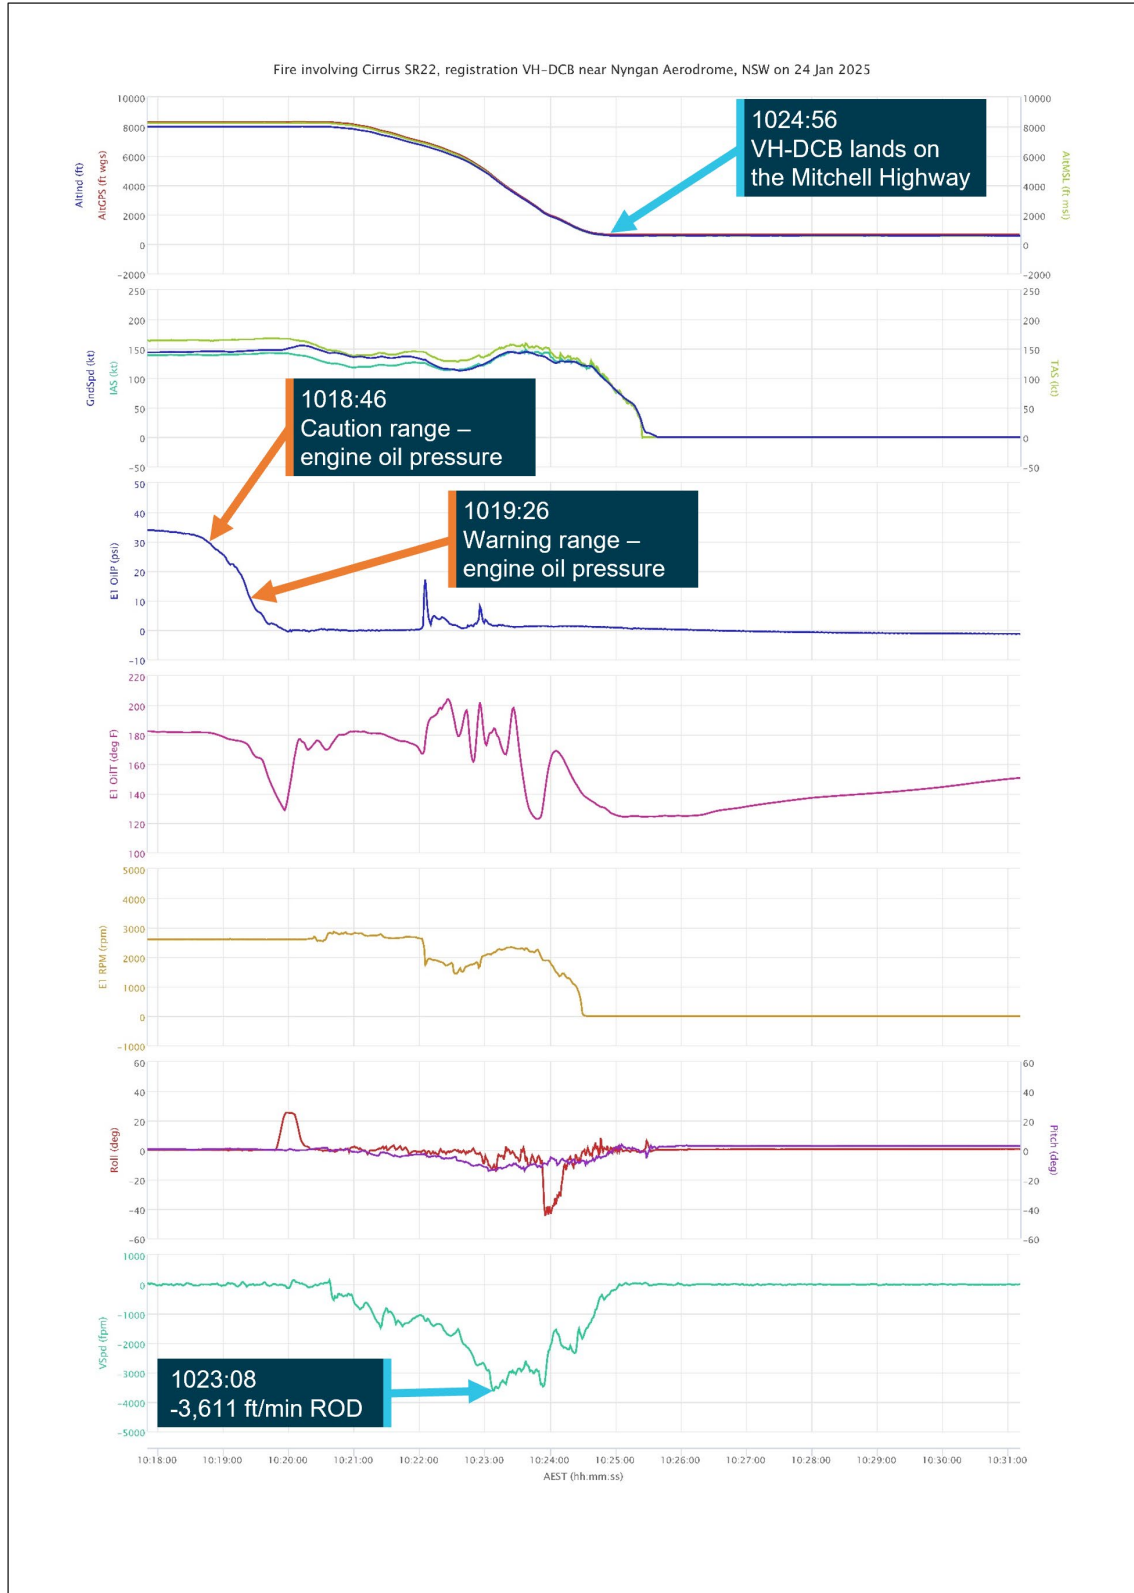
Figure A1: In-flight data and key events after loss of engine oil pressure

The recorded flight data captured parameters such as engine parameters, altitude, airspeed, vertical speed, bank angle and various avionics functions (*Appendix A – Recorded data*). This data enabled a detailed reconstruction of the flight, providing insights into the aircraft’s performance and pilot actions during the occurrence (Figure A1).

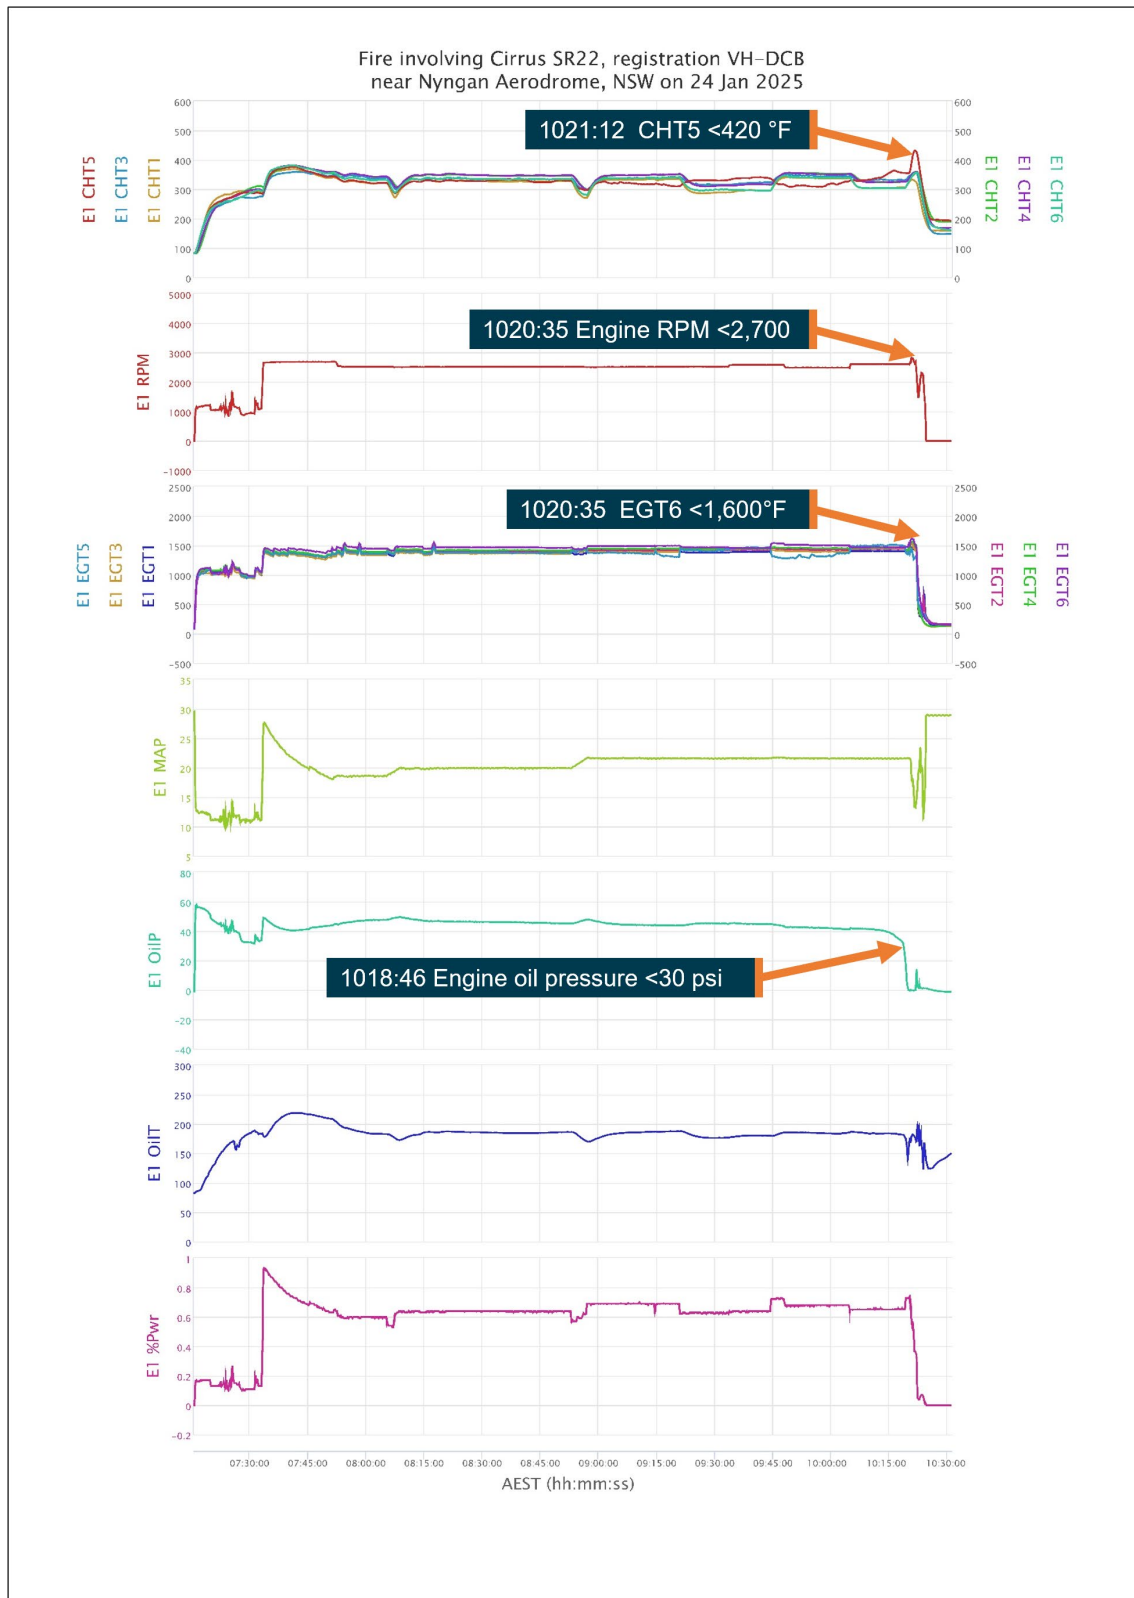
**Figure A2: In-flight engine parameters after loss of engine oil pressure**

Prior to the occurrence, the recorded flight data (Figure A2) indicated that all recorded engine parameters were within normal operating limits outlined in the powerplant limitations section of the pilot’s operating handbook prior to the loss of engine oil pressure. Table 1 depicts the normal and recorded ranges of each engine parameter from the time the aircraft became airborne at 0733:21 until the engine oil pressure decreased below the normal range of 30 psi at 1018:46.
