# Unstable approach involving Embraer E190, VH-UYO

near Darwin Airport, Northern Territory, on 12 February 2025

## **ATSB Transport Safety Report**

AO-2025-012

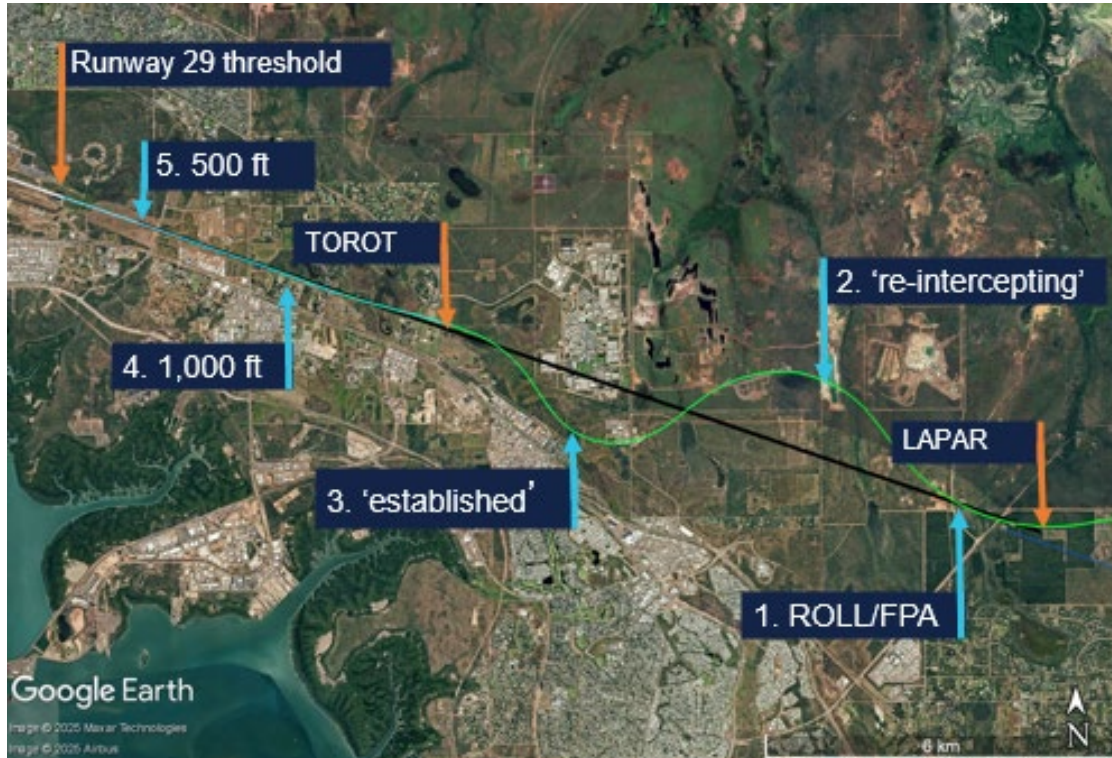
**Figure 2: VH-UYO flight path (green/blue) and ILS-Z localiser path (black) showing key events (blue arrows)**

At 1631, the approach controller cleared the flight crew to descend to 3,000 ft and conduct the instrument landing system (ILS)<sup>4</sup> -Z approach to runway 29. LAPAR was the initial approach fix<sup>5</sup> for the ILS and was aligned with the runway centreline (Figure 2).

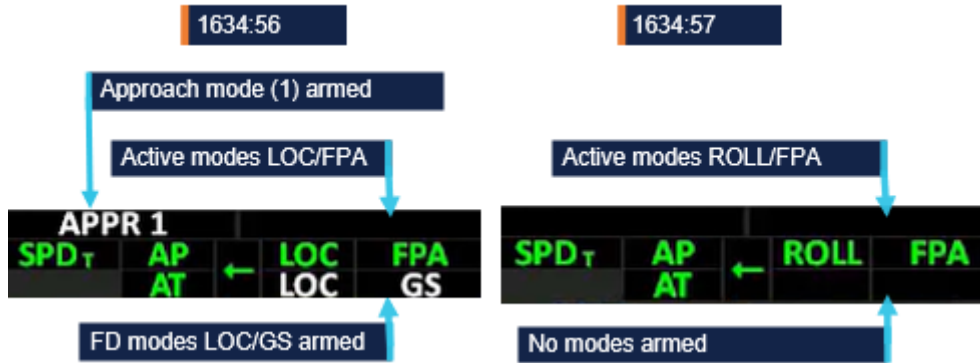
**Figure 3: Flight mode annunciation display showing localiser (LOC) capture followed by reversion to basic modes (ROLL/FPA)**

The ATSB found that on crossing the initial approach fix for the ILS approach, due either to a system synchronisation issue or the pilot flying inadvertently disarming the approach mode, the aircraft's auto-flight system reverted to roll and flight path angle modes.

Recorded flight data showed LOC mode became active and then disarmed within 1 second. The active mode was recorded every second, but the armed mode was recorded every 2 seconds. Hence at 1634:56, the recorded data showed LOC as both the armed and active mode.

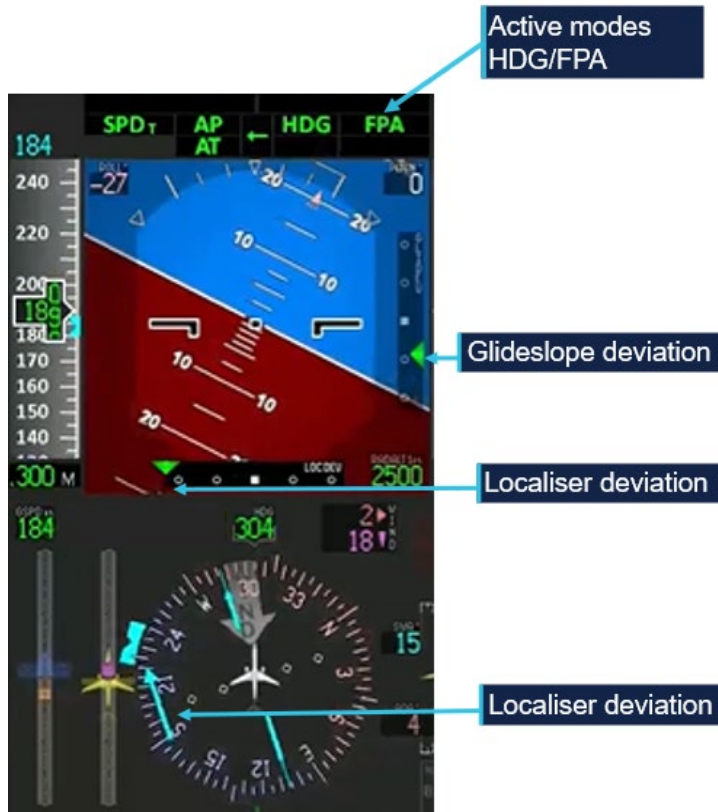
Figure 5: Primary flight display at 1635:30 showing full-scale localiser deviation (localiser left of the aircraft)

- banked 27° left
- at full scale localiser deflection
- one dot above the glideslope
- at 2,470 ft above mean sea level (AMSL)
- descending at 1,254 ft/minute (fpm).

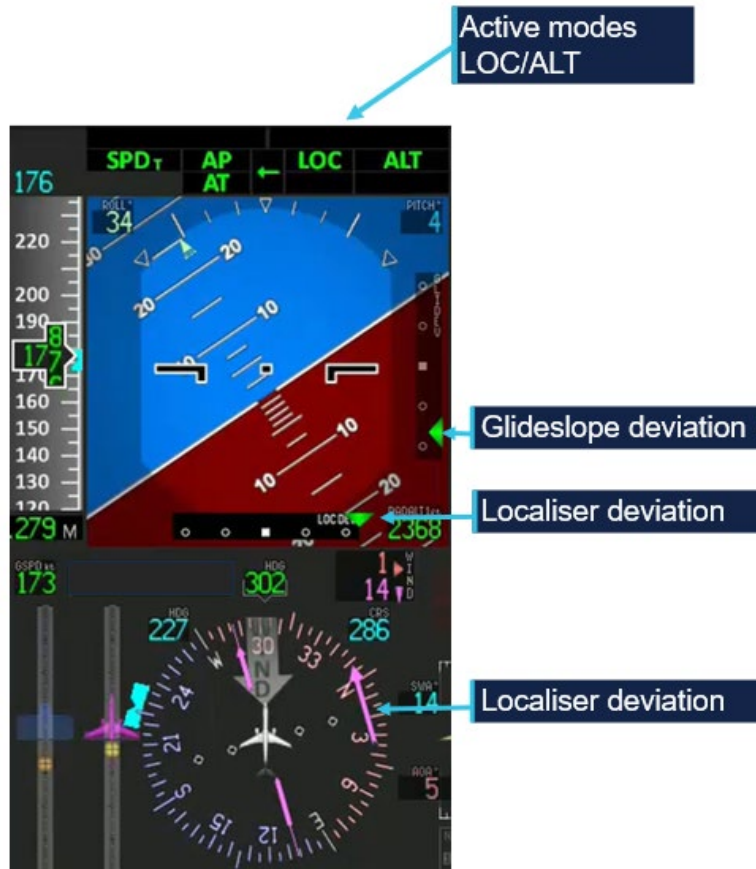
Figure 6: Primary flight display at 1636:22 showing full-scale localiser deviation (localiser right of the aircraft) and nearly 2 dots glideslope deviation (glideslope below the aircraft)

Flap 2 was selected at 1635:55, at about 2,200 ft AMSL. The active lateral mode automatically changed from HDG to LOC mode one second later, but because the APP mode was not armed, GS mode did not become active although the aircraft was within one dot of the glideslope. The aircraft then passed through the localiser 52° off the runway heading, before entering a right turn, as the FGCS commanded re-interception of the localiser course.

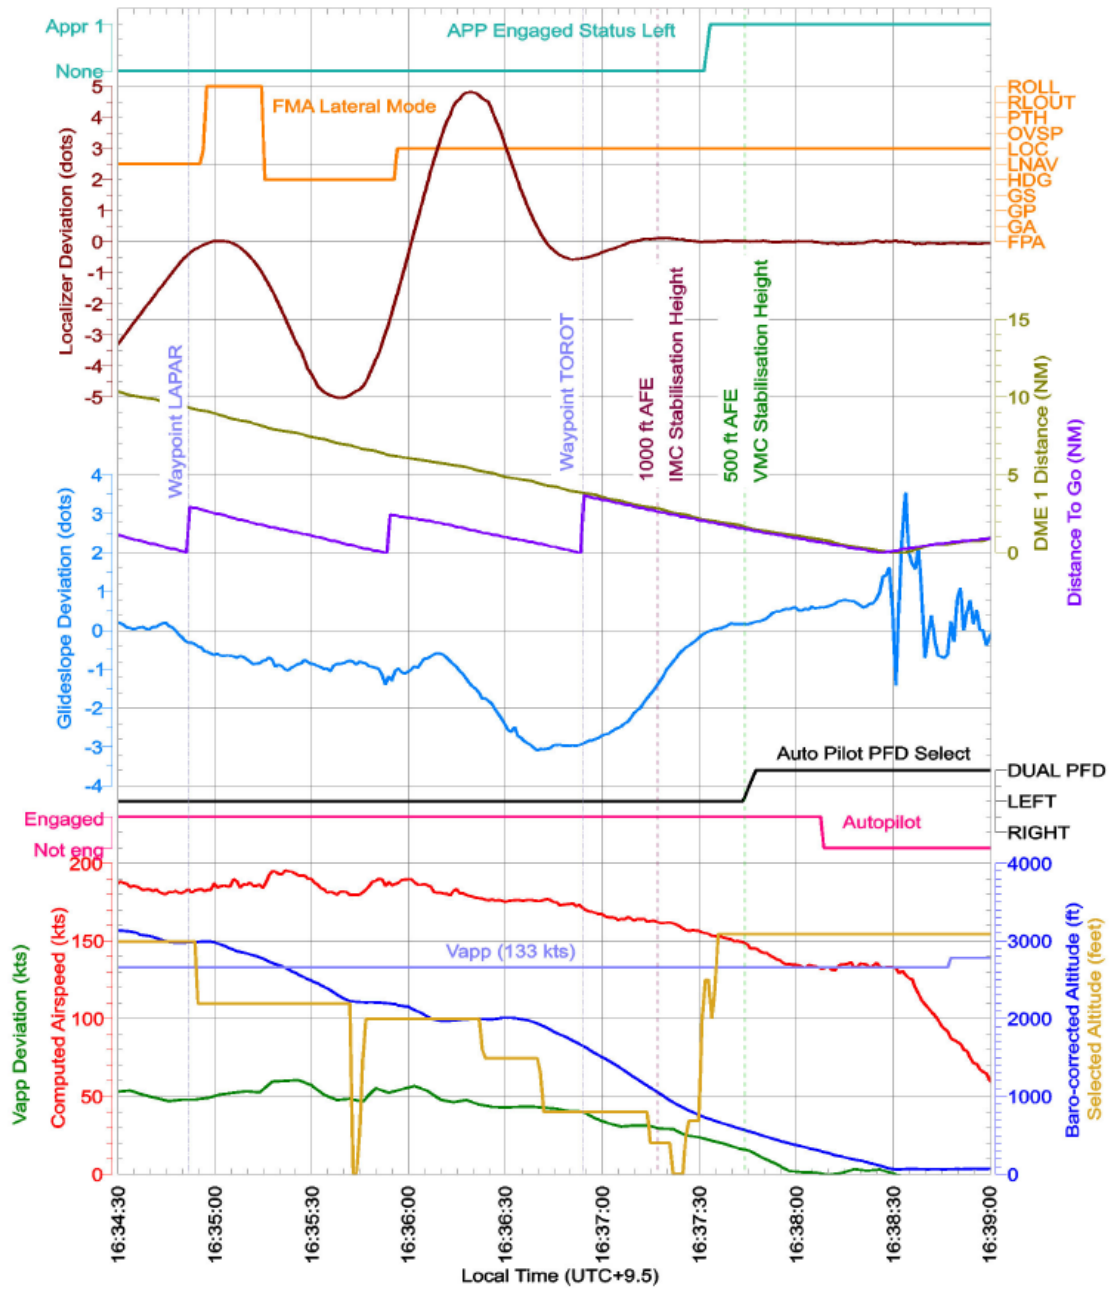
Figure 11: QAR data depicting speeds and key lateral flight path parameters

Although cockpit localiser and glideslope indications showed full-scale deviation of 2.5 dots on the primary flight display and compass instrument, the recorded QAR data captured up to 5 dots deviation. Key parameters depicted in Figure 11 showed:

- airspeed (red) remained above the target approach speed of 133 kt ( $V_{AP}$ ) (purple) until 1638 (deviation in kt – green)
- 5 dot left and right deviations from the localiser course between LAPAR and TOROT
- 3 dot deviation above the glideslope approaching TOROT.
