# **Unstable approach involving Fokker 100, VH-FKF**

near Perth Airport, Western Australia on 29 April 2025

**ATSB Transport Safety Report**  
Aviation Occurrence Investigation (Short)  
AO-2025-025  
Final – 12 August 2025

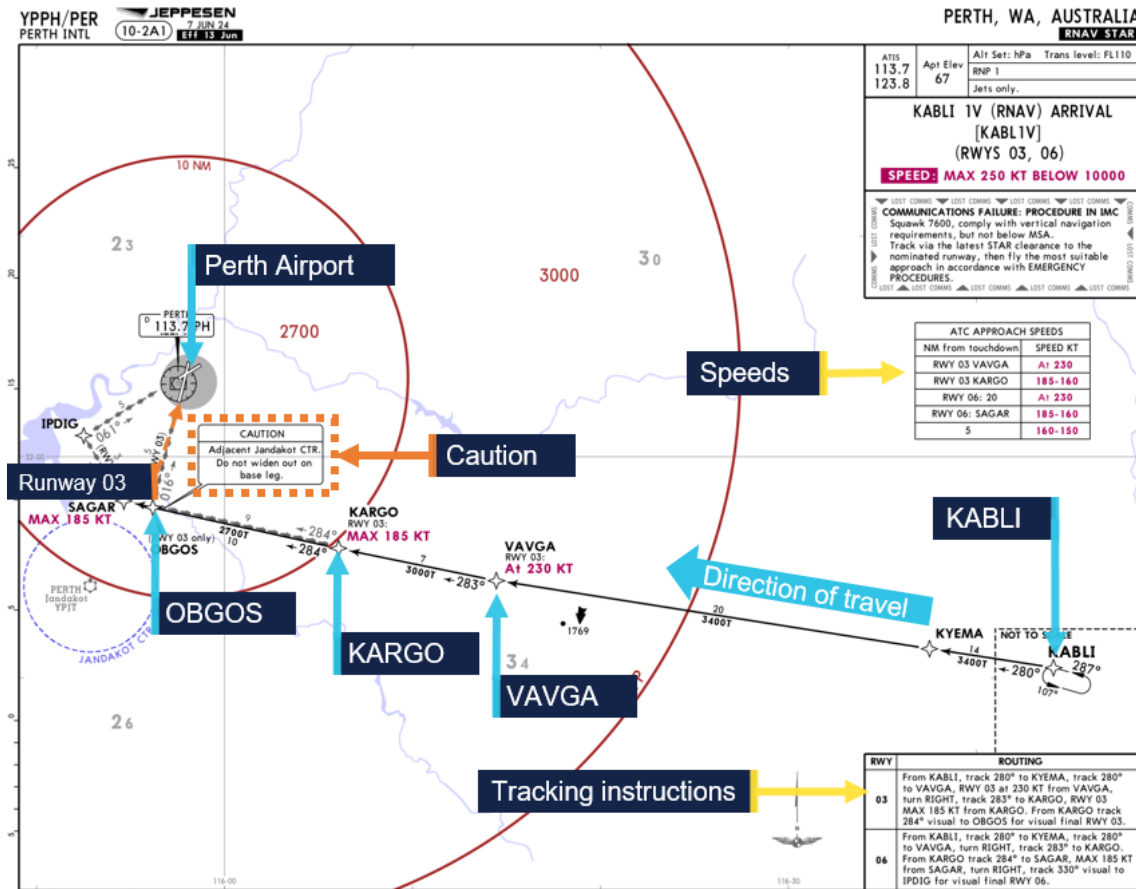
Figure 1: KABLI One Victor Standard Instrument Arrival chart

At about 1449 local time, while in the cruise at flight level (FL) 340,<sup>2</sup> the flight crew received an air traffic control (ATC) clearance to conduct the KABLI One Victor standard instrument arrival (STAR) to Perth Airport's runway 03 (Figure 1).

As ATC had cancelled the STAR speed restrictions, the flight crew did not have to adhere to the airspeeds on the approach chart. Therefore, as the aircraft descended through 5,000 ft, it passed waypoint VAVGA at an indicated airspeed of about

270 kt – 40 kt faster than the published speed restriction. The aircraft subsequently passed waypoint KARGO, descending through about 3,300 ft at 230 kt airspeed – 45 kt faster than the published speed restriction.

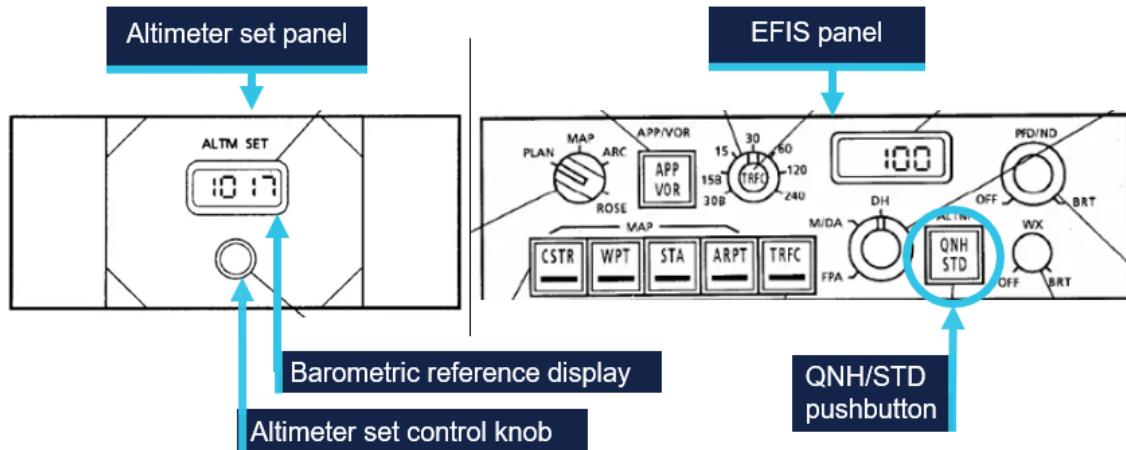
**Figure 2: Altimeter set panel and electronic flight instrument system (EFIS) panel (not collocated)**

Recorded flight data showed that the first officer's PFD altimeter reference pressure changed from STD to QNH passing about FL 114, but the captain's PFD remained on STD. The standby altimeter pressure setting was not recorded, but the captain reported having set the standby altimeter to QNH.

After each setting their own PFD, the standard operating procedures required each flight crewmember to crosscheck all 3 altimeters were set correctly. The PF was required to call out 'Transition [1,024] set. Passing [x] ft now. Speed [x] knots'. The PM was to respond, '[x] ft checked'. The crew reported completing the checks, but did not identify that the no 1 PFD was incorrectly set to STD and therefore indicating about 300 ft lower than the no 2 PFD (and the standby altimeter).

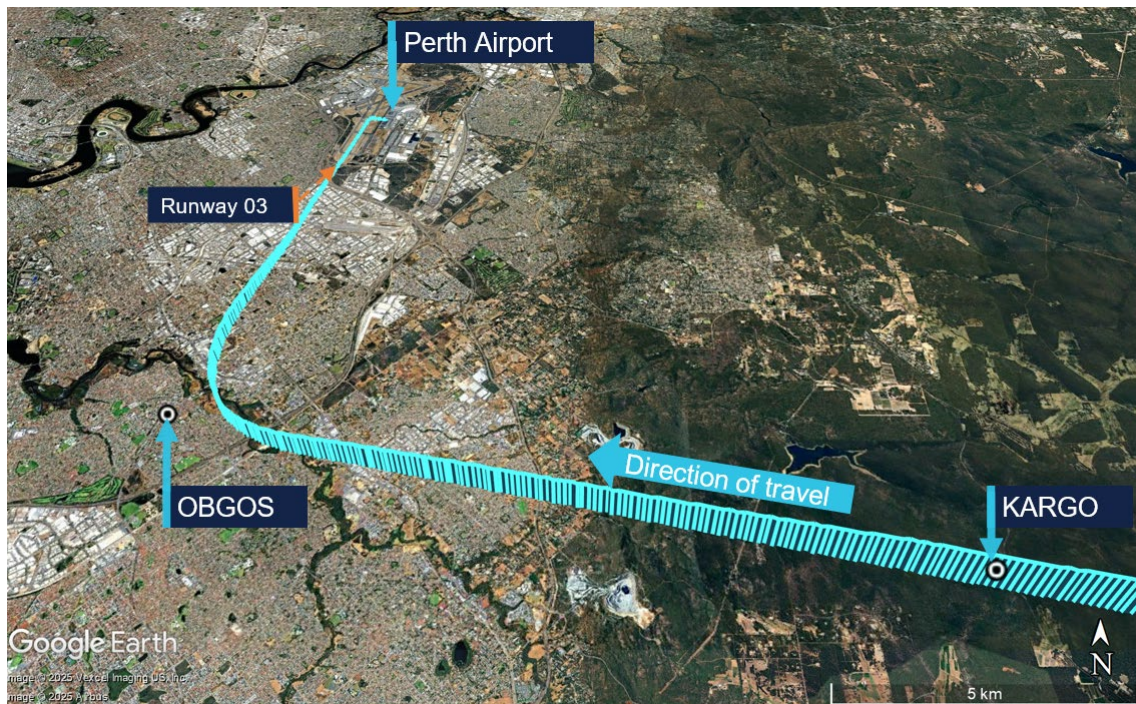
**Figure 3: Recorded flight data showing VH-FKF turn past fly-by waypoint OBGOS**

A review of recorded flight data identified that, at 1536:46, the aircraft commenced the right turn past waypoint OBGOS (Figure 3), at about 2,000 ft above mean sea level (AMSL) and 180 kt airspeed. During the turn, landing gear was extended, followed by flap 25. Just before the aircraft was levelled, the captain deployed the speed brake.

The captain reported identifying a discrepancy between the altimeter and the radio altitude during the turn, passing about 1,500 ft, and assessed it as an instrument error. As they were visual, the captain was primarily focused outside, ensuring the aircraft aligned with the runway and on the correct profile by following the precision approach path indicator (PAPI) guidance.

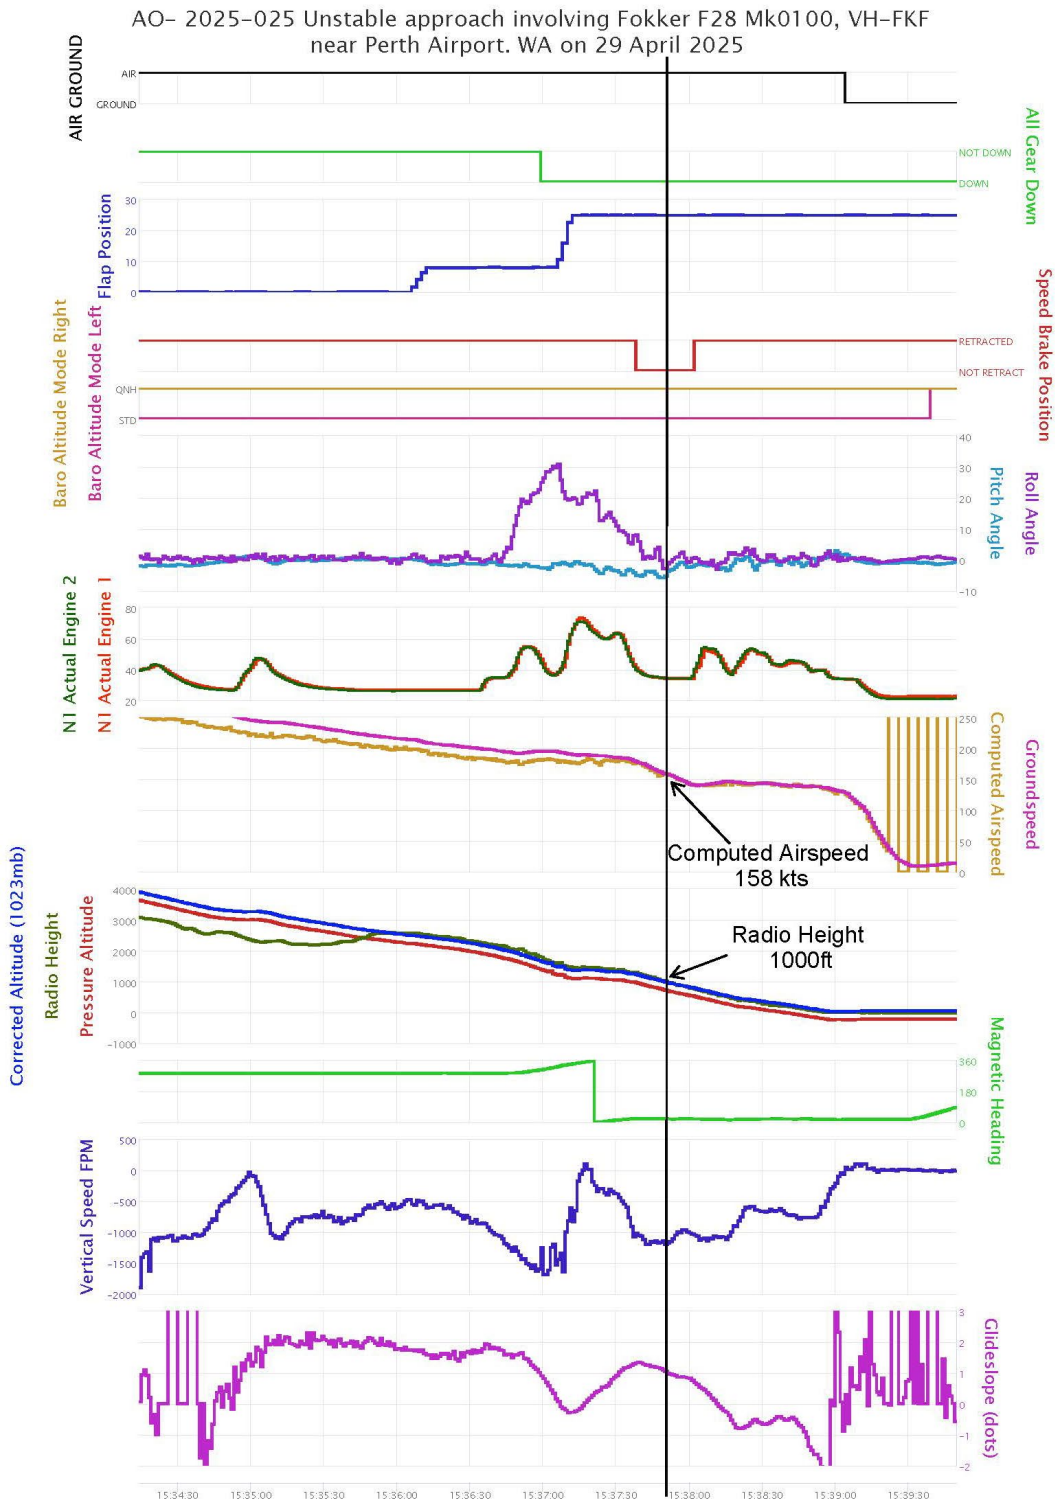
**Figure 4: Recorded flight data of approach to runway 03 from 3,000 ft**

Figure 4 depicts key parameters of the recorded flight data during the approach from 3,000 ft. At 1,000 ft radio altitude, the recorded airspeed was 158 kt, which reduced to the stabilised criterion of  $V_{APP} + 10$  (142 kt) by 800 ft, 9 seconds later. The vertical speed was not recorded but was calculated from the change in recorded altitudes.

Table 1 shows the derived vertical speed, with exceedances of the stabilised criterion of 1,000 fpm between about 1,000 ft and 450 ft radio altitude. These included an expected increase in vertical speed associated with the retraction of the speed brake, passing about 800 ft radio altitude. The recorded data also showed that the aircraft was within one dot of the 3° glideslope from 1,000 ft and therefore on the correct approach profile.
