# Breakaway and grounding of *CSC Friendship*

Port of Brisbane, Queensland on 27 February 2022

**ATSB Transport Safety Report**

MO-2022-003

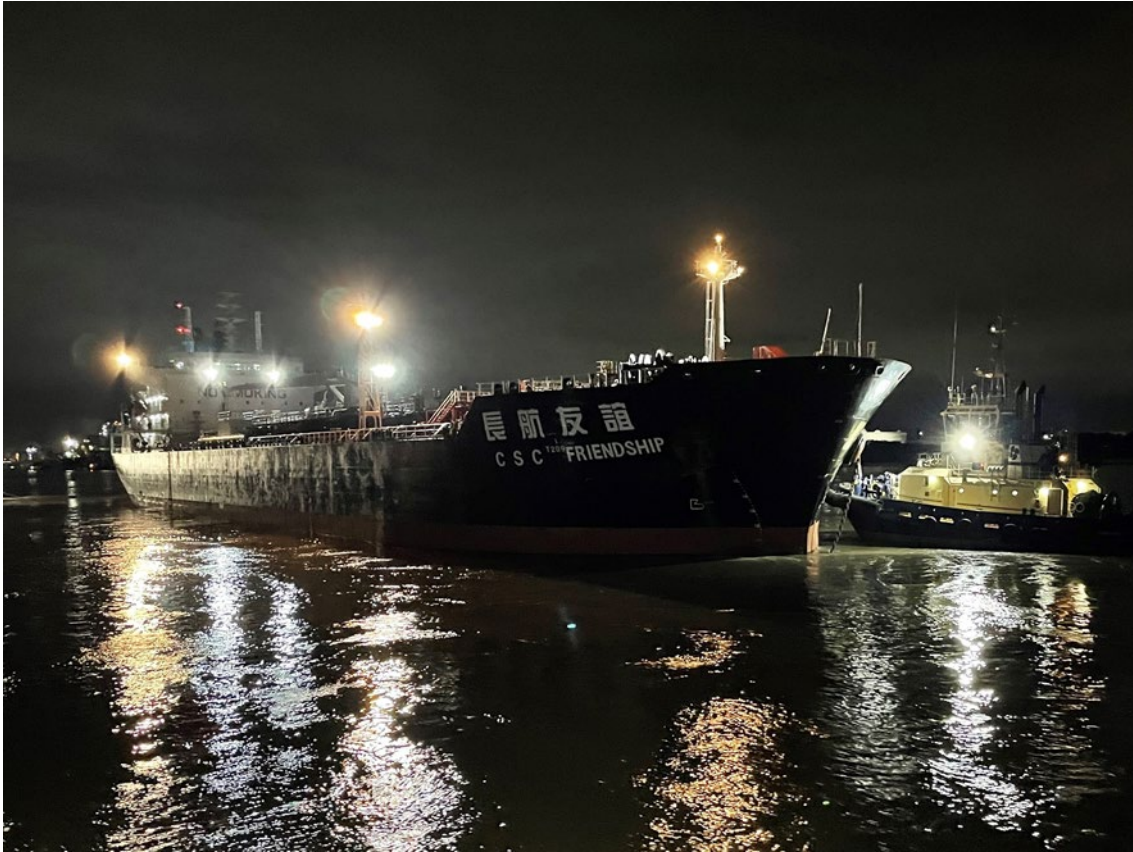
**Figure 2: *CSC Friendship* aground at Lytton Rocks Reach with tug in attendance**

Internal and external hull inspections, including an underwater survey, were carried out while the ship was at anchor. The inspections confirmed shell plate damage, including buckling and medium to heavy abrasion of the hull. However, no hull penetration or cracking of plate or welds was found. The propeller had impact damage on 3 of its 4 blades and the rudder was dented and abraded to its lower parts. Although the steering gear was in working order, a rudder angle of only 25° to port could be achieved (designed maximum angle was 35°).

*CSC Friendship*'s classification society, China Classification Society (CCS), imposed a condition of class on the ship permitting a single voyage to discharge cargo and transit directly to dry dock for repair.

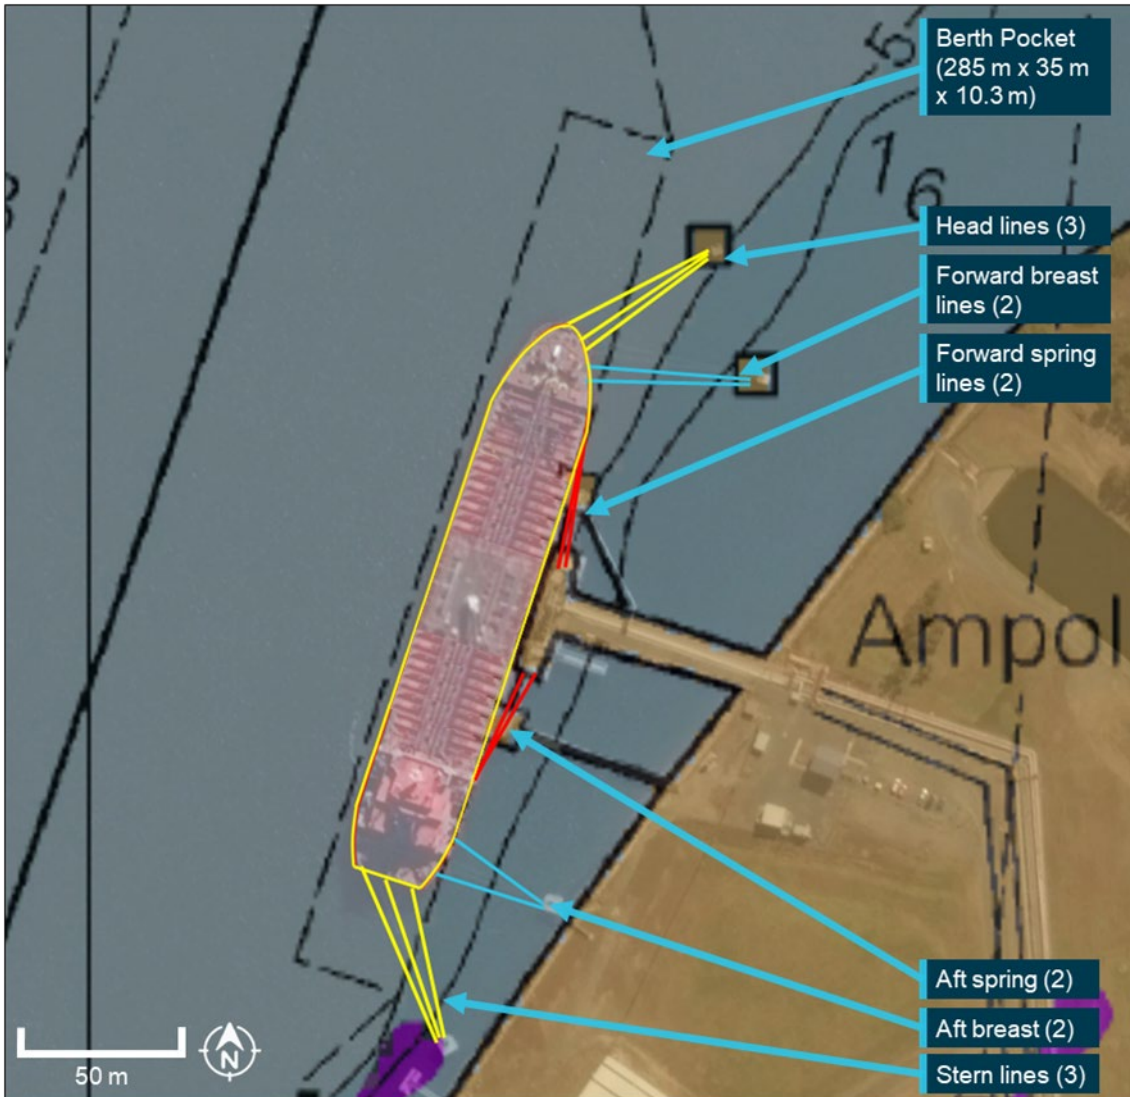
Figure 4: *CSC Friendship's* mooring arrangements

At the time of the breakaway, *CSC Friendship* was secured with 14 polypropylene mooring ropes – 3 head and stern lines, 2 breast lines forward and aft and 2 spring lines forward and aft, or 3-2-2 forward and aft (Figure 4). Each mooring rope had a minimum breaking load of about 51 t and the ship's maintenance records indicated they were in good condition. Of the 14 ropes, 12 were run onto drum winches and held by a manual brake set to slip at about 31 t. The ship was therefore optimally secured at the wharf for a tanker of its size, utilising adequate ship and shore mooring equipment to meet industry standards.

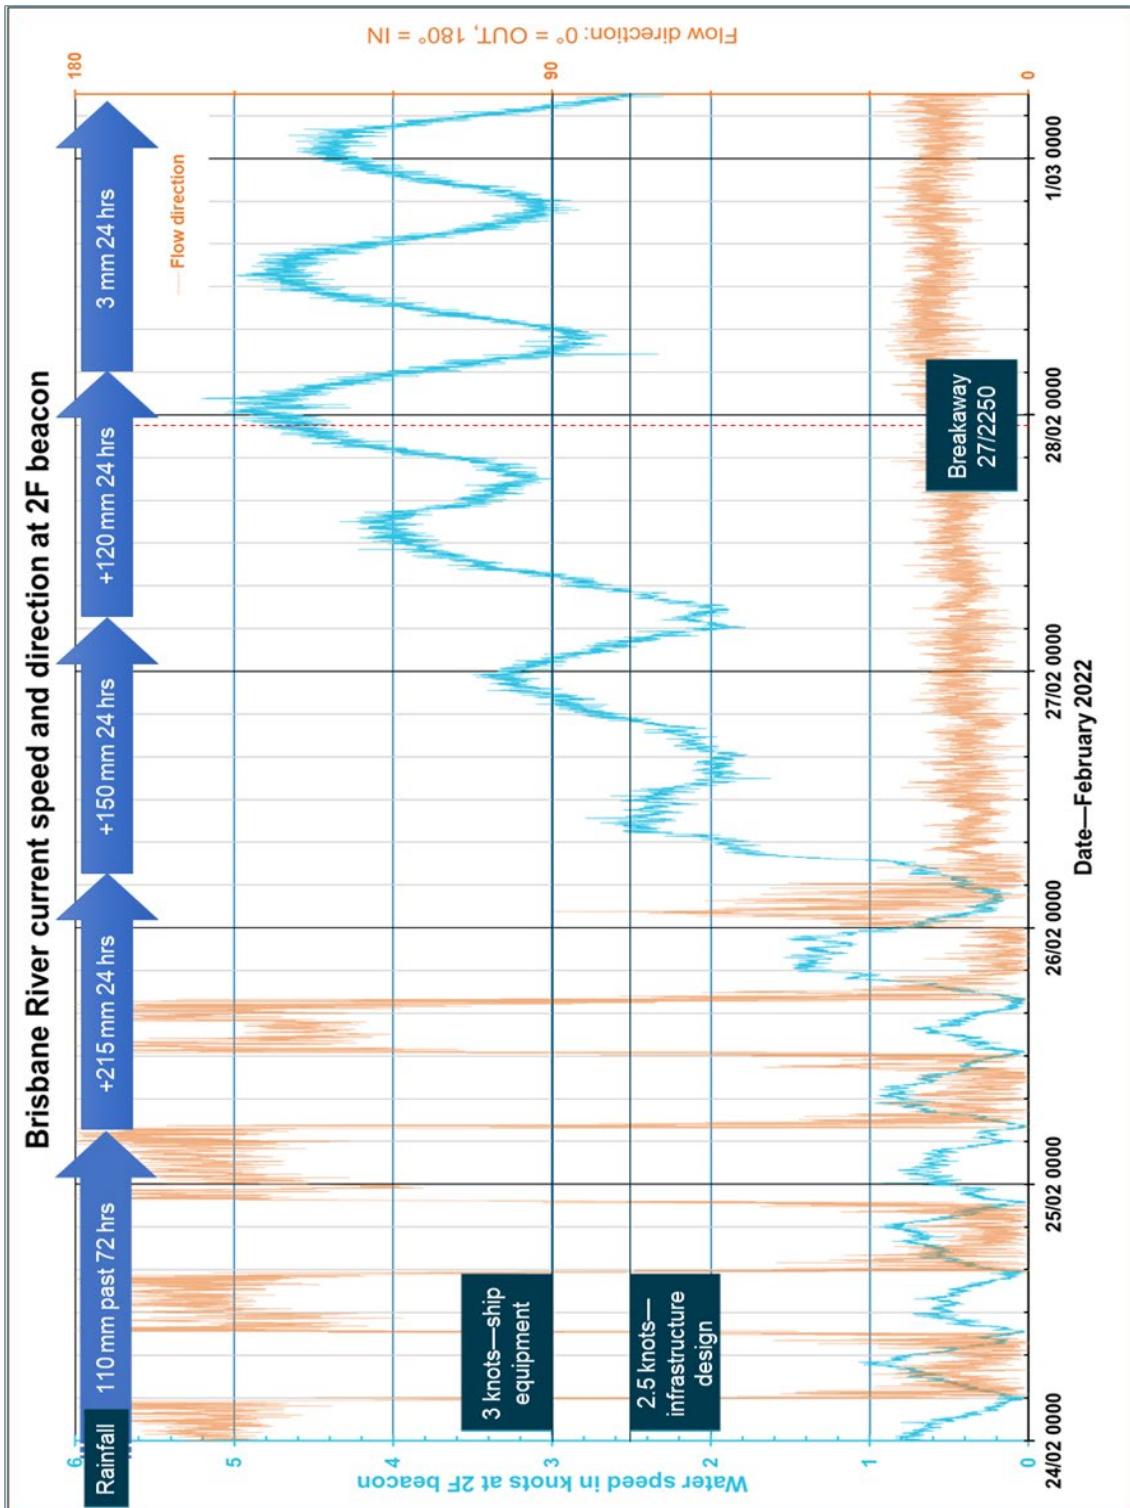
Figure 9: Brisbane River current speed and flow direction

Recorded current data showed that the mooring arrangements and equipment (both ship and berth) withstood current speeds in excess of design requirements on multiple occasions prior to the breakaway (Figure 9).

The mooring equipment and its arrangement to secure ships at the Ampol Lytton Products Wharf were designed to withstand current speed of at least 2.5 knots. Additionally, *CSC Friendship's* mooring equipment was required to withstand 3 knots of current from ahead or astern. At the time that the ship surged ahead, the current was recorded at more than 4.5 knots from astern and had been more than 3 knots for the preceding 14 hours.
