Breakaway occurrences involving *OOCL Brisbane* and *CMA CGM Bellini*

Port of Brisbane, Queensland, on 16 May and 20 May 2022, respectively

ATSB Transport Safety Report

MO-2022-004

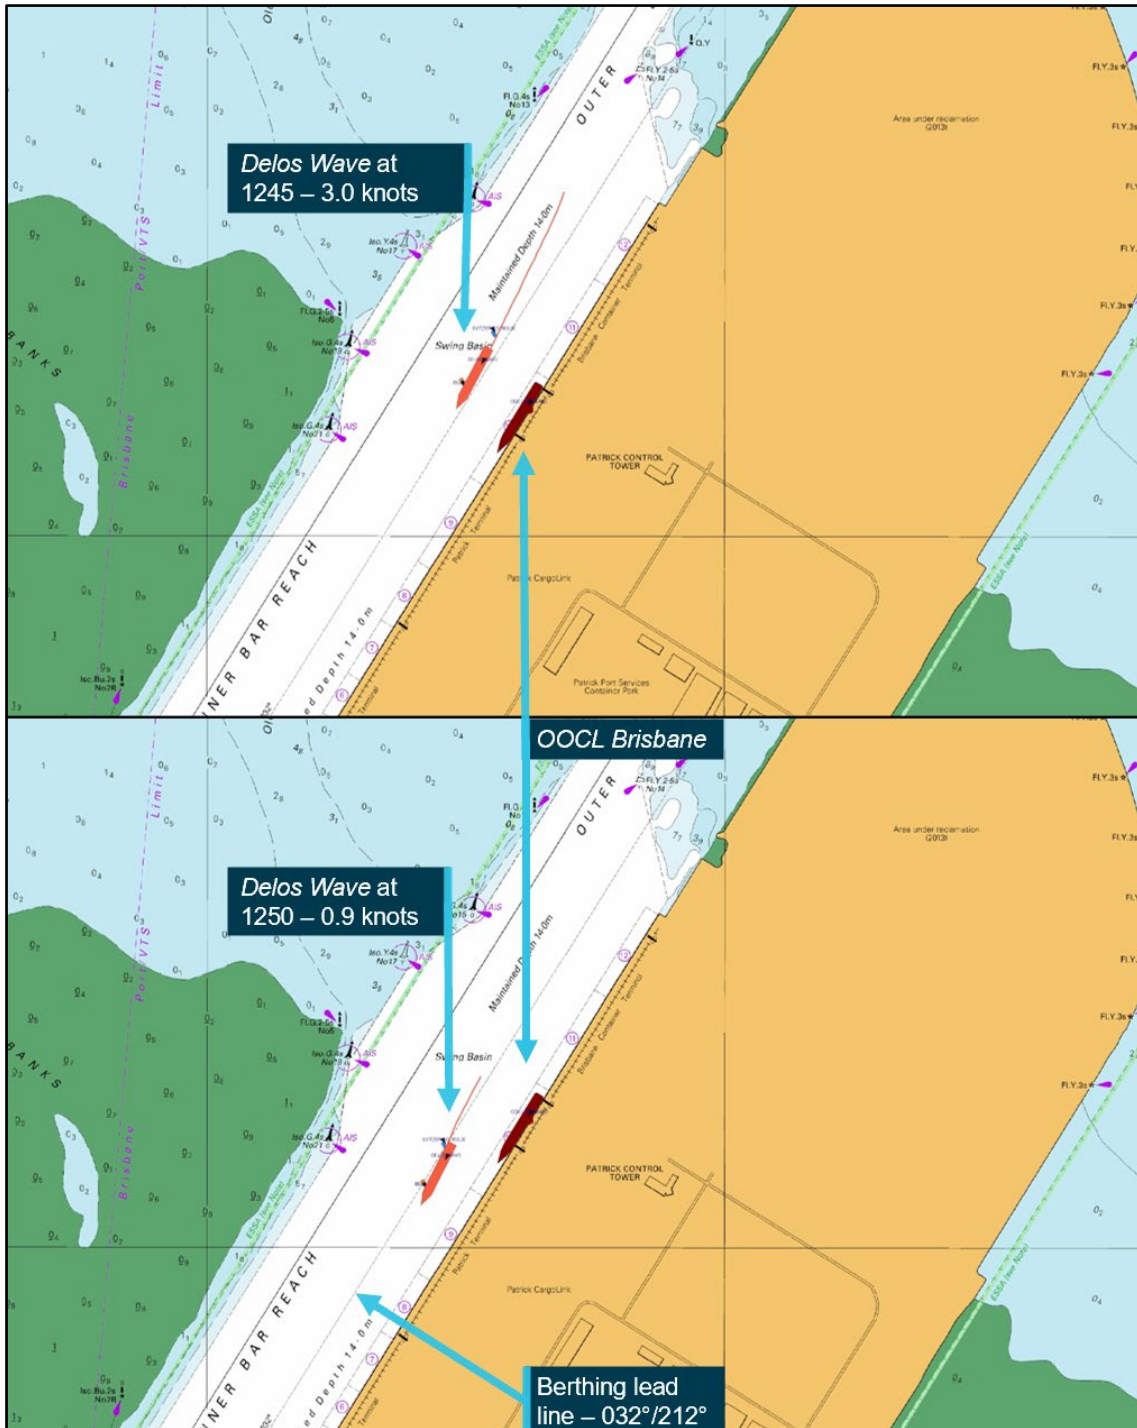
Figure 4: *Delos Wave* passing *OOCL Brisbane*

At 1245, *Delos Wave* was passing *OOCL Brisbane* at a distance of about 113 m at 3 knots (Figure 4, Top). Five minutes later, *Delos Wave*'s speed was 0.9 knots as its stern passed the bow of *OOCL Brisbane*. The distance between the ships was about 100 m.

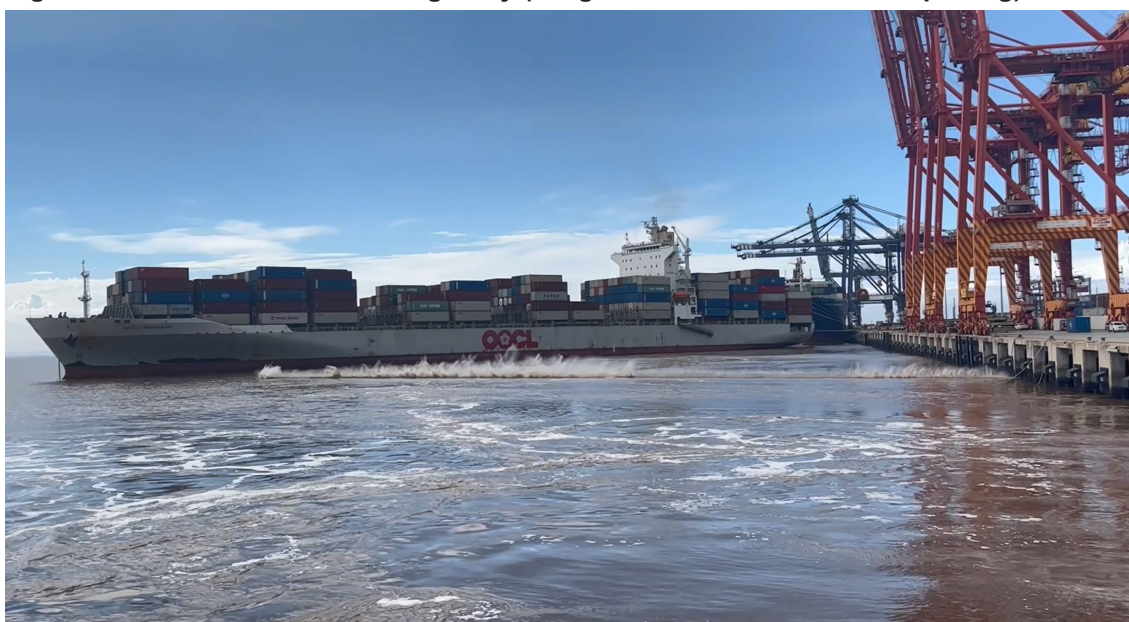
Figure 5: *OOCL Brisbane* breaking away (image shows the last headline parting)

By 1308, all forward lines had parted or fully paid-out (Figure 5). All the aft mooring winches had also begun to pay out and the 2 inboard stern lines turned up on the bits parted at about this time.

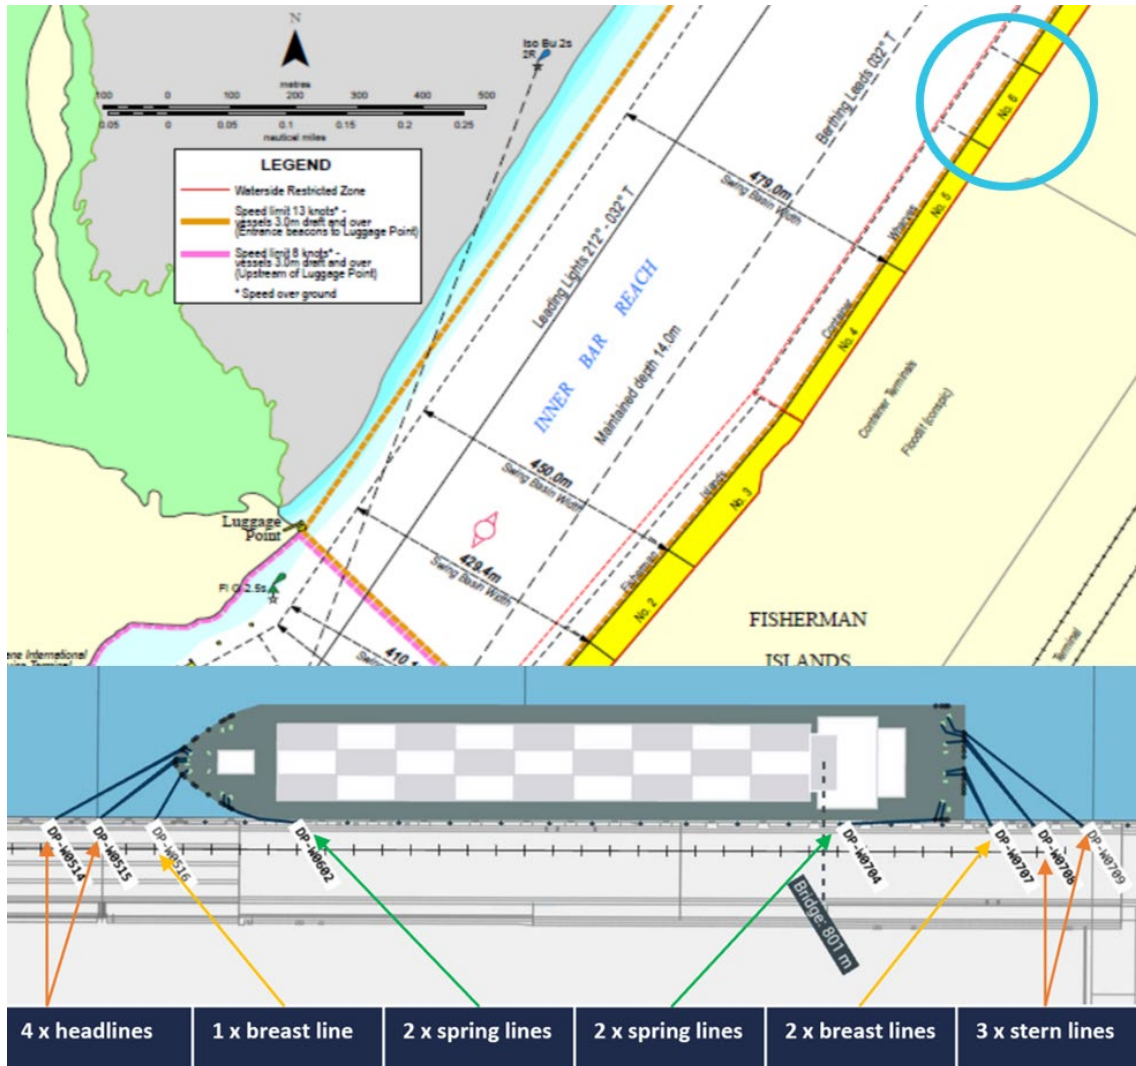
Figure 7: CMA CGM Bellini mooring arrangement

At the time of the breakaway, each of *CMA CGM Bellini*'s 14 nylon (polyamide) mooring lines used to secure the ship alongside (Figure 7) had a minimum breaking load of 96.3 t. The ship's maintenance records indicated they were in good condition. The mooring equipment maintenance records also indicated that the mooring winches and winch brake linings complied with the requirements of class and the ship's safety management system.

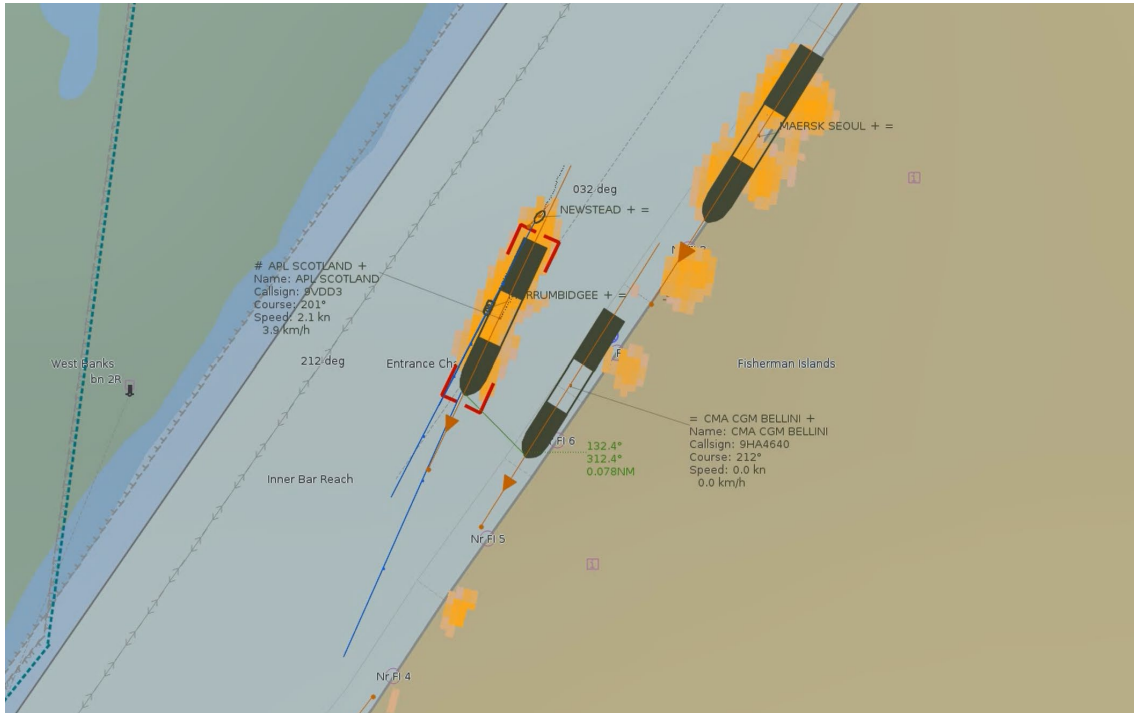
Figure 8: APL Scotland passing CMA CGM Bellini at 0628

At 0625, *APL Scotland*'s speed had slowed to 4.2 knots as its bow came into line with the stern of *CMA CGM Bellini*. At this time, the distance between the ships was about 160 m. By 0628, *APL Scotland* was 120 m off *CMA CGM Bellini*'s beam, at a slight angle to the 212° leading line for berthing and its speed had reduced to 2.1 knots (Figure 8).

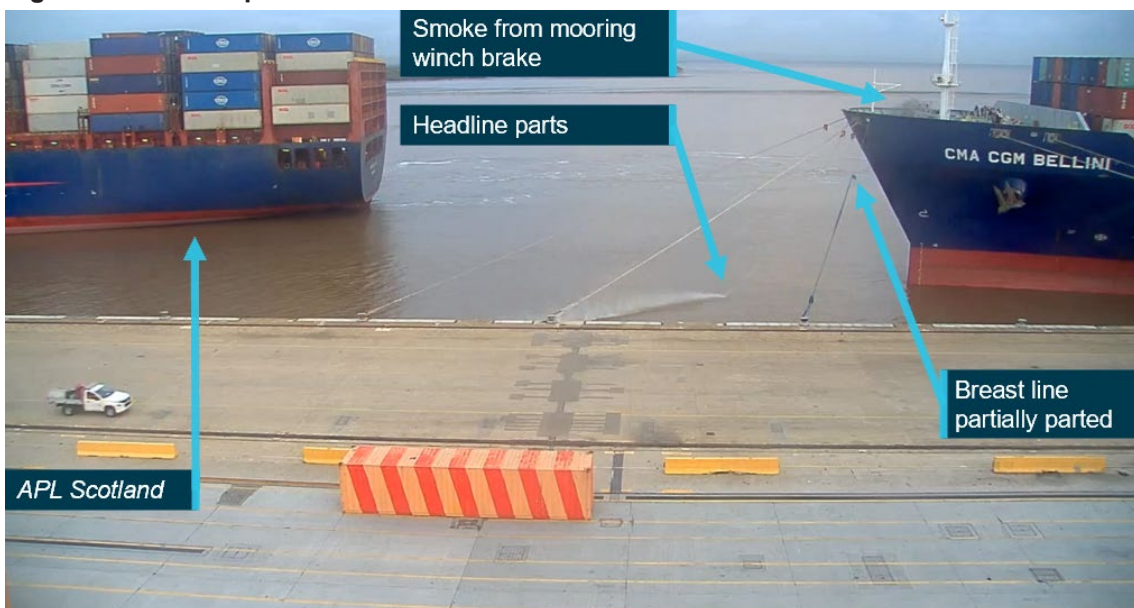
Figure 9: Headline parts at 0635

At 0635, as the pilot began manoeuvring *APL Scotland* towards the berth, one of *CMA CGM Bellini*'s inner headlines began to pay out. A duty crew member on deck saw the bow moving away from the berth and called the duty officer (the third mate) on the bridge (via UHF radio). The third mate alerted the chief mate via radio and then went forward. At 0636, the forward breast line partially parted, followed by the parting of one of its forwardmost headlines a few seconds later (Figure 9).

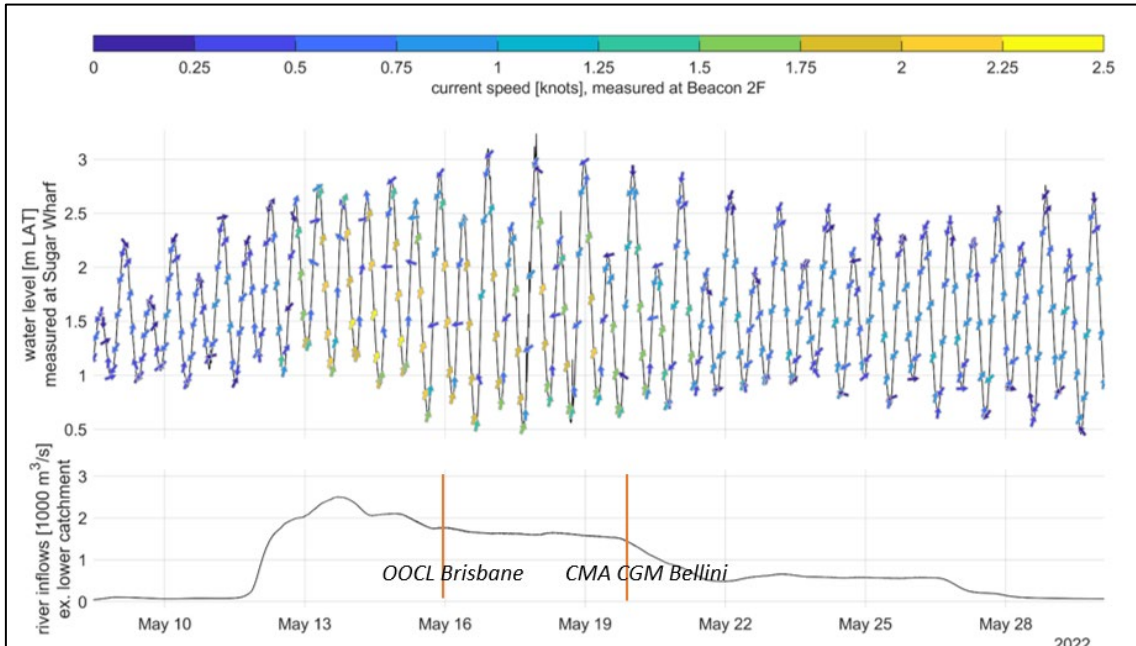
Figure 14: Catchment inflows and subsequent water levels and current speeds

Following heavy rainfall over the Brisbane River catchment areas, the resulting freshwater inflows to the river were observed to generate abnormally high currents in the port, including along the Fisherman Islands berths. These inflows coincided with a perigean⁹ spring tide from 16 May, which resulted in a higher-than-average spring tidal range during the time of both breakaways, thereby further increasing ebb current flows.

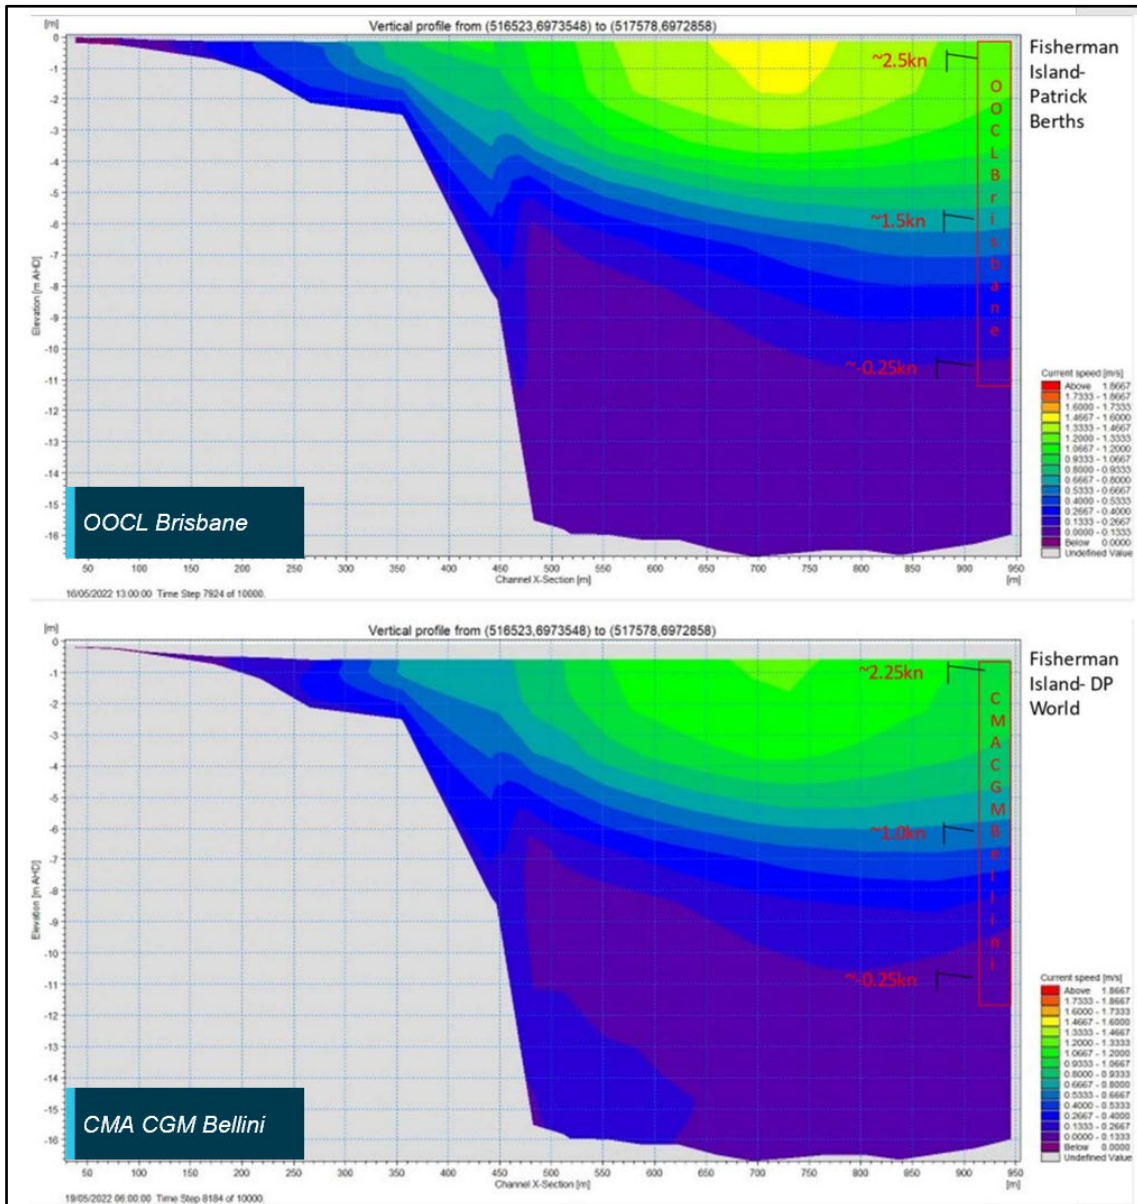
Figure 15: Cross-section of simulated current speeds

The current meter at 2F beacon was installed at a minimum water depth of approximately 5 m. Simulation results produced by Seaport OPX for the time of the breakaways indicated that maximum surface current at the Fisherman Islands berths was greater than that recorded by the meter and estimated the ebb flows to be 1.5 to 2 knots higher than a normal spring ebb tide. Current speed was also found to vary across the channel, with lower speeds closer to the wharf.

The report stated that hydrodynamic conditions 'were complicated by the likely presence of a strong density-driven stratification of the flows over the draught of the moored vessels, with higher speeds and lower water density near the surface compared to at the bottom of the draught of the vessel' (Figure 15). According to modelling, the vertical stratification of the flows over the draught of the moored ships meant that denser saline water could flow slowly upriver even while the freshwater surface layers were flowing seaward at up to 3 knots.
