# Propulsion failure and near stranding of *Portland Bay*

On the coast 22 km south of Port Botany (Sydney), New South Wales, on 4 July 2022

Marine Occurrence Investigation (Systemic)

MO-2022-006

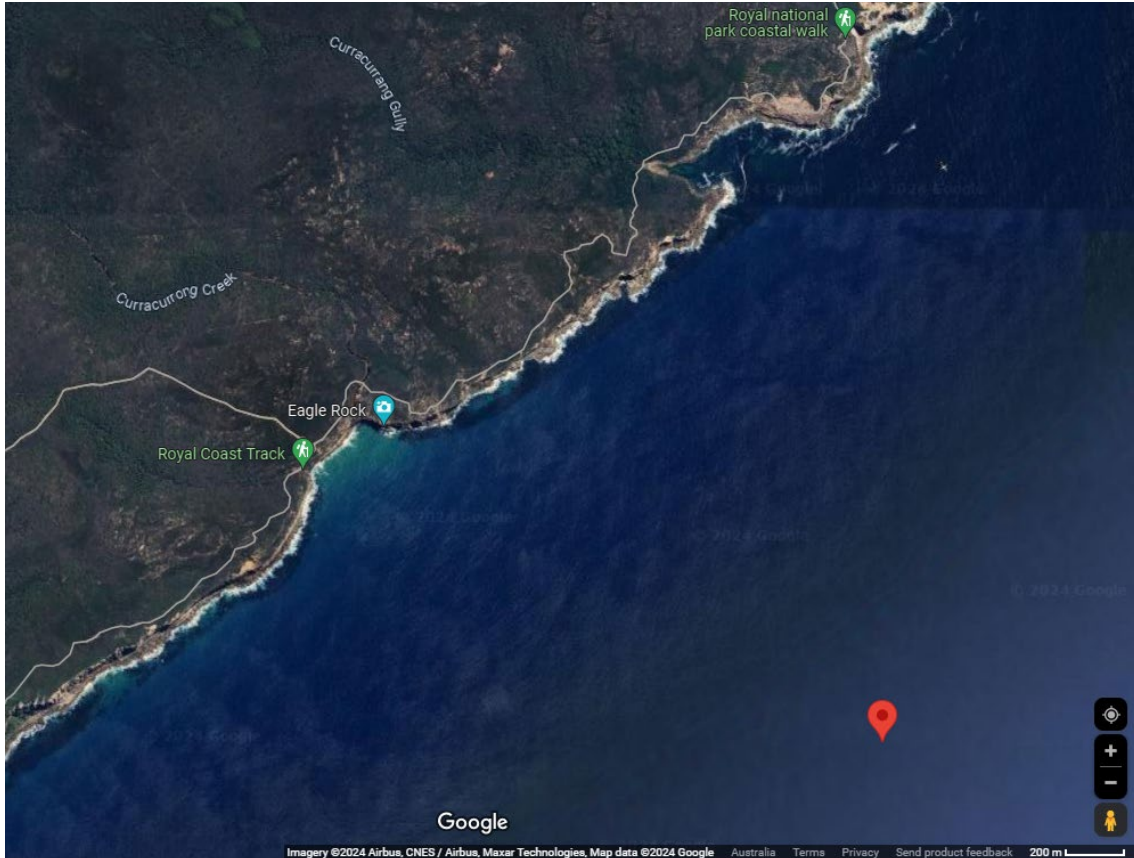
**Figure 5: Ship’s anchor position (red marker) off Eagle Rock**

go at 0909 and, by 0915, its cable had been secured with 7 shackles out. Soon afterwards, the engine was stopped. The ship was anchored in depths of 45 m with a sandy seabed about one mile from the shore (Figure 5).

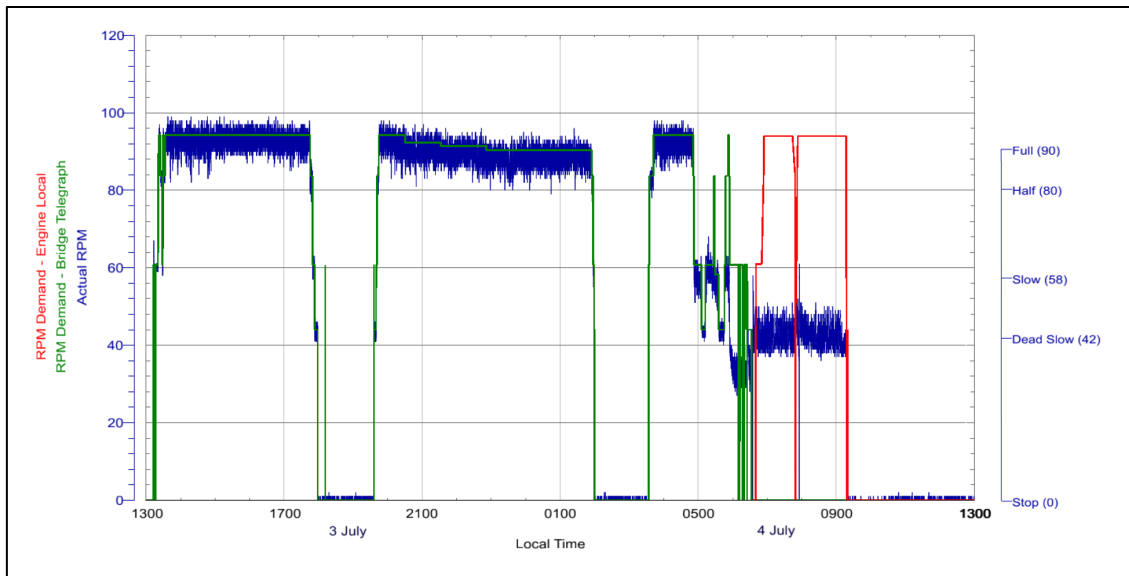
**Figure 9: Engine speed demand (green or red) and actual speed (blue) on 3 and 4 July**

After *Portland Bay* left Port Kembla on 3 July and the pilot disembarked, the main engine order (demand) was set at full ahead (90 rpm). The engine rpm achieved fluctuated widely about the demand (90 rpm) as the ship (in ballast condition) rolled and pitched heavily in the prevailing weather conditions with its propeller not always fully immersed (Figure 9).

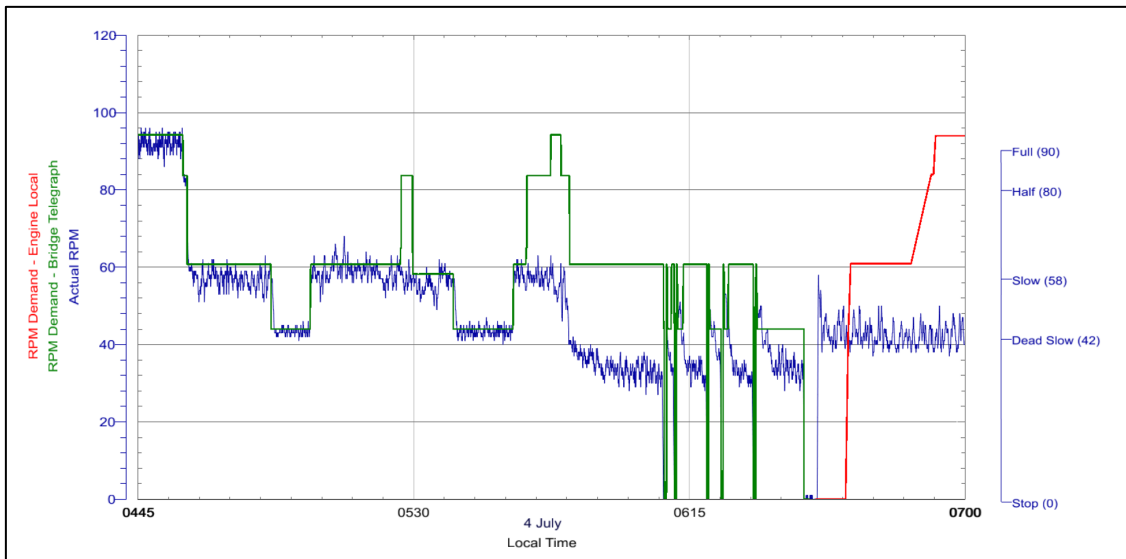
**Figure 10: Speed demand (green or red) and actual speed (blue) from 0445 to 0700, 4 July**

made to increase speed beyond slow ahead, the engine did not respond to the speed demand (Figure 10).

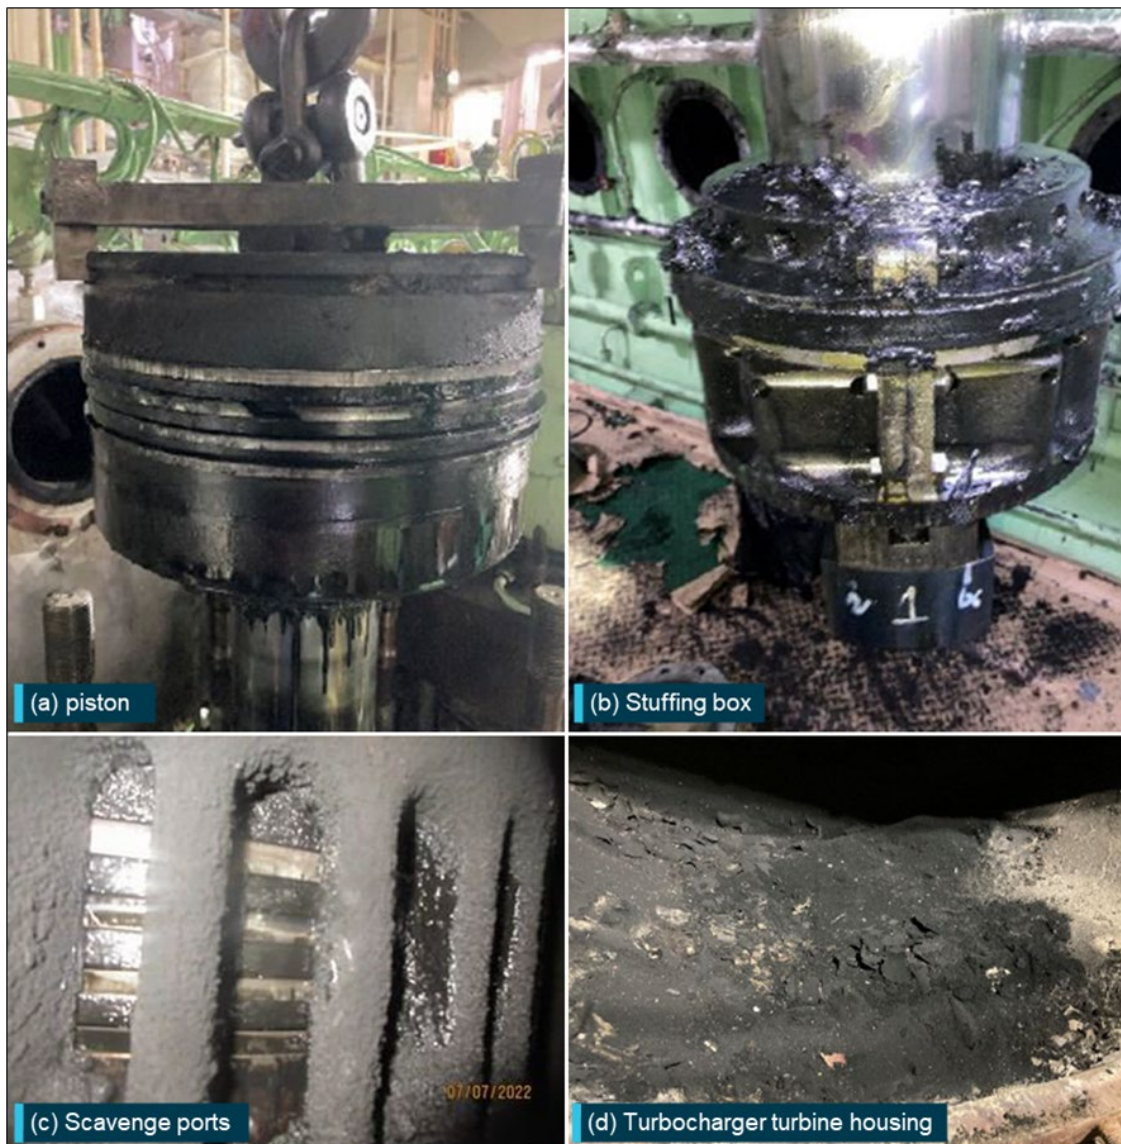
**Figure 11: Condition of some engine components**

- piston, ring and ring gap measurements close to wear limits

A build-up of carbon, fuel and deposits throughout the scavenge system, pistons, turbocharger and other engine components was also evident. Figure 11 shows the condition of a piston (a), stuffing box (b), scavenge ports (c) and turbocharger turbine housing (d).

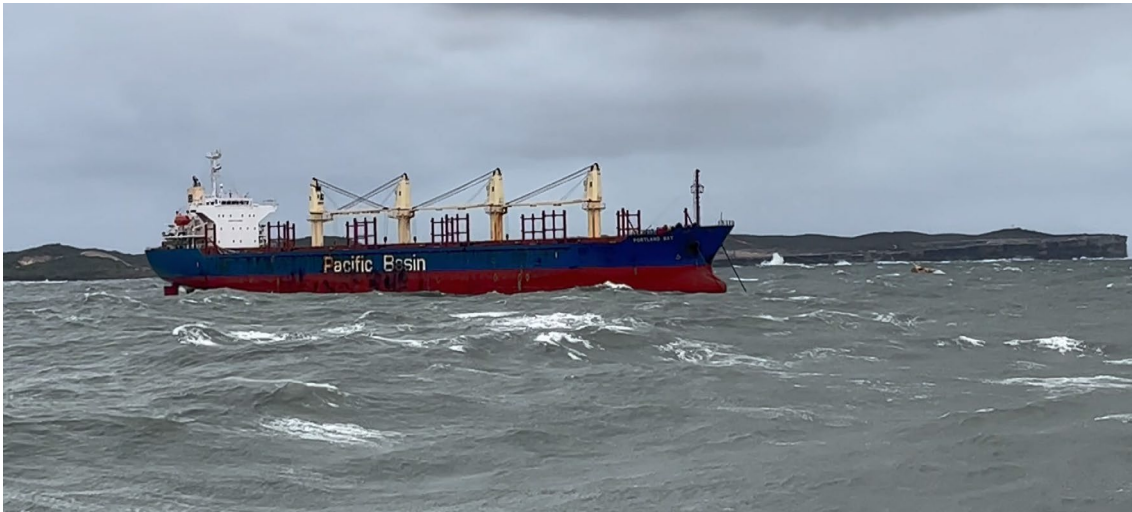
**Figure 13: *Portland Bay* at anchor about one mile from the cliffs near Eagle Rock**

Anchor position 1 was about one mile from the cliffs near Eagle Rock south of Wattamolla (Figure 13). Similarly, anchor position 2 was about one mile from the nearest reef in Bate Bay. The ship dragged its anchors towards the shore in both locations. As described in the Admiralty Sailing Directions,<sup>46</sup> the coastline between Port Kembla and Sydney offers little to

The Sailing Directions stated that the coastline from Port Kembla extends in a northerly direction for 10 miles to Bellambi Point and then runs in a north-north-easterly direction. The Directions indicated that the shore is generally low up to the vicinity of Coalcliff (19 miles south of Sydney) after which the coastline is dominated by cliff faces and rocky shores. The Directions noted that Garie Beach breaks the line of cliffs fronting the coast between Stanwell Park (near Coalcliff) and Wattamolla (11 miles south of Sydney). It was stated that, between Wattamolla and Port Hacking Point, the coast is a continuous line of cliffs broken only by Marley Beach. The proximity of the cliffs and rocky shores to anchor position 1 made it a very hazardous location (Figure 13).
