Derailment of freight train Y279

Traveston, Queensland, on 23 February 2022

ATSB Transport Safety Report

RO-2022-003

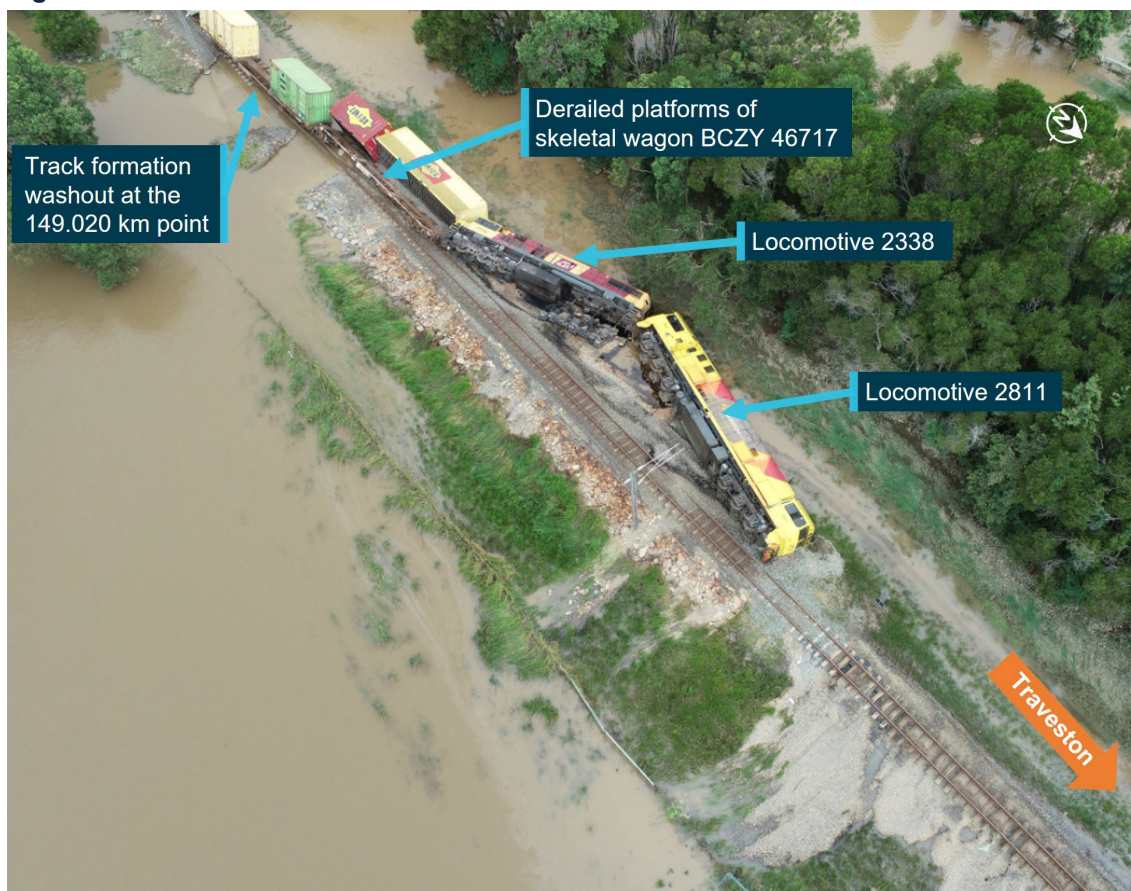
Figure 2: Derailed rail vehicles from train Y279

The image (taken later on the day of the derailment) shows derailed rail vehicles from train Y279, washout and other damage to the track formation.
Source: ATSB

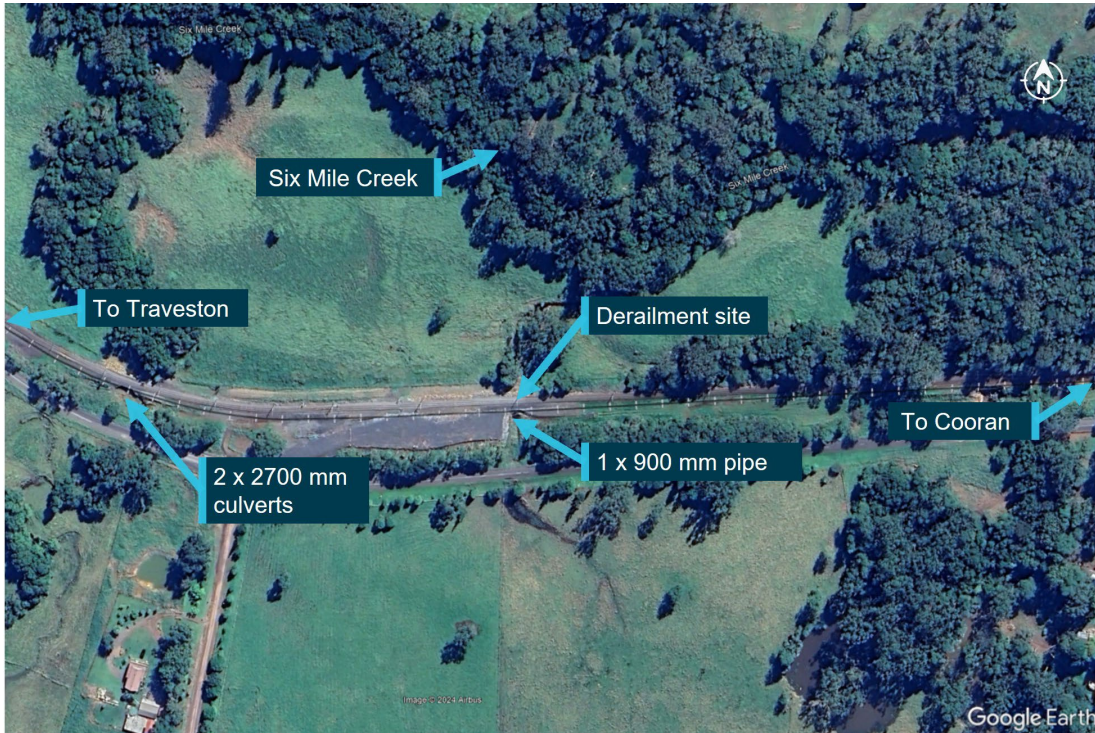
Figure 9: Cross-track drainage systems installed near the derailment site

The track adjacent to the derailment site had a 900 mm diameter concrete pipe installed beneath the track formation at the 149.020 km mark. To the west of the derailment site, 2 x 2,700 mm concrete box culverts were installed beneath the track formation at the 149.280 km mark. The undertrack drains were installed on 4 January 1998 and 6 December 1951. The flow of rainwater run-off through these drainage systems was generally from the south toward the Six Mile Creek in the north (Figure 9).

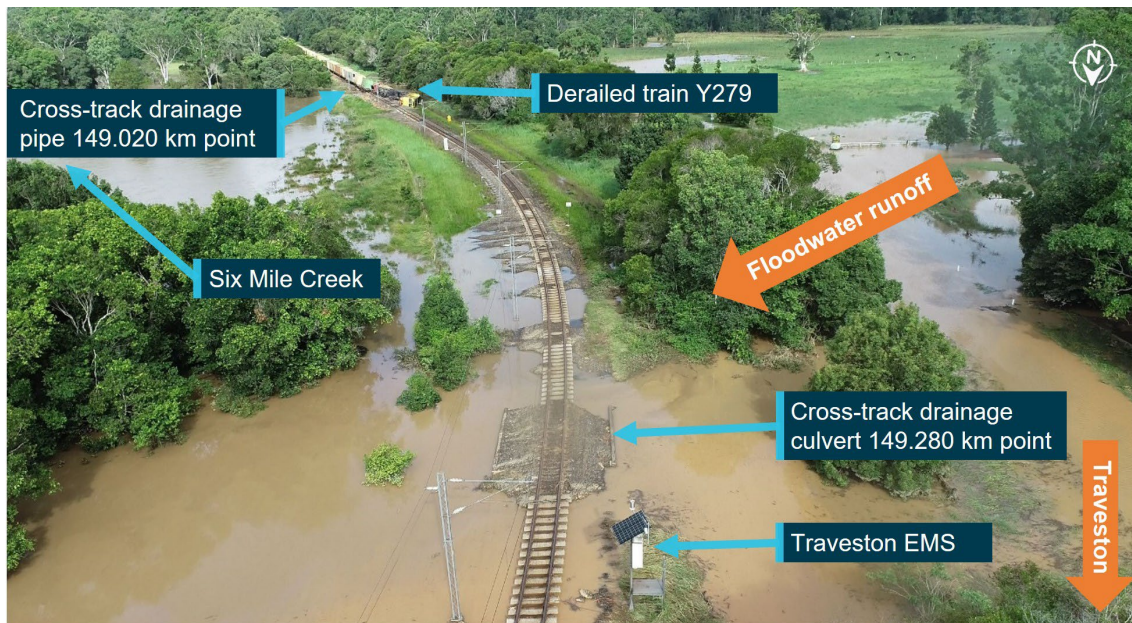
Figure 13: Location of Traveston wayside environmental monitoring station and cross-track drains

The image taken later on the day of the derailment shows the relative locations of the derailed train Y279, cross-track drains and the Traveston weather station.
Source: ATSB

The Traveston station recorded rainfall, water level (flood) and temperature data. At the time of the accident, no rainfall data was recorded from the station due to a faulty sensor. As there was no formal procedure in place at the RMC for network control personnel to be notified of such an unserviceability (refer to section titled *ATSB investigation (RO-2018-007)*), QR were unable to determine if personnel were made aware the function was faulty, and that no rainfall data was available from that site.

The Traveston EMS was also equipped with CCTV for assessing the local conditions at the cross-track drainage point. However, at the time of the derailment of train Y279, the CCTV camera was not fitted with a memory card and was not operational. QR was unable to determine when or why the memory card was removed or whether network control personnel at the RMC were made aware the equipment was faulty and not available for use. As mentioned above, there was no formal procedure for network control personnel to be notified of an equipment unavailability.

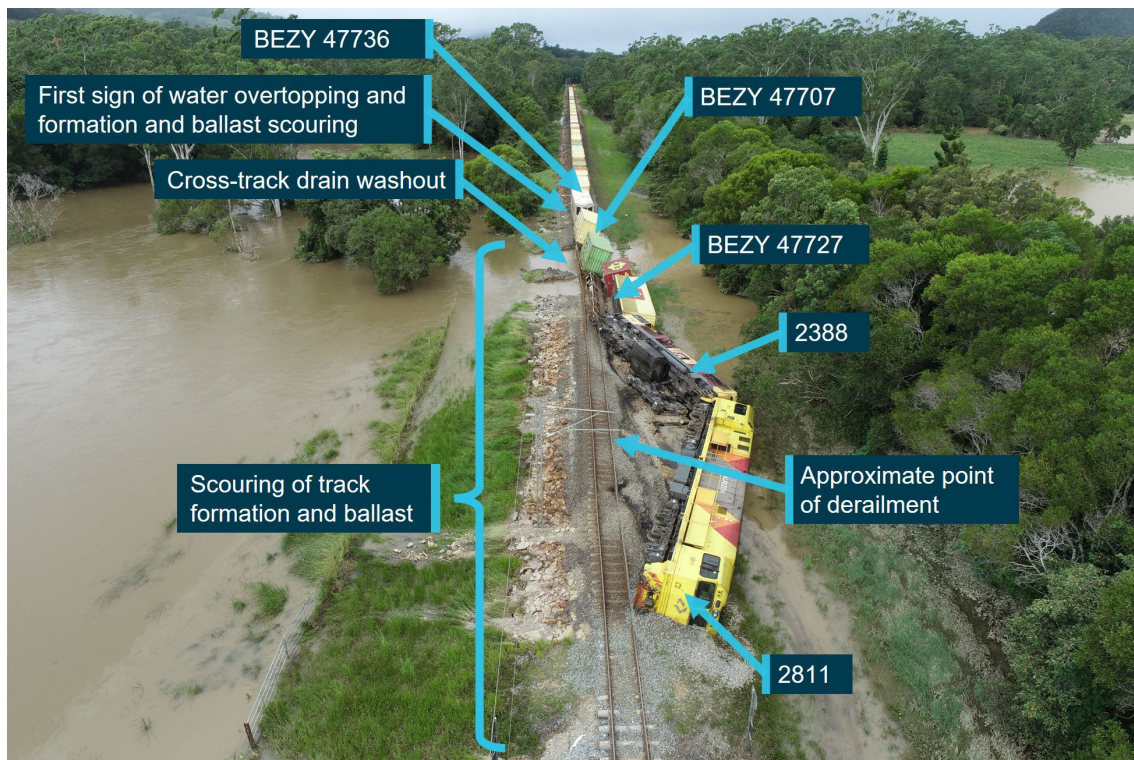
Figure 16: Train Y279 derailment site

Following the derailment, the lead and trailing locomotives (2811 and 2388 respectively) rolled and came to rest on their sides to the south of the track formation. Three BEZY wagons (47727, 47707 and 47736) also derailed with some of the containerised load becoming dislodged from the twist lock mounts (Figure 16). Figure 2 also highlights the extensive scouring of the track formation and ballast from the floodwaters overtopping the rail head.

Derailment site viewed in an easterly direction.
Source: ATSB

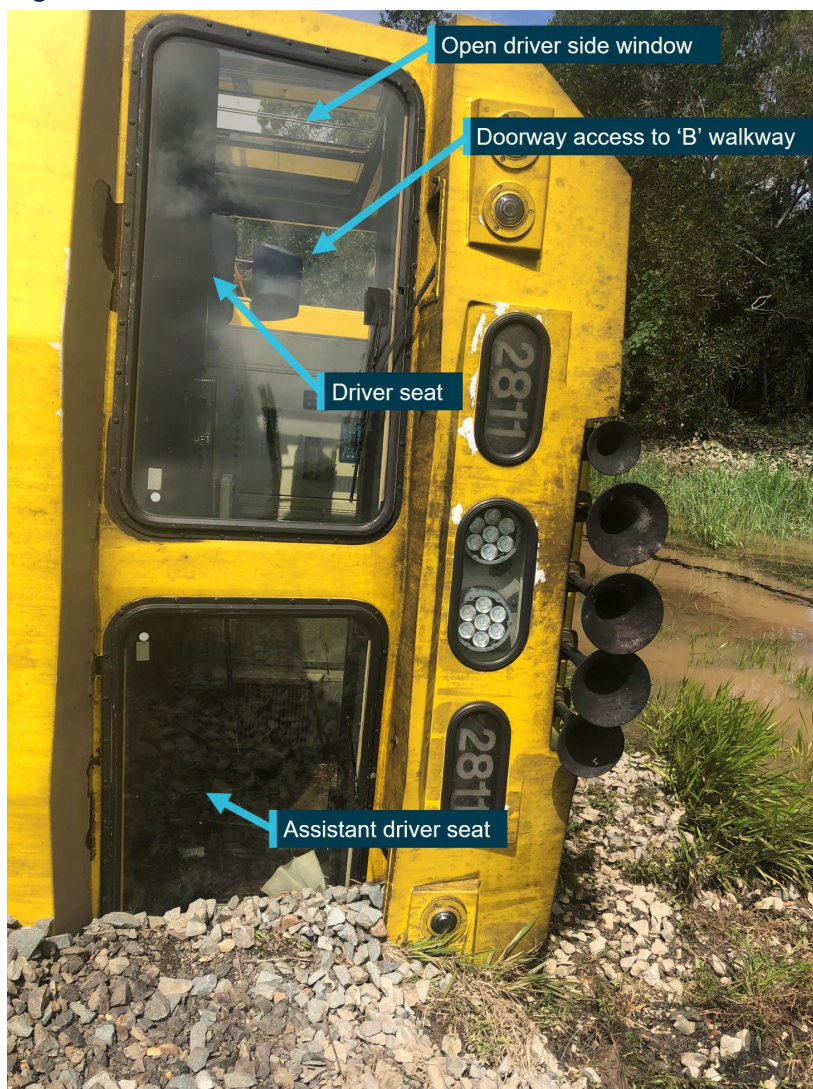
Figure 17: Derailed lead locomotive 2811 no 2 end cab

After self-assessing the extent of their injuries, the driver was able to climb on the train inspector's seat to reach the external door, which they were able to easily open, as the door was hinged to open outward from the cab and toward the engine hood. The door did not need to be latched or propped in the open position. Additionally, the driver side window was in the open position as the driver had opened it just before the derailment. The open window, although at height, provided an alternative escape path from the overturned locomotive cab. The 2800 class locomotive was not fitted with any purpose-built footholds or climbing arrangements to assist rail traffic crew egress via the alternative pathway or to assist with descending the outside of the locomotive.

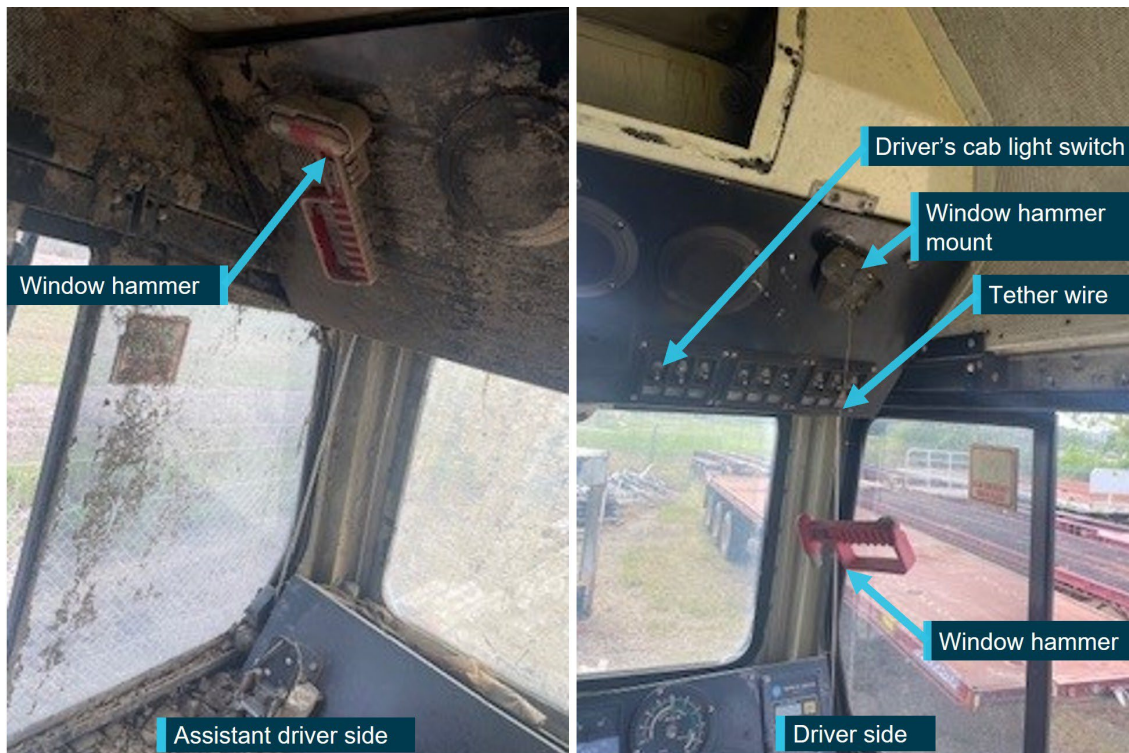
Figure 18: Window-breaking hammer installation in locomotive 2811 no 2 end cab

The cab was equipped with 2 window-breaking hammers to facilitate emergency egress should the side windows not slide open, or the opening space was insufficient to provide

ready egress. Hammers were fitted to the overhead console above the driver and assistant driver positions. Each hammer was attached by a short tether to the mount (Figure 18).

*Images obtained following the recovery of locomotive 2811. Detached hammer on driver side occurred post-recovery.
Source: Aurizon, annotated by the ATSB*
