# **Collision with terrain involving Air Tractor AT-502, VH-AQW**

17 km south-west of Bourke Airport, New South Wales, on 10 February 2024

## **ATSB Transport Safety Report**

AO-2024-005

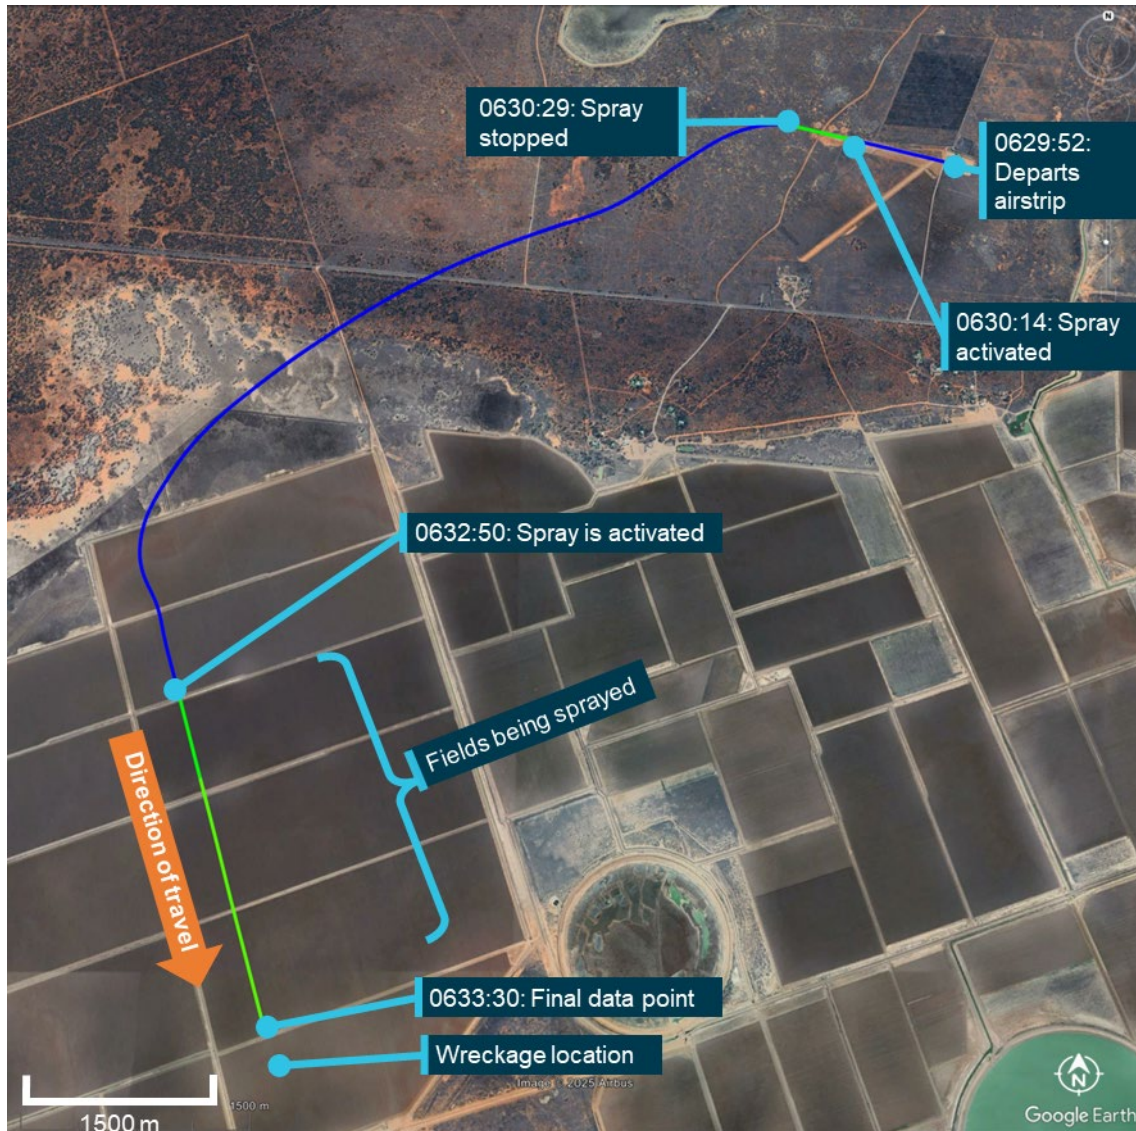
Figure 1: Overview of flight path and key events

At 0632:50, GPS data from the onboard Satloc<sup>1</sup> system showed that the aircraft was positioned at their first planned field, parallel to the previous day's spray run at a heading of 161° and a height between 10 ft and 22 ft above ground level (Figure 1). At this time, the spray system was activated, but no spray flow was recorded. For 40 seconds, the aircraft maintained the same heading tracked in a south-easterly direction with a ground speed between 112 kt and 115 kt and height between 4 ft and 22 ft. At 0633:30, the final data point captured recorded the aircraft in the third (southern-most) field of the planned run with a ground speed of about 115 kt, a height of up to 7 ft and maintaining heading. Shortly after this point, the aircraft contacted the ground, ran along the rest of the field and then impacted an irrigation levee that ran perpendicular to the end of the field.

The first part of the flight path is blue, with green indicating when the spray was activated.  
 Source: Google Earth, annotated by the ATSB

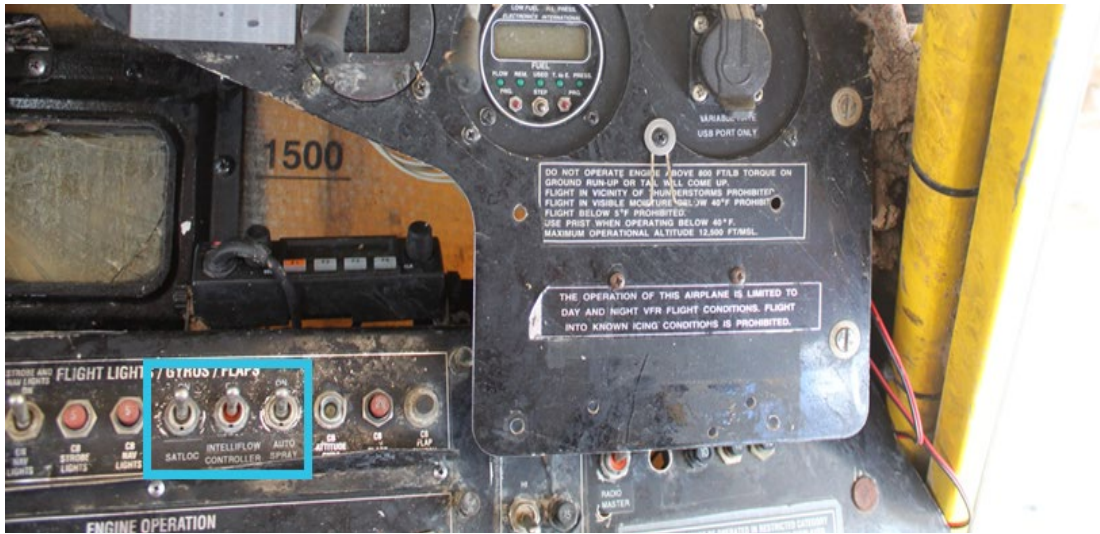
**Figure 2: Switches (in box) used for spraying in VH-AQW**

All Air Tractor aircraft were fitted with a spray dispersal system at the time of production. To activate the dispersal system, the pilot switched on the spray pump from the cockpit (Figure 2) and moved the spray handle down to release the load from the hopper (Figure 3). This movement opened the control valve. The hopper contents, driven by the spray pump under the aircraft, would then be dispersed through the spray nozzles on the spray boom mounted under each wing (Figure 3). Additionally, a flow controller system, including a flow meter, was installed on the spray boom as part of the Satloc system (Figure 4). This allowed for spray flow information to be displayed in the cockpit, on the Satloc screen or light bar (refer to section titled *Recorded data*).

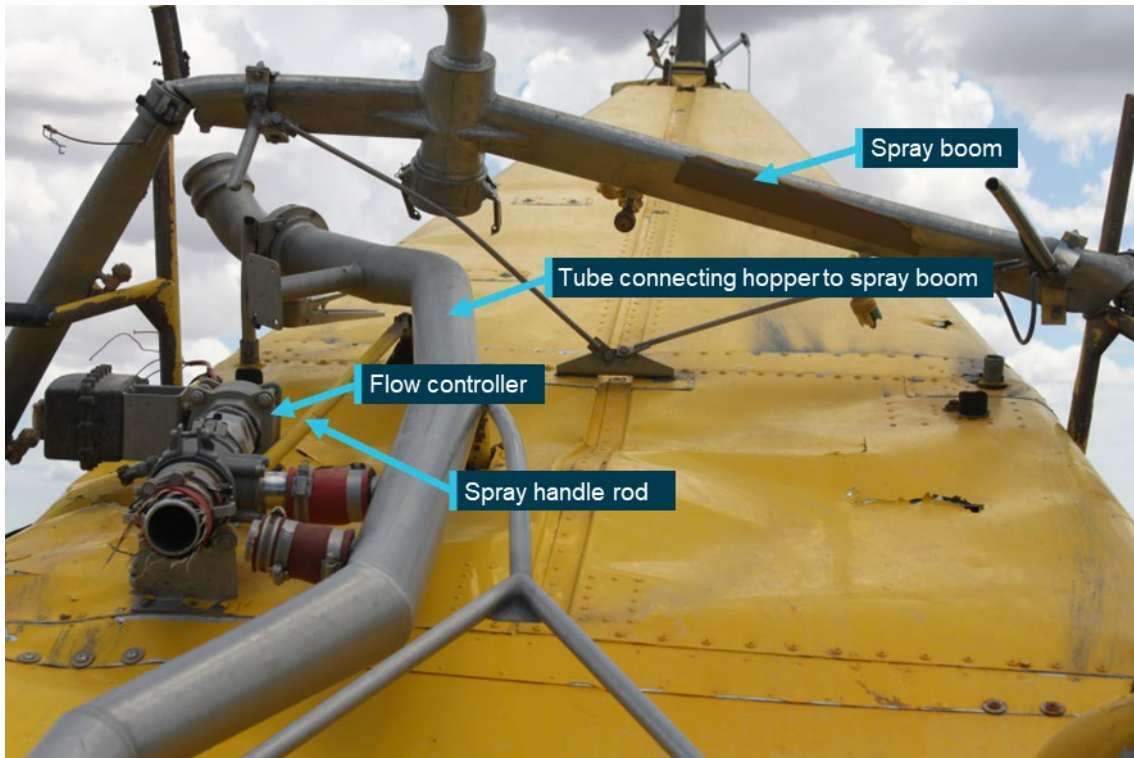
Figure 4: VH-AQW's dispersal system

The pilot’s mobile phone contained a note written 2 days prior to the accident that the spray door seal was ‘chewed out’ and the spray valve was ‘binding up’. It was unknown whether these issues contributed to the no flow recording.

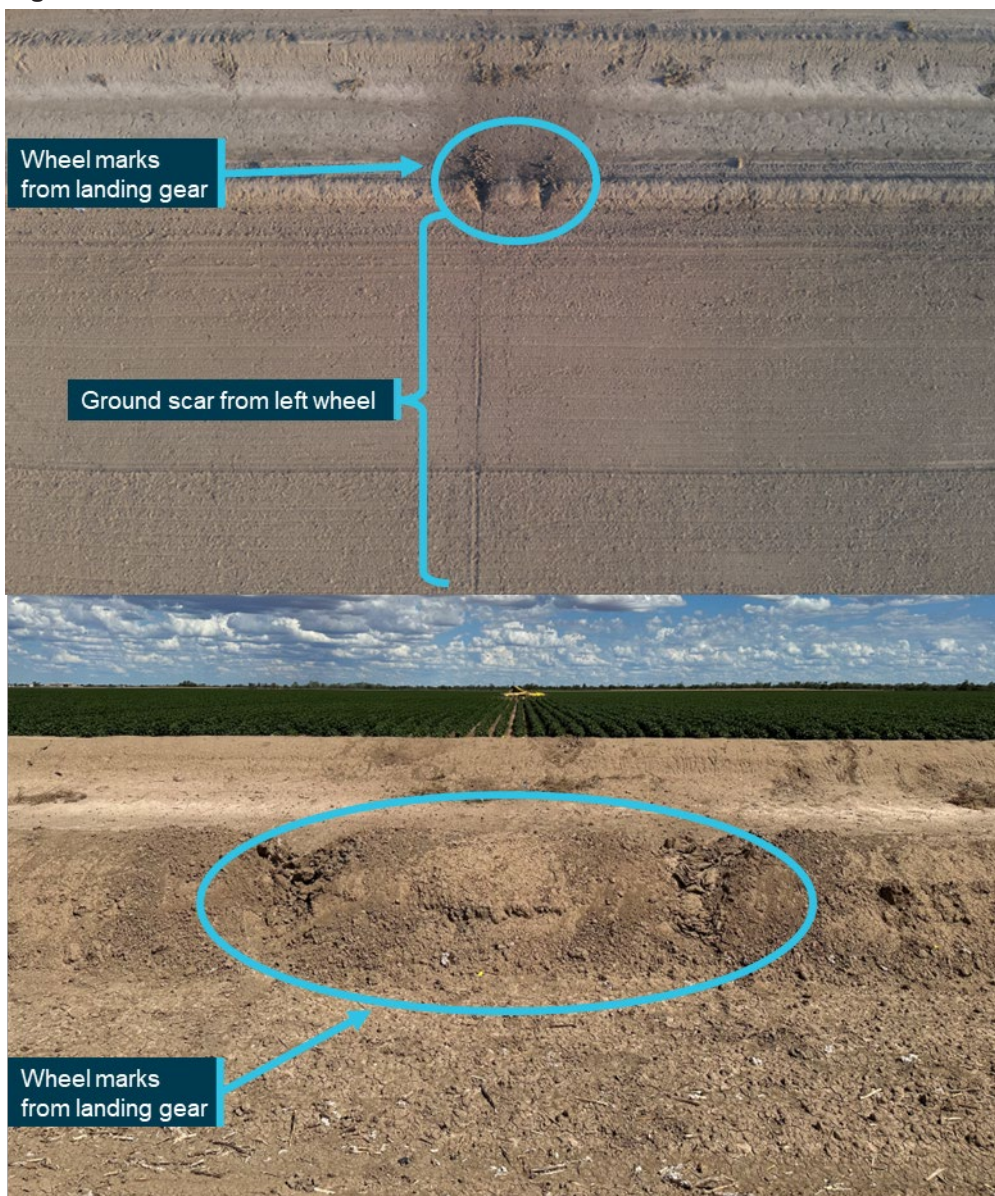
Figure 5: Wheel marks in the field and levee

The ATSB's site examination found a shallow, uniform ground scar about 27 m long from the aircraft left main wheel contacting the end of the field being sprayed (Figure 5).

Two wheel marks were found in the irrigation levee from the left and right main landing gear. After the impact with the levee, the main landing gear separated from the fuselage and struck the flaps and sections of the tailplane, resulting in their detachment.

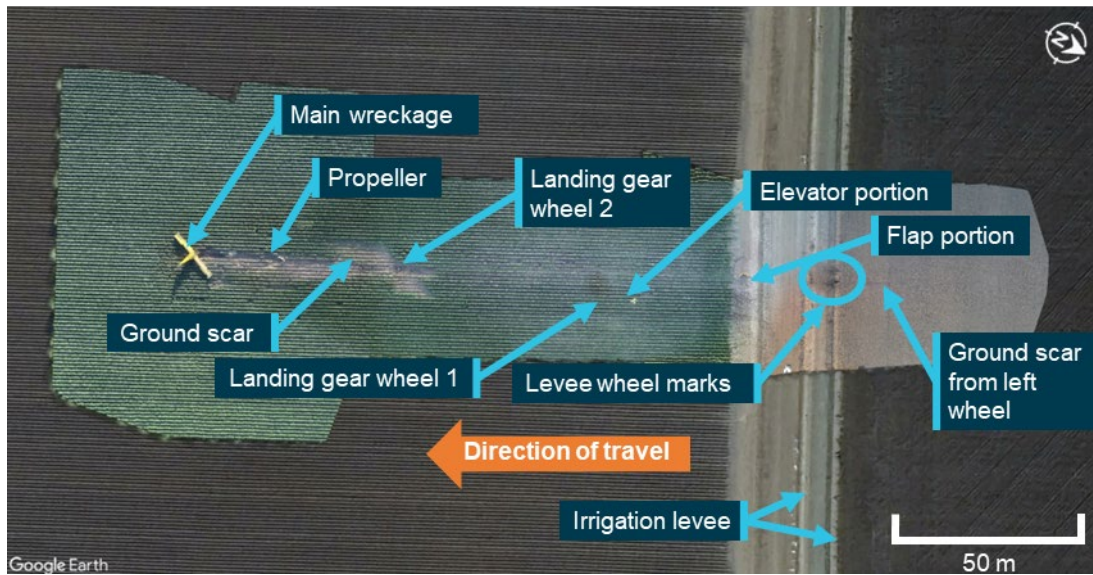
Figure 6: Overview of wreckage distribution

A larger ground scar was found in an adjacent cotton field where additional debris, including the elevator, flap, parts of the landing gear and the main wreckage were located. The position of the propeller and parts of the engine in the large ground scar indicated that the aircraft initially collided with terrain nose down, before coming to rest inverted (Figure 6). It was considered likely that the detachment of the flaps and elevator affected aircraft controllability. The ground scars and main wreckage were aligned with the final data point recorded on a track of about 160°, and perpendicular to the levee at the site of the main wheel impact.

All the major aircraft components were present at the accident site, with no evidence of an in-flight break-up or birdstrike occurring. No pre-impact defects were identified that would have affected the airframe or flight controls. The elevator trim control lever was set for slightly 'nose up' trim. The flap position was consistent with retraction, but the exact position could not be determined due to possible differences between aircraft and the static rigging position of the flap system. The operator stated that the normal configuration for spraying straight and level would be flaps fully retracted.

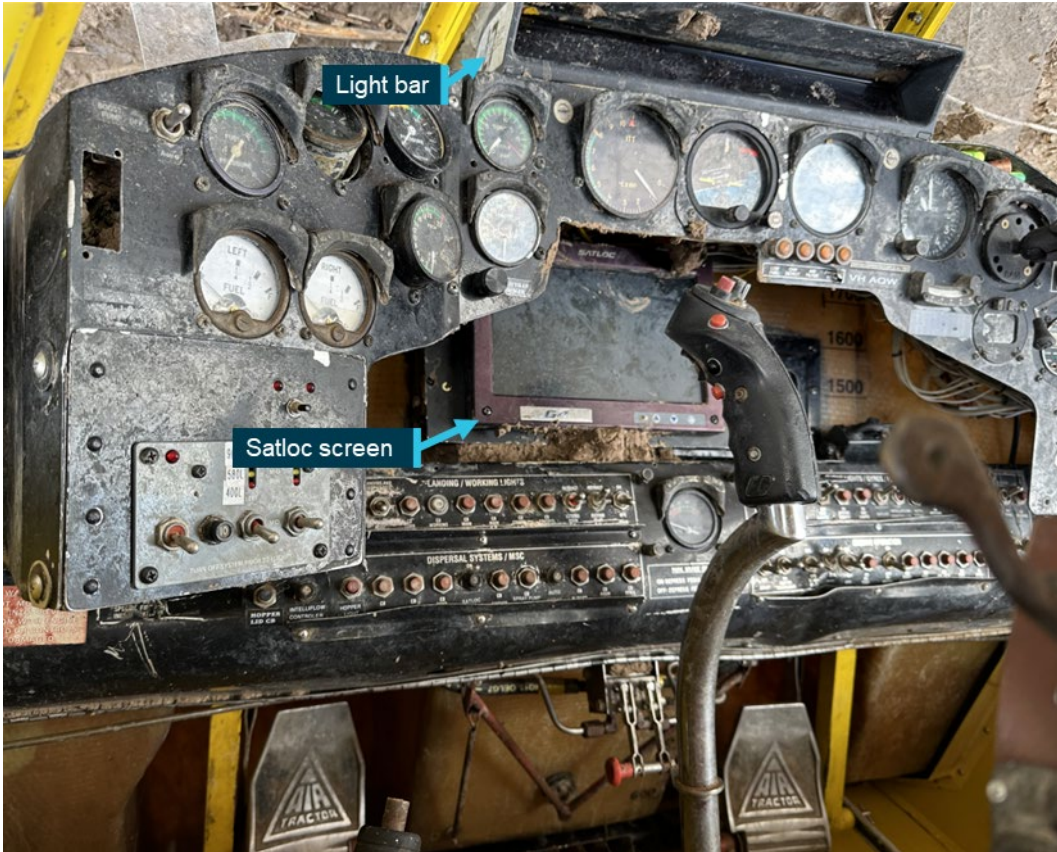
Figure 7: VH-AQW cockpit displays

There were 3 places where indications of no flow would be shown to the pilot; the Satloc screen and light bar in the cockpit (Figure 7), and the boom pressure gauge immediately outside the front windshield (Figure 8). While the pilot’s primary visual reference in flight was outside the aircraft, each indication was located within the pilot’s field of view and was included in the standard pilot scan conducted during the spray run. The aircraft had a camera inside the hopper connected to a display inside the cockpit, but it was not normally referred to when spraying liquid products.

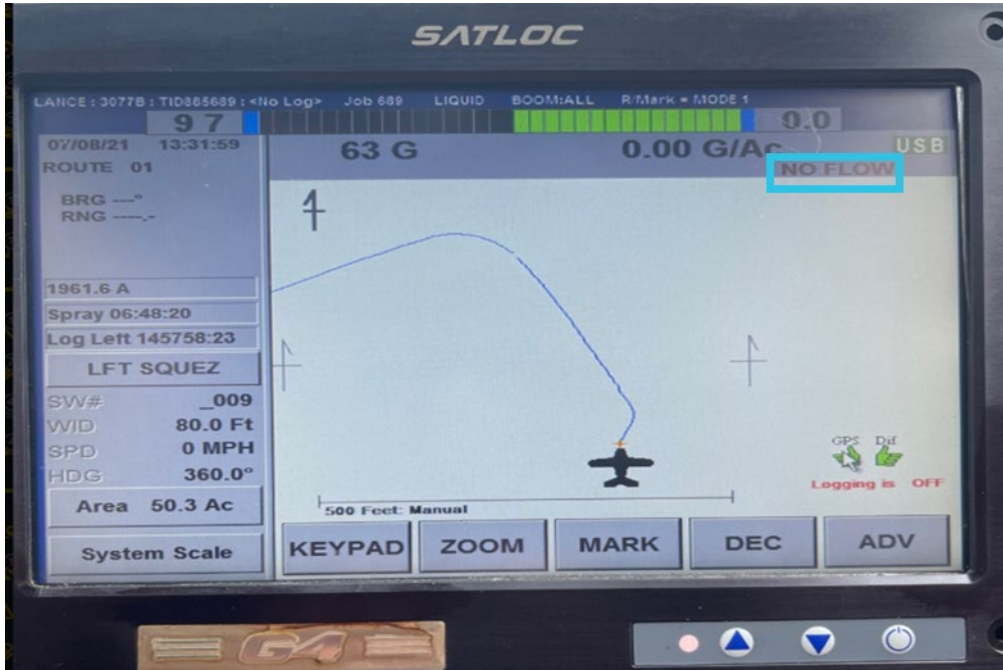
**Figure 9: Example of the 'no flow' visual warning (in blue box) on Satloc screen**

If there were spray flow problems, the Satloc screen would display a visual warning indicating 'no flow' (Figure 9) and the light bar would show a reduced spray rate. The boom pressure gauge would also indicate no pressure. The operator reported that general practice was that, if the pilot observed the 'no flow' warning on the Satloc screen, then they would likely check the boom pressure gauge. If the dispersal system was functioning, the boom pressure gauge would be expected to change as the load was dispersed from the hopper. It was also expected that if a problem was identified, the pilot would climb and troubleshoot when operating at a higher altitude, return to the airstrip, or dump the load.
