Engine failure and forced landing involving Aeroprakt-32, VH-VIK

0.1 km north of Tumut Aerodrome, New South Wales, on 10 April 2024

Aviation Occurrence Investigation (Short)

AO-2024-010

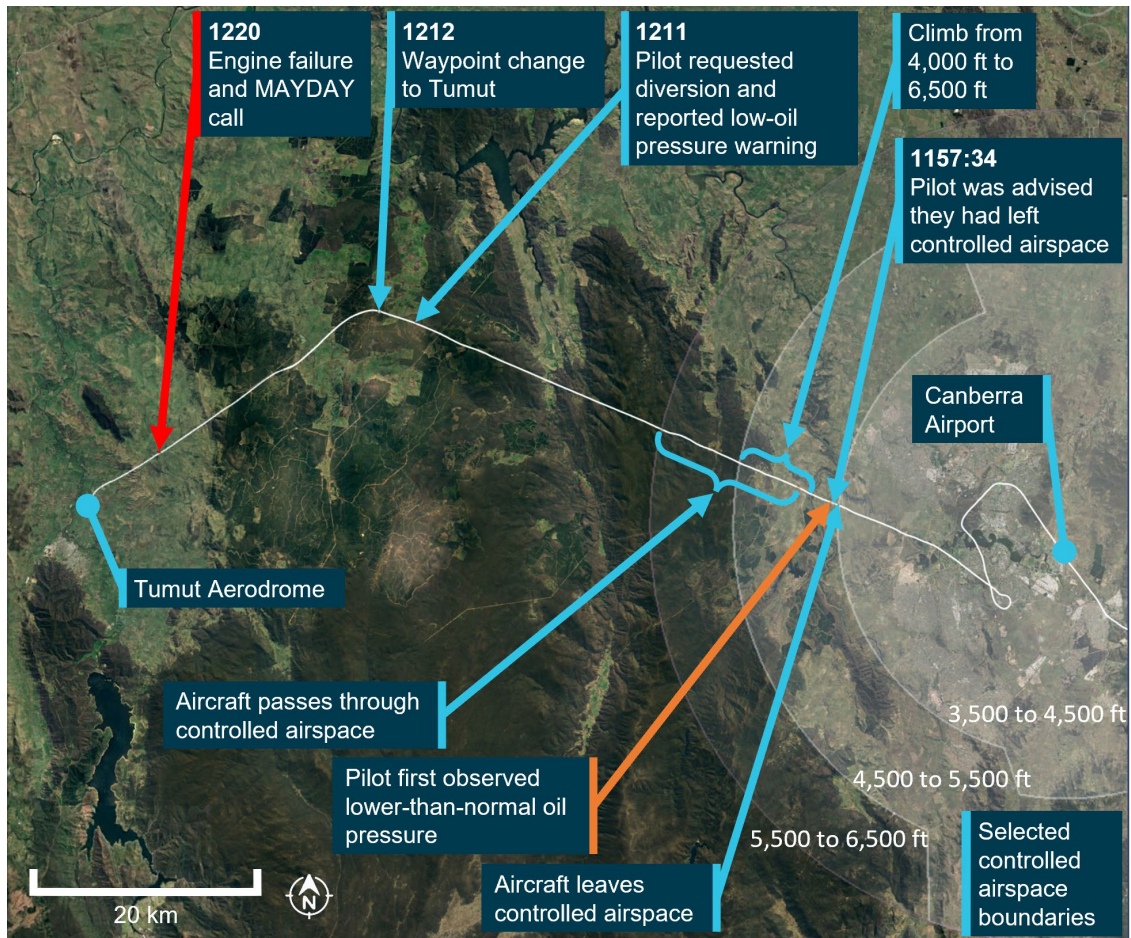
Figure 1: Flight track of VH-VIK after passing Canberra Airport

As the flight continued, the oil pressure did not recover and further dropped from 30 psi to 10 psi. The pilot stated that they delayed making a decision about diverting or landing, wanting to believe that there was no issue with the aircraft. At 1211:42, around 15 minutes after the initial observation of the low oil pressure, the pilot contacted ATC and reported that they were diverting to Tumut Aerodrome due to a low oil pressure warning. At this time Tumut Aerodrome, located west of the Great Dividing Range at an elevation of 863 ft, was the closest landing area, at 16.6 NM (30.7 km) distance. The pilot changed their navigation waypoint in their Dynon Skyview Touch flight computer to Tumut Aerodrome, turned the aircraft on to the new track, and immediately began a descent to expedite the landing. The pilot recalled feeling in denial that there was an issue, but with hindsight, recognised that it would have been beneficial to maintain altitude for as long as possible.

At 1220:17, around 9 minutes after the diversion, and while the aircraft was still 5 NM (9.3 km) from Tumut Aerodrome, the engine failed. The pilot reported focusing on the need to aviate, navigate, and communicate, then attempted to restart the engine, but was unsuccessful. At 1221:12, the pilot declared a MAYDAY,⁶ reporting their location and an engine failure. They attempted a glide approach to runway 17,⁷ which was aligned with their direction of travel, but the pilot judged that they had insufficient height, and at 1225 they conducted a forced landing in the field to the north of the aerodrome. The aircraft sustained substantial damage, and the pilot received minor injuries.

When about 11.4 NM (21.1 km) from Canberra Airport, the pilot observed lower-than-normal engine oil pressure, which continued to decay. Under these circumstances, the pilot's operating handbook recommended course of action was to conduct a precautionary landing, which included a check for the nearest suitable airfield or landing area. The pilot acknowledged that they delayed making the decision to divert and that this was influenced by incorrectly interpreting that the low-oil pressure was due to the flight characteristics. Consistent with Orasanu-Engel and Mosier (2019), this resulted in the pilot underestimating the risk posed by the abnormal indication. Additionally, the pilot reasoned that they were already far from Canberra and were reluctant to return due to the perceived complexity of conducting a precautionary landing at an airport in controlled airspace. The pilot's decision-making may have also been degraded by fatigue generated by the increased workload they reported when they were hand flying the aircraft in turbulence near Canberra.

time, it would have been possible to conduct a safe precautionary landing before the engine failed. Ultimately, the 14 minutes taken to make the decision to divert took the aircraft 20 NM (37 km) further from Canberra Airport, over mountainous terrain, and meant that the engine failed in-flight.

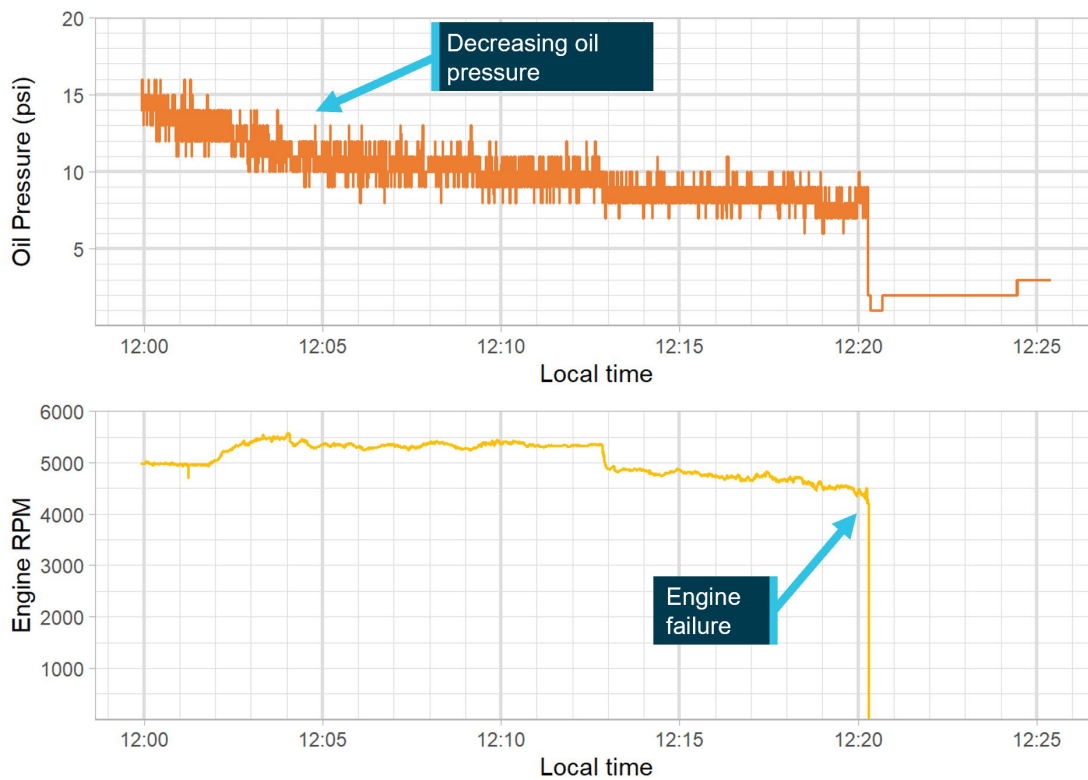
Figure 2: Oil pressure and engine RPM data recorded for accident flight

The aircraft was equipped with a Dynon Skyview Touch avionics system. This system recorded flight and engine parameters over the final 25 minutes of the flight, at a sampling rate of 16 entries every second. As such, it did not capture when the oil pressure began to drop below normal. The unit recorded that the pilot changed the programmed waypoint to Tumut at 1212:45, at which time the aircraft was about 16.6 NM (30.7 km) from Tumut Aerodrome. The data showed that the oil pressure continued to decrease after the diversion, and that the engine stopped at 1220:17, 7 minutes and 32 seconds after the waypoint change (Figure 2). Data recorded in previous flights indicated that the normal oil pressure was around 50 psi, which was consistent with the pilot’s recollection.

The ATSB's examination of the aircraft identified a lower-than-normal amount of oil in the engine and oil coating various parts of the aircraft. There was also no oil on the dipstick. The loss of oil observed was consistent with the flight data, which showed a decline in the oil pressure until the engine failed. The oil cap was found secure, the oil cooler was not defective, and no issues were found with the other systems that would explain the loss of oil and engine failure. Therefore, the ATSB could not determine the source of the engine oil loss.

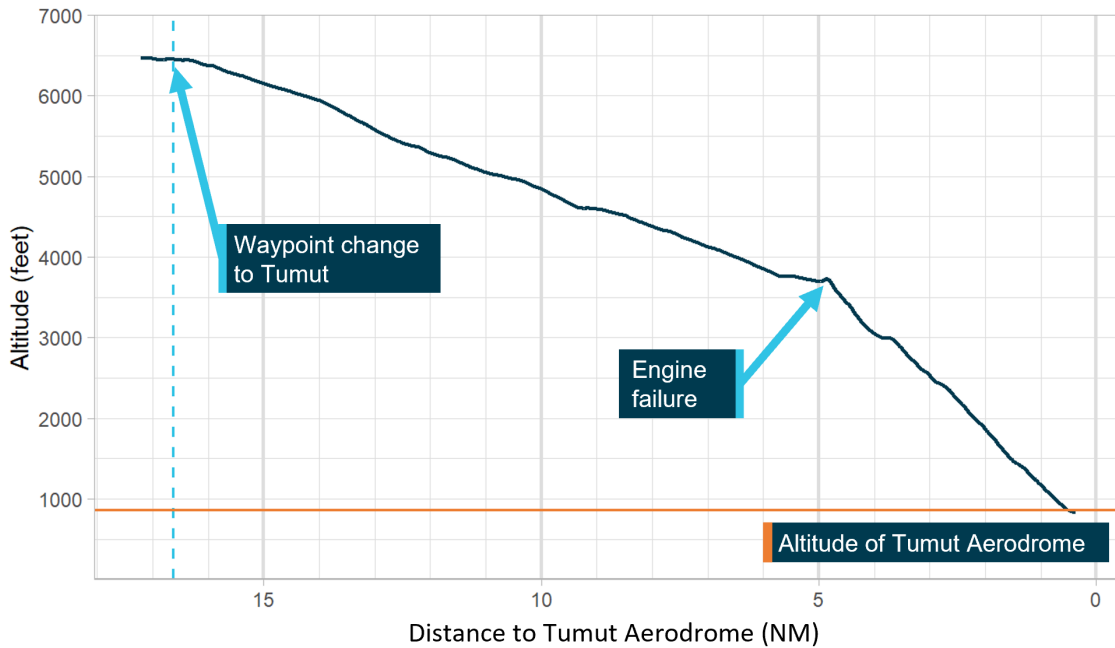
Figure 3: Altitude (above mean sea level) as a function of distance to Tumut Aerodrome

GPS data from the Dynon captured the descent profile of the aircraft from the diversion point until the forced landing (Figure 3). The profile showed that the pilot assumed a fairly constant rate of descent from the diversion point until the engine failed. Once the engine failed the rate of descent increased. Considering the descent profile of the aircraft following the engine failure, the ATSB estimated that, if the cruise altitude had been maintained until the failure, the aircraft would have been within glide range of the runway at Tumut.

The recorded data showed that once the pilot made the decision to conduct a precautionary landing, they commenced a powered descent towards Tumut Aerodrome. Given the decreasing oil pressure, the pilot could not be assured the engine would continue to operate normally. As such, maintaining altitude, as suggested in the literature, until they were confident of reaching the aerodrome with a glide profile in case the engine stopped, would have increased the likelihood that Tumut Aerodrome would be reached.

At about 5 NM (9.3 km) from Tumut, the engine failed and, as expected, the data showed the descent rate increased. This escalated the situation from requiring a precautionary landing to a forced landing. The height of the aircraft at that location was insufficient to reach the runway and the pilot's remaining option was to conduct the forced landing in a field. ATSB calculations indicated that it was likely that, had the cruise altitude of 6,500 ft been maintained to within 5 NM (9.3 km) of Tumut, the aircraft would have been within glide range of the runway. As such, when the engine failed, the pilot would have been able to complete the forced landing onto the runway.
