# Ground strike involving British Aerospace BAe 146-300, VH-SAJ

Brisbane Airport, Queensland, on 25 June 2024

## ATSB Transport Safety Report

AO-2024-036

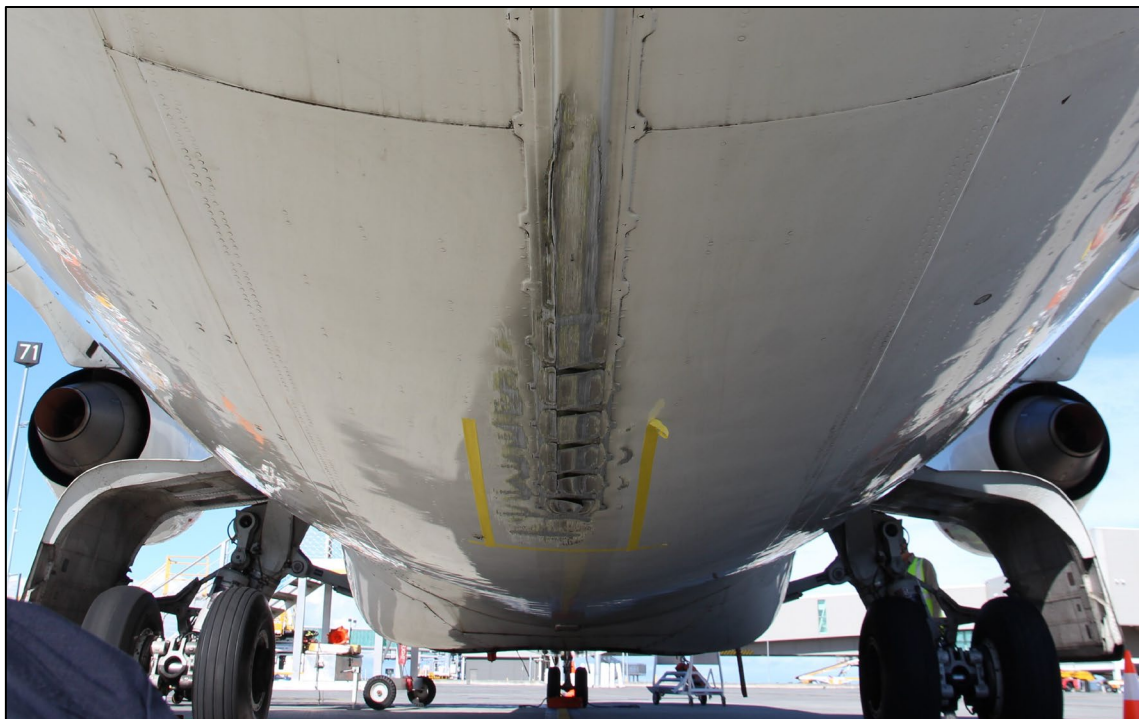
**Figure 3: VH-SAJ damage to tail strike indicator and surrounding panels**

The FO disconnected the autopilot at about 110 ft and made control inputs that resulted in an increasing aircraft pitch attitude with decreasing airspeed. The aircraft touched down with a high pitch angle and a vertical acceleration of about 2.4 g. The tail of the aircraft struck the runway, resulting in damage to the tail strike indicator and surrounding panels.

The crew were unaware of the tail strike until the damage was discovered on the post-flight aircraft inspection. The tail contact with the runway damaged the tail strike indicator and surrounding fuselage skin panels (Figure 3).

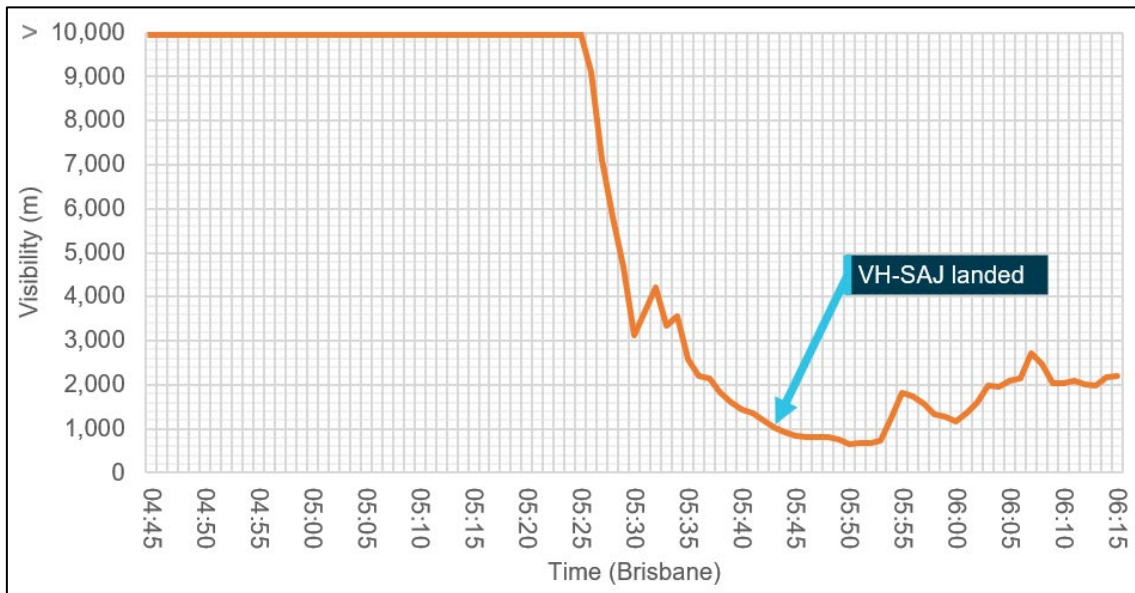
**Figure 6: Brisbane Airport visibility 0445 to 0615 on 25 June 2024**

The aircraft departed Sydney Airport at 0415, one hour and 15 minutes after the scheduled departure time and had an estimated time of arrival in Brisbane at 0555. Over the period 0500 to 0525 the visibility at Brisbane Airport remained greater than 10 km. From 0525 to 0550 the visibility reduced from greater than 10 km to 660 m due to the formation of advected fog.<sup>18</sup> The recorded visibility at the time VH-SAJ landed was 912 m (Figure 6).

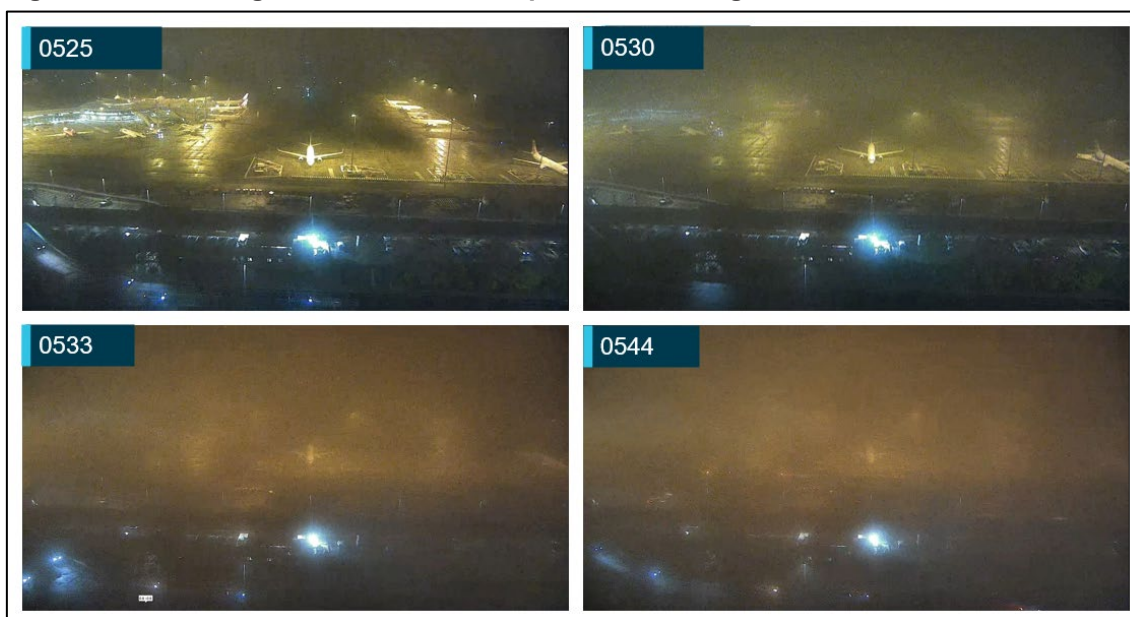
**Figure 7: CCTV images from Brisbane Airport tower facing south**

Closed circuit television (CCTV) recorded from the Brisbane air traffic control tower captured a progressive reduction in visibility that was consistent with the recorded meteorological information (Figure 7).

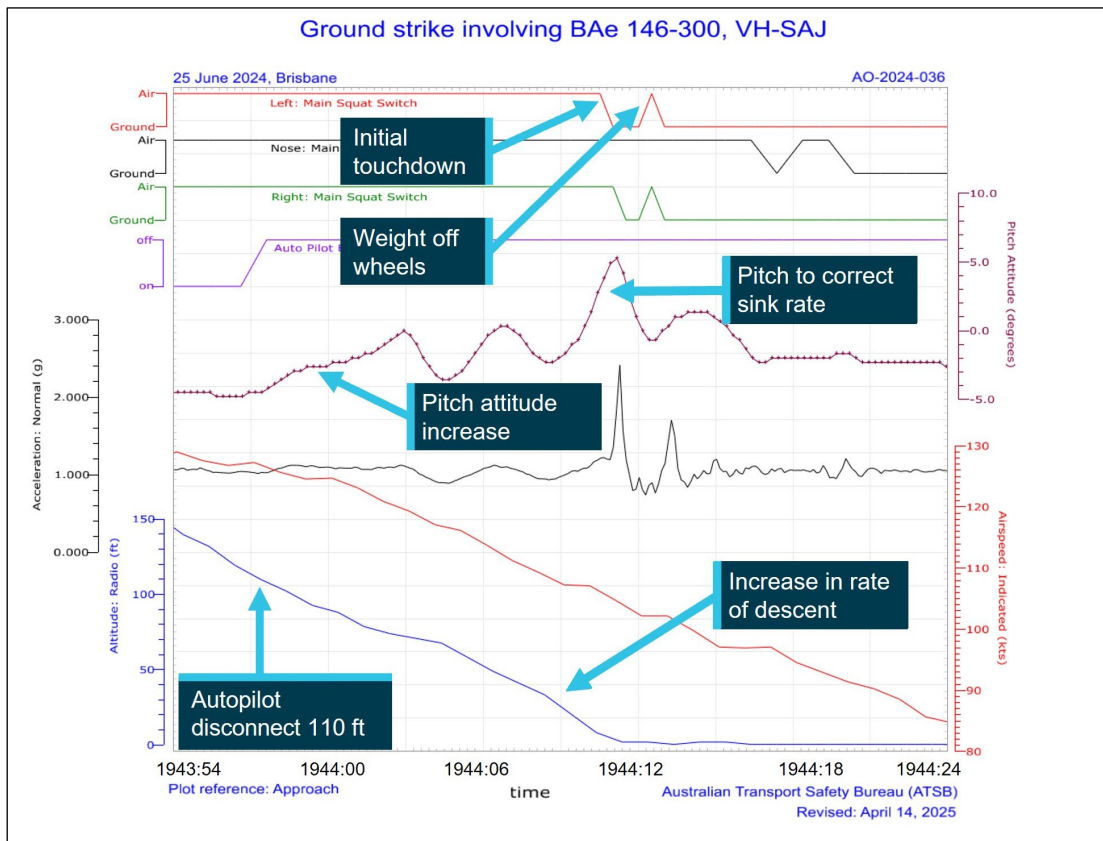
**Figure 8: Recorded flight data**

The airbrake was deployed at a height of 100 ft and was fully extended when the aircraft reached 80 ft. ASL Airlines Australia standard operating procedures manual for the BAe 146 advised that the airbrake should be deployed on final approach once the landing was assured.

At a height of about 65 ft, the aircraft decelerated through 117 kt with a pitch attitude of about  $-3.6^\circ$  and an increasing rate of descent. Several further pitch attitude adjustments were recorded as the aircraft continued to descend.
