Australian Transport Safety Bureau

Unstable approach involving Boeing 737, VH-YIL

near Sydney Airport, New South Wales, on 12 June 2025

AO-2025-032

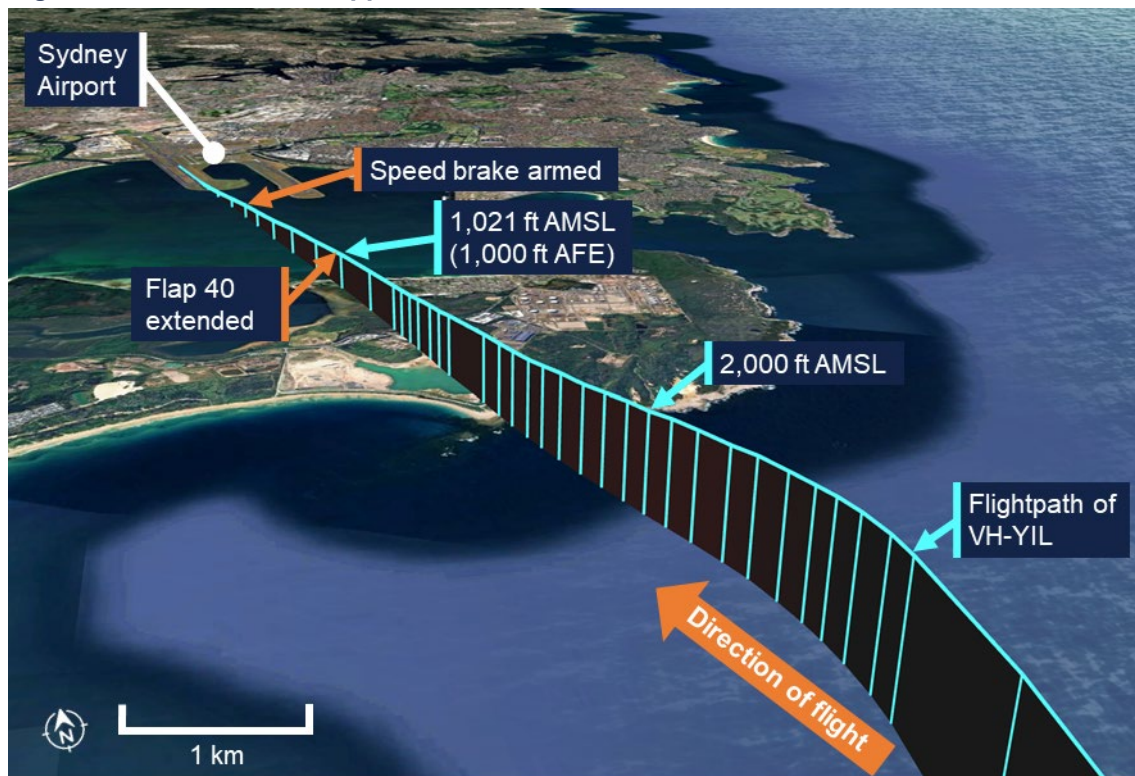
Figure 1: Overview of the approach

As the aircraft descended toward 2,000 ft above mean sea level (AMSL) (Figure 1), the aircraft intercepted the final approach track. The crew expected the descent to continue, but the aircraft began automatically levelling off to capture the 2,000 ft altitude set in the MCP altitude window, taking the aircraft above the desired approach descent profile.

The crew immediately recognised the deviation and identified that the incorrect altitude was entered into the MCP altitude window; to continue the descent, but without verbalising the action, the captain entered 500 ft in the altitude window. Shortly after, the captain recognised that this selection would not re-establish the required approach path, so, without first alerting the first officer to their intentions, disengaged the autopilot and auto thrust to manually re-establish the approach descent profile.

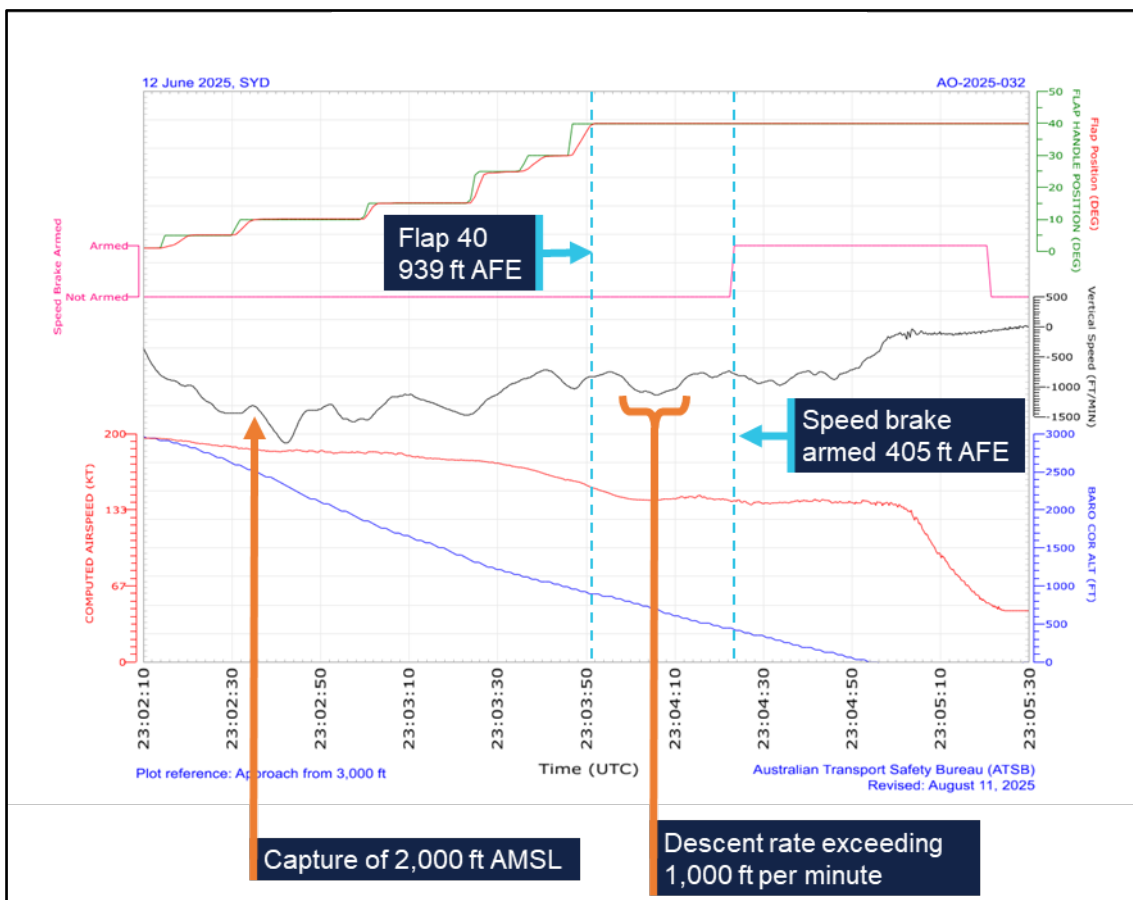
Figure 2: Graphical representation of the recorded quick access data

The recorded data (Figure 2) showed that the landing flap selection (flap 40) was completed 3 seconds after the aircraft descended below 1,000 ft above the airport elevation (AFE), at 939 ft AFE (960 ft AMSL). The flaps then completed moving to that extension as the aircraft descended below 875 ft AFE (896 ft AMSL). The speed brake lever was moved to the armed position as the aircraft descended below 405 ft AFE (426 ft AMSL).

After descending below 1,000 ft, the aircraft maintained an appropriate speed and flightpath. The rate of descent exceeded the 1,000 ft per minute stabilised approach criteria limit for a 9 second period between 0904:02 and 0904:11. During this period, the aircraft descended from 747 ft AFE to 587 ft AFE, and the maximum recorded descent rate was 1,136 ft per minute at 0904:07.
