# **Loss of propulsion while entering the Port of Fremantle involving *Al Messilah***

2 km from Fremantle, Western Australia, on 4 March 2025

## **ATSB Transport Safety Report**

MO-2025-001

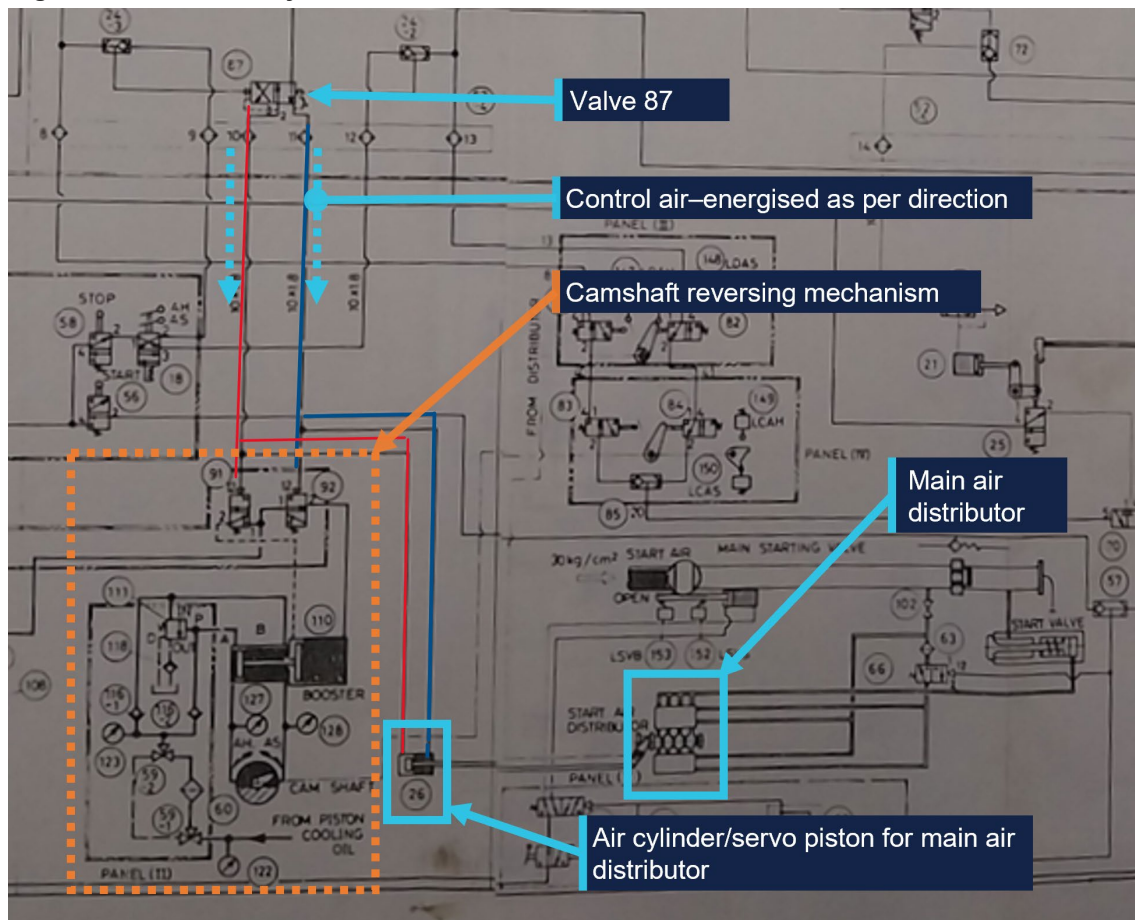
**Figure 2: Pneumatic system**

The main engine's pneumatic system (Figure 2) used compressed air, referred to as control air, at a working pressure of 7 kg/cm<sup>2</sup>. This air came from the main air bottles, which store air at 30 kg/cm<sup>2</sup>. A pressure-reducing valve lowered the pressure to the required level. To meet the manufacturer's air quality standards, the system also included a control air dryer.

The blue line is showing the path of the control air in the AHEAD line and the red line is showing the path of the control air in the ASTERN line.

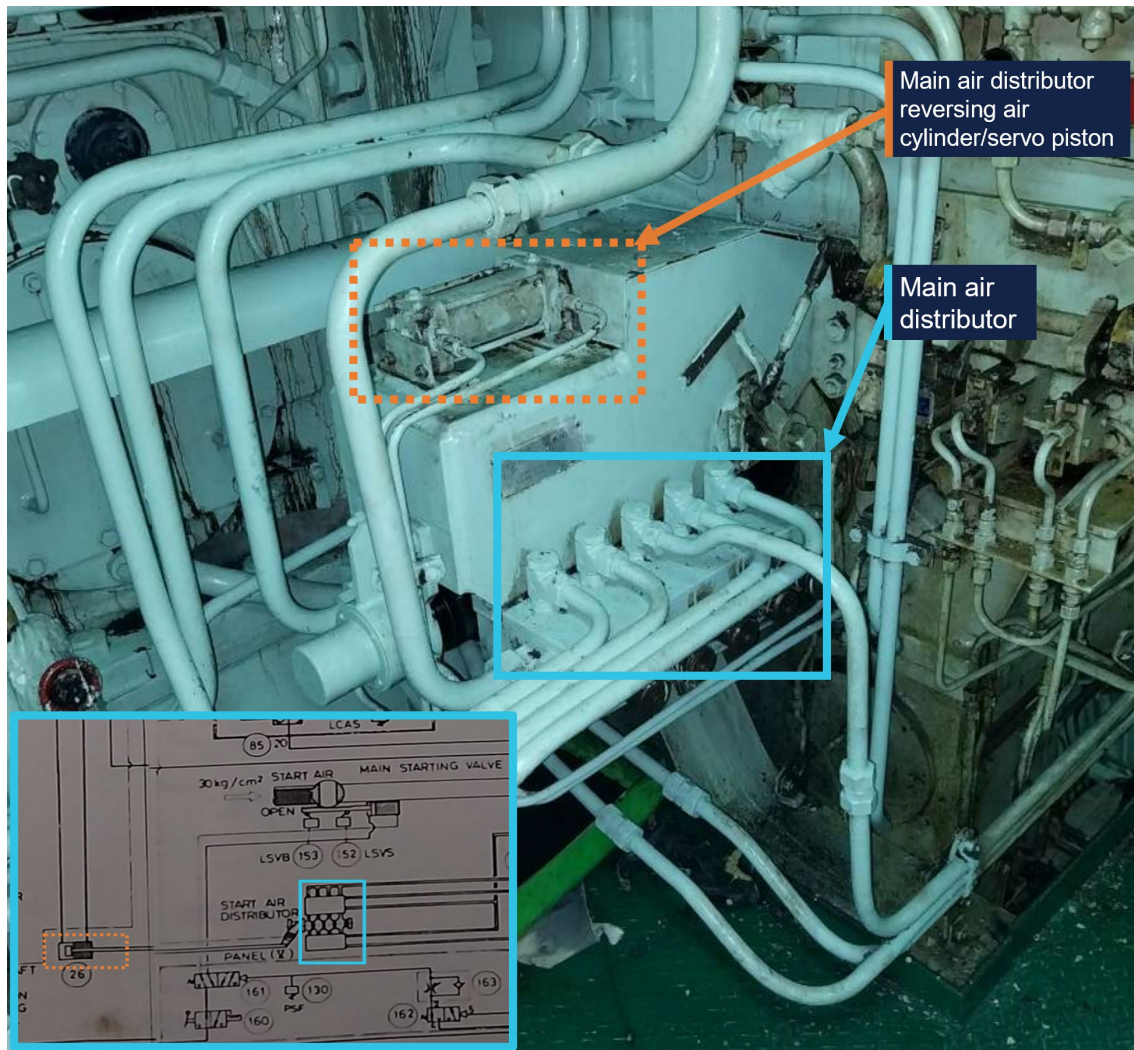
**Figure 3: Main air distributor**

Control air supplied through valve 87 was directed to either the AHEAD or ASTERN line and acted on the servo piston (Figure 3). This piston moved the main engine air distributor into the correct position for the selected direction. The distributor then directed high-pressure air to each cylinder's start air valve to initiate engine rotation. By adjusting the firing order (timing and sequence of air delivery to the cylinders), the distributor ensured the engine was started and rotated in the intended direction.

The investigation found that degraded seals inside the servo piston allowed control air to leak between the AHEAD and ASTERN chambers of the reversing air cylinder. This leakage introduced air into the ASTERN line of the camshaft reversing mechanism. This likely resulted in the system not being able to maintain the control air pressure needed to fully actuate and hold the camshaft in the AHEAD position. The camshaft then likely moved to an indeterminate position, which misaligned the fuel injection and exhaust valve timing. The result was engine misfiring and stopping.

While entering the Port of Fremantle, the main engine failed twice, most likely due to a failure of the seals in the servo piston of the main air distributor.

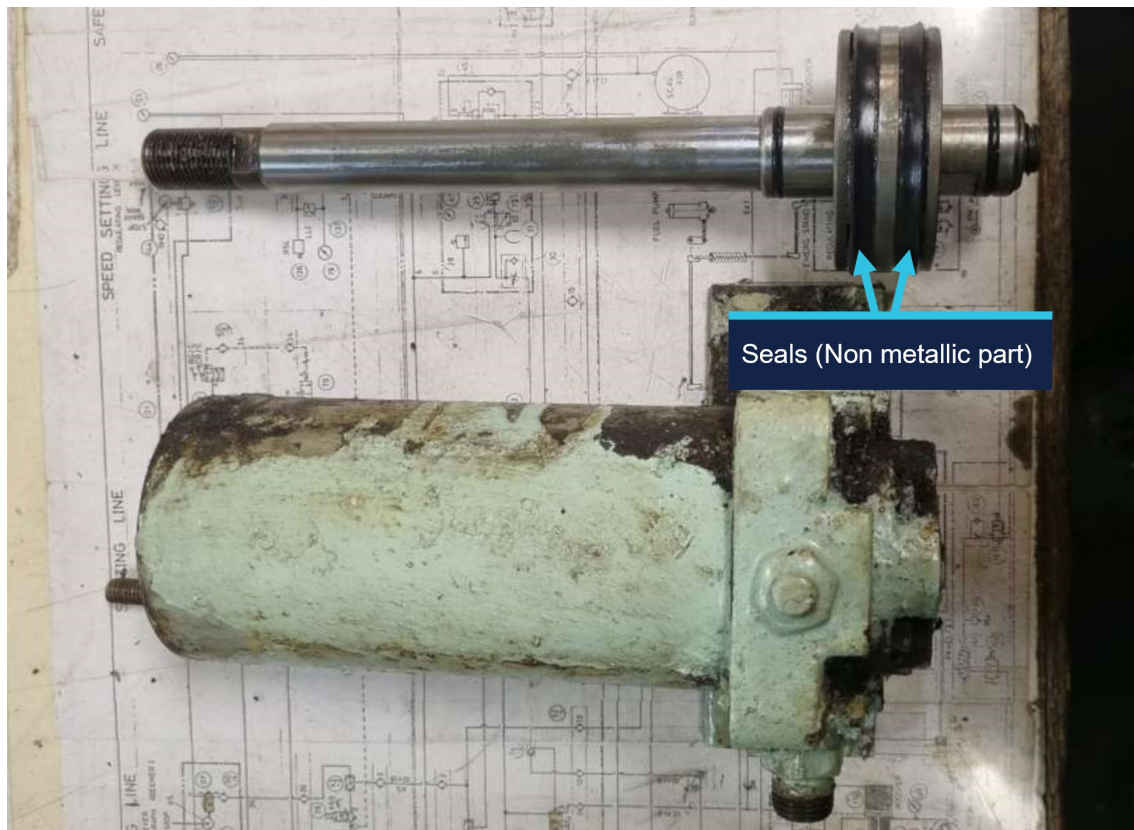
**Figure 5: Main air distributor reversing cylinder/servo piston with new seals**

*The image shows the piston after the seals had been replaced.*  
Source: Ship's manager, annotated by the ATSB

The affected seals were subsequently replaced by shipboard personnel once the ship was safely moored alongside (Figure 5).

When the ship arrived at Khor Fakkan anchorage in the United Arab Emirates, the ship manager arranged for a complete overhaul of the main engine pneumatic system. The engine maker's service team attended the ship on 11 April 2025, inspected, and overhauled the entire pneumatic manoeuvring system, including all of the pneumatic valves.
