# **Crew injuries during maintenance involving oil tanker, *Wisdom Venture***

About 60 km east of Sydney, New South Wales, on 6 May 2025

MO-2025-004

Final – 26 September 2025

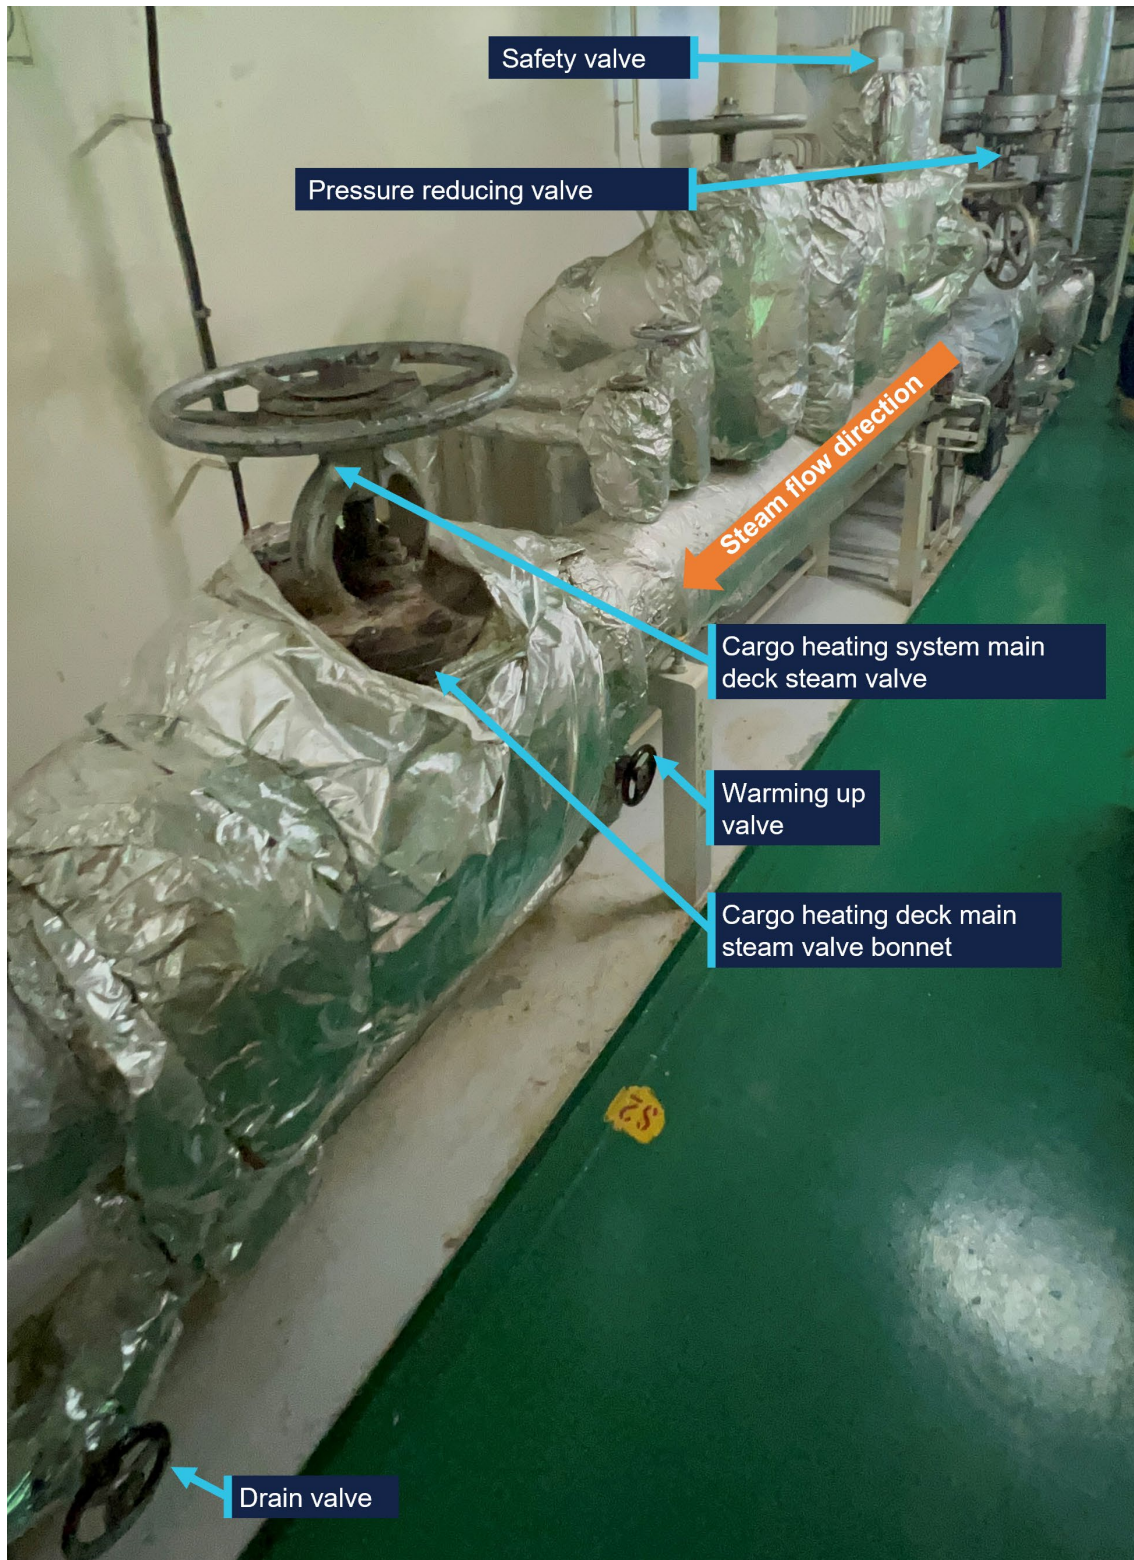
Figure 2: Cargo heating steam main line in engine room

Low pressure steam passed through the main deck steam valve (Figure 1 and Figure 2), the last valve in the steam line in the engine room, which led to the deck and the cargo heating system. This valve was the main steam isolation valve for the cargo heating system. It was closed when cargo heating was not required and played a critical role in making sure the system could be safely shut down for maintenance and isolating the deck heating system during emergencies.

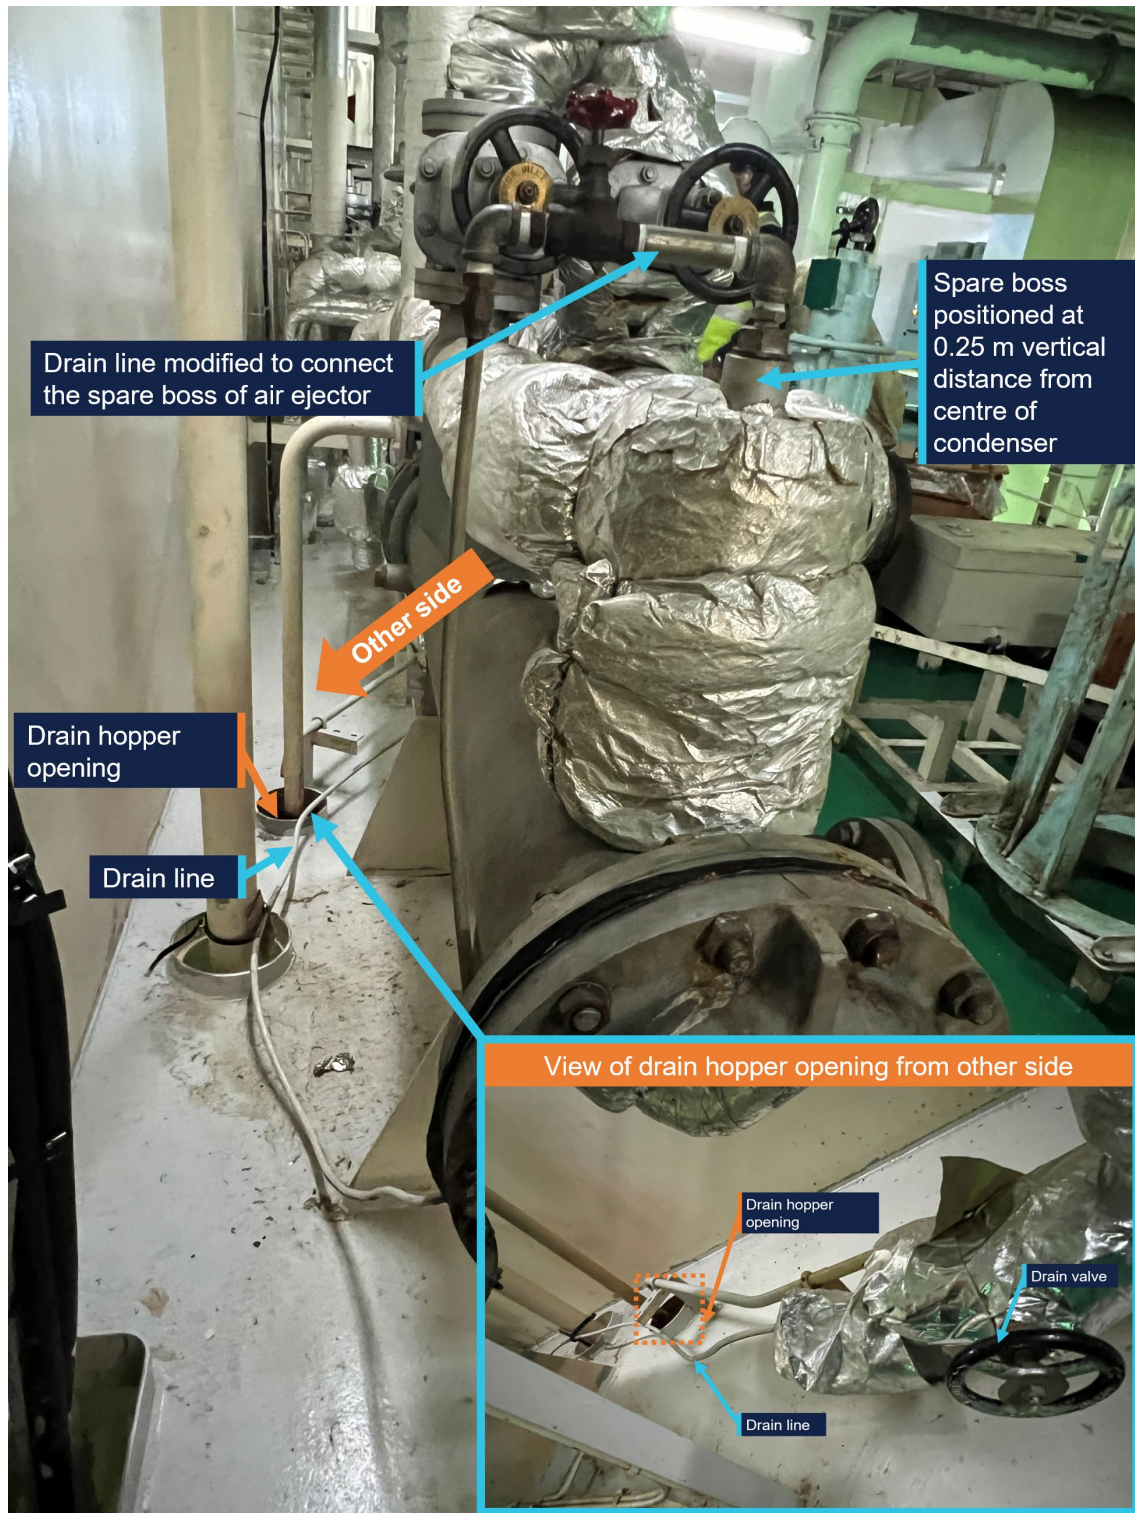
Figure 3: Drain line modification

During the site inspection, the ATSB identified a permanent modification to the drain line from the warming-up line (Figure 3). It was reported that the modification was to save water by redirecting condensate away from the open drain hopper (which led to the engine room bilges) and returning the water to the boiler feedwater system.

The modification connected the drain line to a spare boss<sup>4</sup> on the condenser for the air ejector. The condenser was at approximately the same vertical elevation as the stop

valve, with the boss about 0.25 m above the condenser. The connection was established using a fabricated pipe assembly comprising unions, elbows and a bronze union bonnet globe valve.

Post-incident interviews revealed that the modified drain line had not been disconnected for visual inspection, and the warming-up line valve remained closed during the depressurisation process.

In combination, this configuration did not allow for a positive visual confirmation that the line was free of steam or condensate. Consequently, when the valve bonnet was removed, residual hot condensate was released, resulting in significant burn injuries to 3 crew members.

This meant that a permanent modification was implemented without supporting documentation or formal engineering review. Additionally, the modification was not incorporated into any risk assessment or technical records, and no evidence was found to indicate that it had been subject to formal inspection or verification. This undocumented change introduced a system vulnerability that compromised the effectiveness of the steam system isolation.

No documentation was found to indicate approval from the ship's manager, classification society, or flag state for the modifications to the cargo heating system drain line. In addition, technical inspection records from the ship manager did not reference the modification, and condition reports rated the steam system as being in 'good' condition without noting any deviations.

Following the incident, the ship manager advised that the drain line on *Wisdom Venture* has been returned to its original design configuration. A fleetwide campaign has also been initiated to identify any unauthorised modifications to shipboard piping systems. Where such modifications are identified, internal investigations will be conducted.
