# Loss of control and collision with terrain involving Cirrus SR22, VH-MSF

near Gundaroo, New South Wales, on 6 October 2023

Aviation Occurrence Investigation (Defined)

AO-2023-045

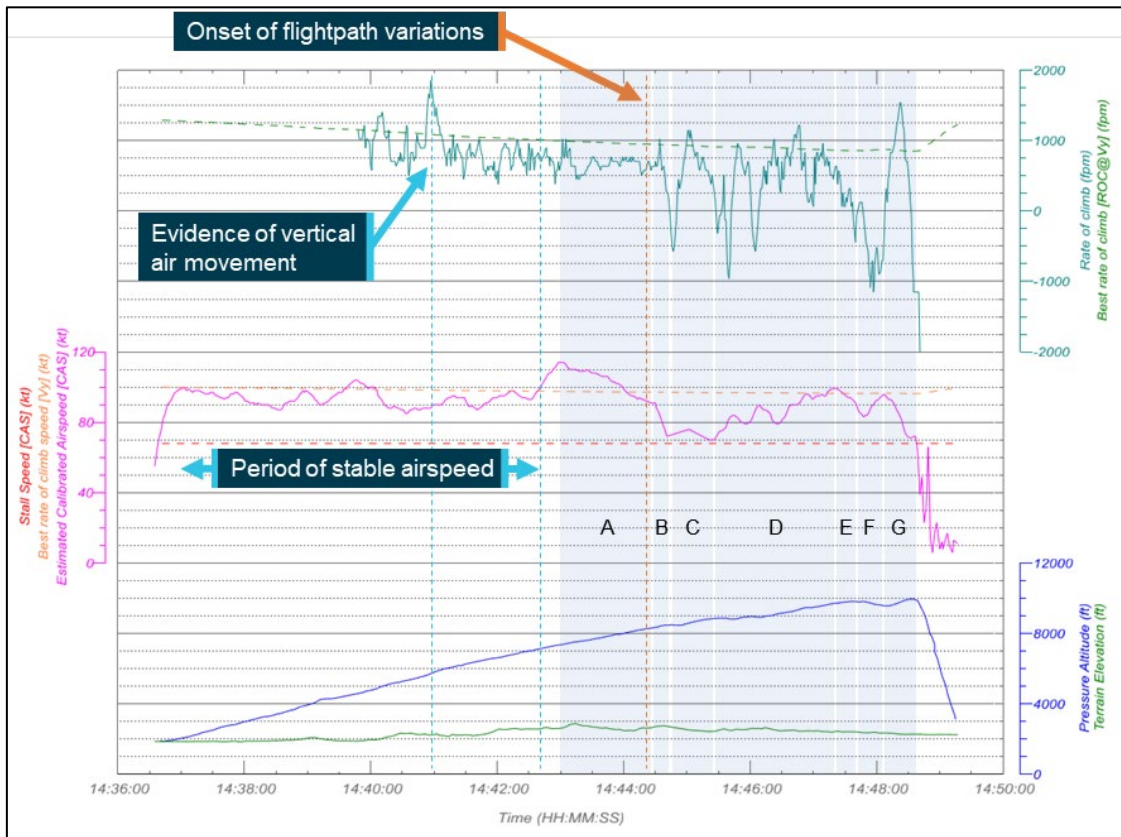
Figure 12: Aggregated ADS-B altitude data for VH-MSF, together with estimated airspeed (CAS)

At 1448:31–33, about 12 minutes after take-off from Canberra, the aircraft reached a maximum altitude of 9,946 ft at an airspeed of 71 kt. Following this, the flight data showed the aircraft’s airspeed and altitude declined, and rapidly so from 1448:37. The descent rate increased to 13,000 ft/min, the ground speed reduced to less than 32 kt and became erratic, and the aircraft track aligned somewhat with the estimated wind direction, all of which indicated the aircraft had likely entered a spin.<sup>22</sup> As the aircraft passed through about 8,000 ft, the rate of descent started to reduce, which was indicative of the increased drag from an increasing air density as the aircraft descended. When the aircraft had reached ground level the descent rate had reduced to around 10,000 ft/min.

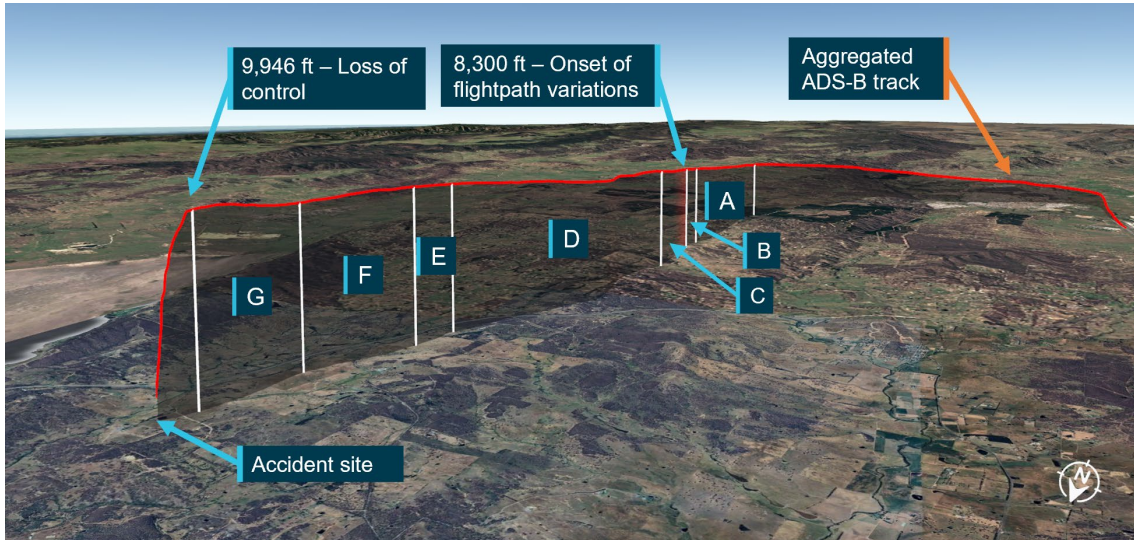
Figure 13: Aggregated ADS-B data for VH-MSF, looking back along the flight path

Figure 13 depicts the aircraft’s flight track looking back along the flight path with A through G labelled to the relevant sections of the flight as shown in Figure 12. As the aircraft climbed through 8,300 ft, the somewhat linear flight track changed, with heading, altitude and airspeed variations commencing.

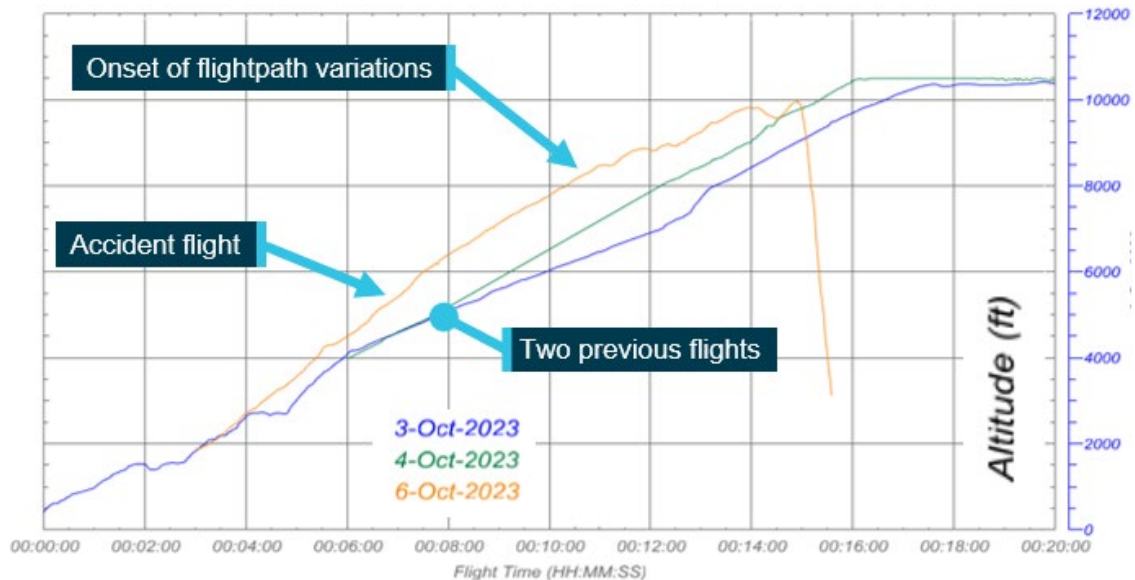
Figure 14: Comparison of ADS-B altitude data for the accident and 2 prior flights

Figure 14 illustrates ADS-B altitude data from initial climb to about 10,000 ft for the accident flight and the 2 prior flights (on 3 and 4 October 2023)<sup>23</sup> conducted by the pilot in VH-MSF. The data showed the aircraft climb performance for the accident flight was initially similar or better than the prior flights. During the period of flight path variations, the aircraft performance reduced, potentially due to manoeuvring, but then momentarily returned to comparable performance after passing 9,000 ft.

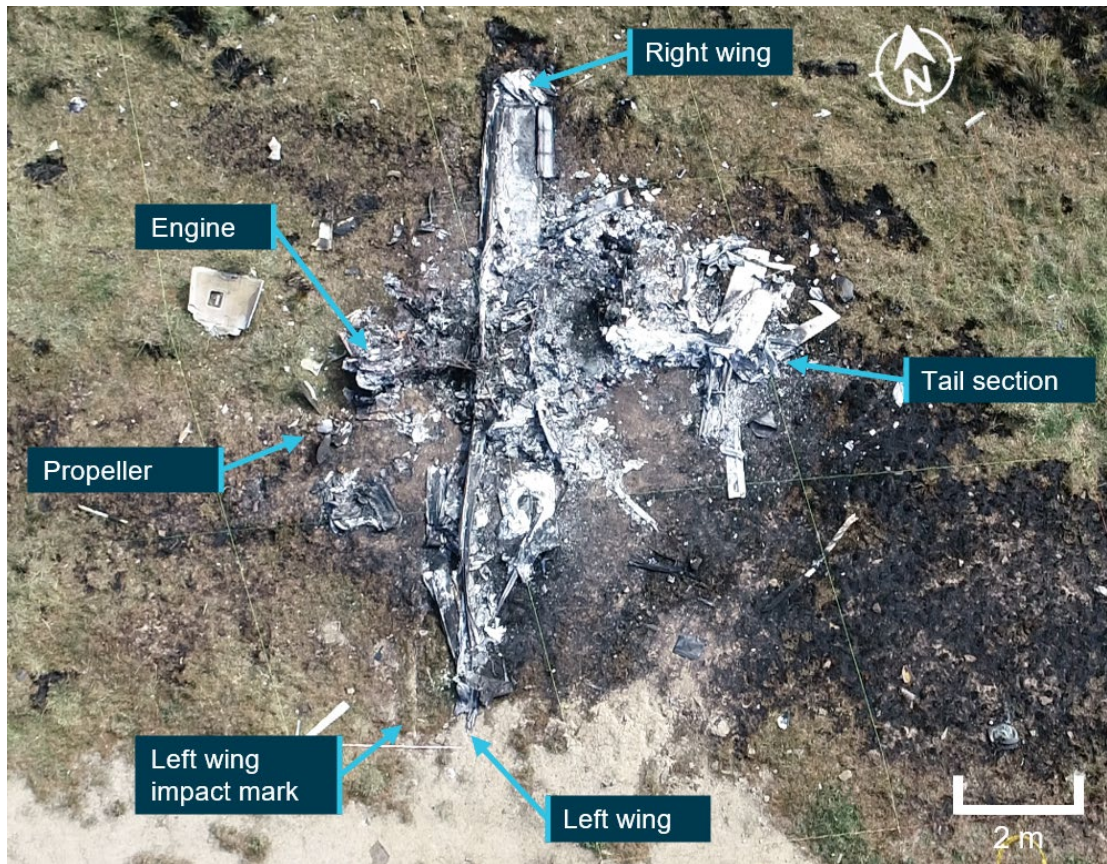
Figure 15: Overview of the accident site and remaining wreckage

The aircraft came to rest in an open field adjacent to a dam wall with a 10° downward slope towards the right wing. Although post-impact fire damage precluded examination of a significant proportion of the aircraft, inspection of the site and wreckage showed (Figure 15 and Figure 16):

- The engine power lever and mixture control positions could not be determined.

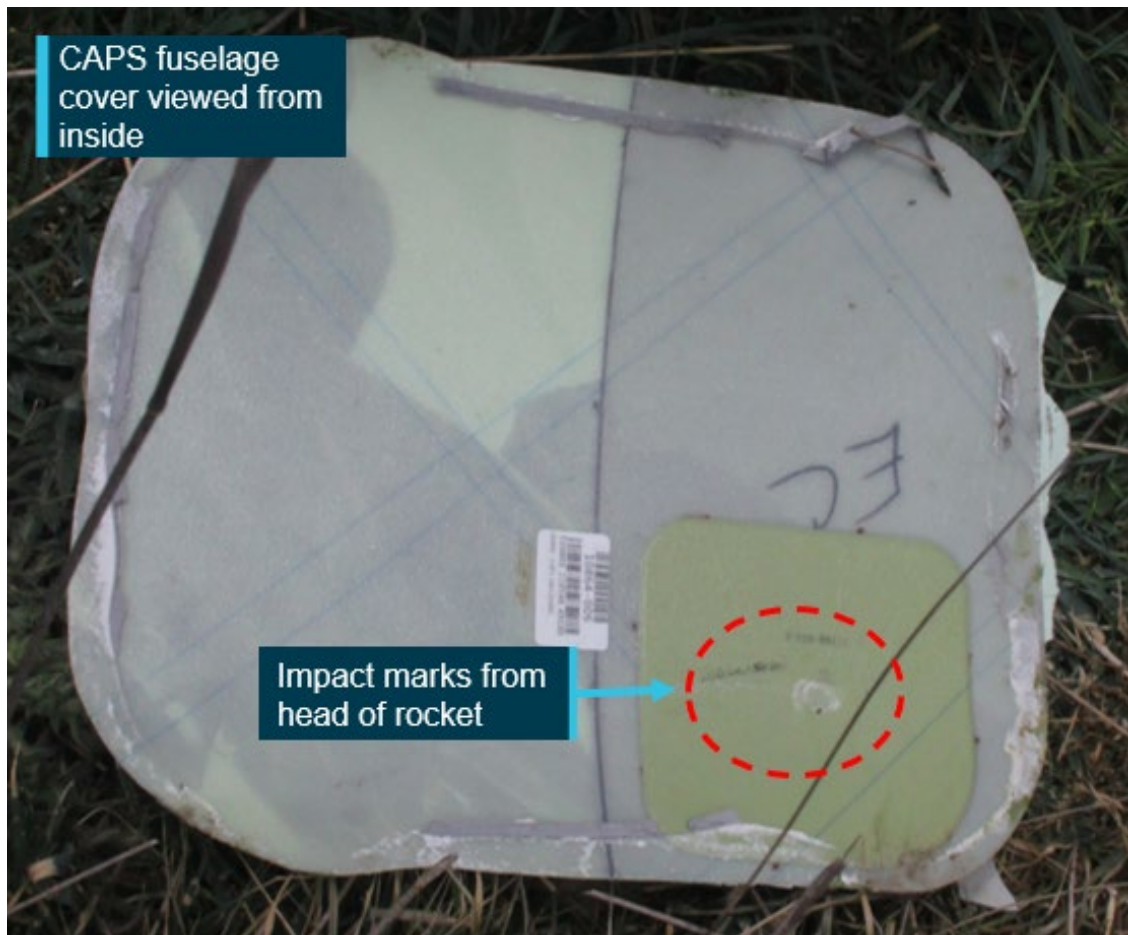
**Figure 17: CAPS external cover showing internal impact mark**

The parachute was located in its normal fitted position, remaining in its pack. After an extensive search throughout the remaining wreckage, the parachute deployment handle and safety pin could not be located. Therefore, the ATSB could not establish if an attempt was made to deploy the parachute in-flight.

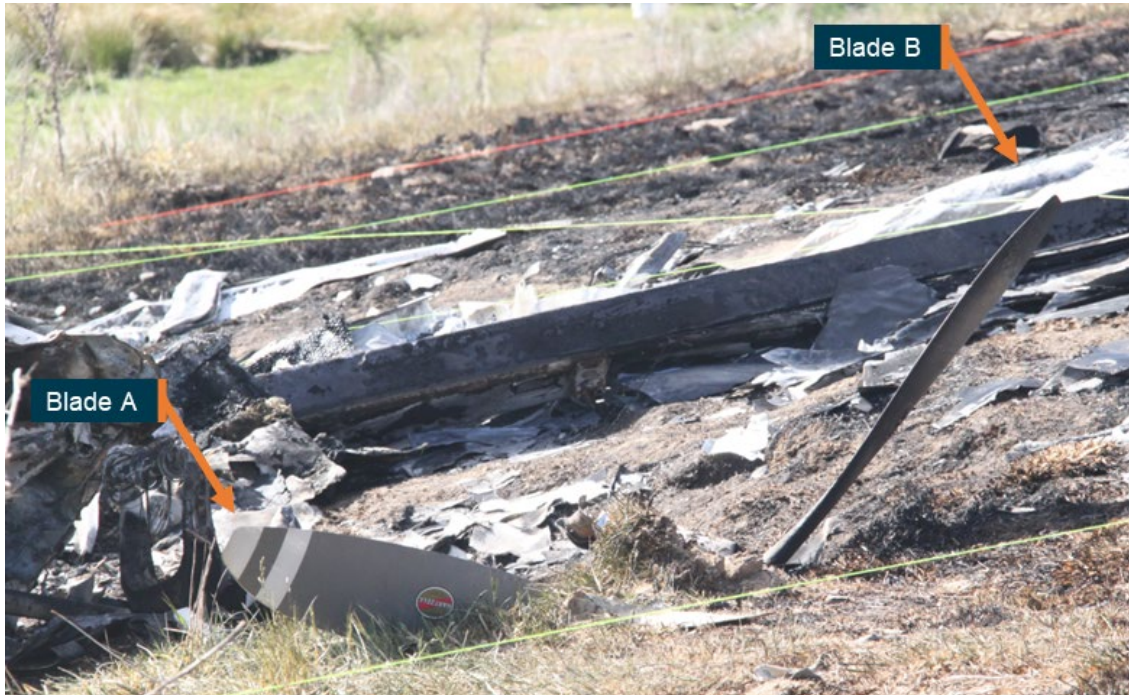
**Figure 18: Propeller as found at the accident site**

The propeller was partially buried at the front of the aircraft. The propeller flange had separated from the engine crankshaft and remained attached to the propeller hub. Two of the 3 propeller blades (Figure 18, blades A and B) were undamaged and showed no signs that they had passed through the ground during the impact with terrain.

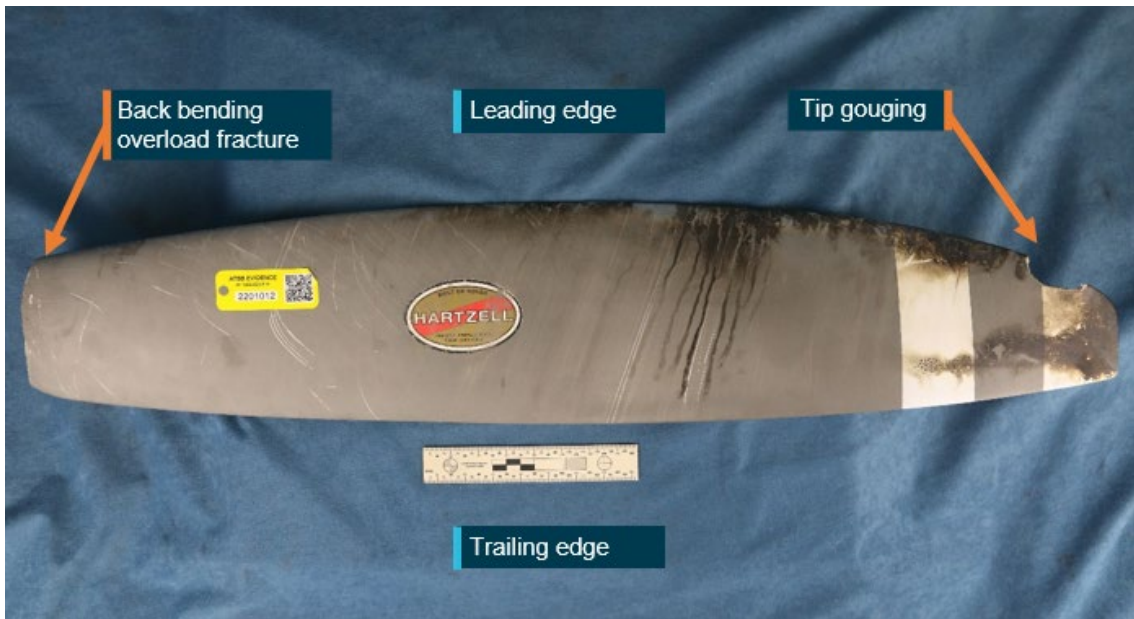
Figure 19: Blade C as recovered from the accident site

Propeller blade C was buried in the earth directly under the hub and showed some signs of rotational scoring, some leading-edge gouges, and slight chordwise twisting. A fracture surface at the base of the blade was from back bending overload as a result of the impact with terrain (Figure 19).

With respect to the engine power output, typically, windmilling or an engine at idle power will stop very rapidly when the propeller blades contact the ground. There is often minimal ground entry and little to no distortion to the blade sections. In this case, when blade C entered the ground, the propeller stopped suddenly. Therefore, the ATSB's analysis concluded that, while there were some signatures that would indicate that the propeller was rotating at the time of impact, there was no evidence of appreciable power being produced by the engine. Rather, the damage to the propeller blades indicated that the engine was operating at low power when it impacted terrain.

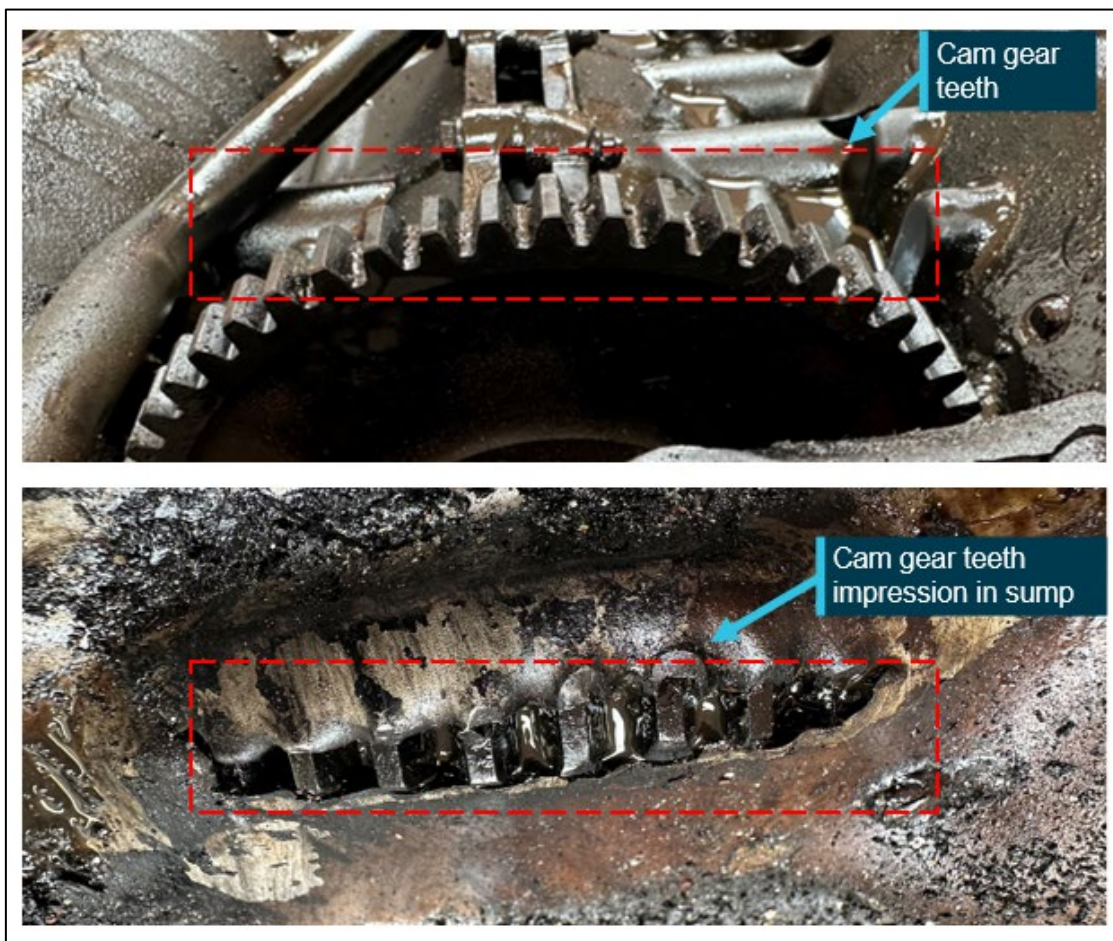
Figure 20: Camshaft drive gear and impressions made in the engine sump

The engine sump was pushed upwards during the impact with terrain, bringing it in contact with the cam shaft drive gear. That contact perforated the sump with gear teeth impressions, indicating that the engine camshaft was not rotating and the engine had stopped by the time the imprints were made (Figure 20).
