# Runway excursion involving Cessna 510, VH-SQY

Bankstown Airport, New South Wales, on 11 January 2025

## **ATSB Transport Safety Report**

AO-2025-002

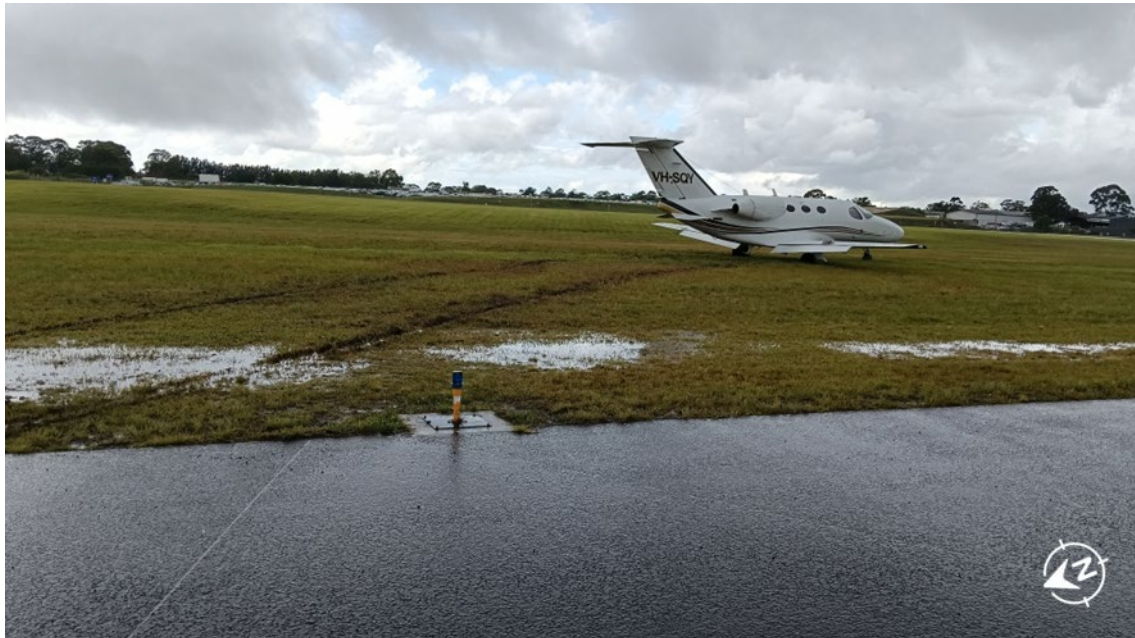
**Figure 2: VH-SQY after runway excursion**

Realising that the aircraft would not stop prior to the end of the runway, the pilot advised air traffic control (ATC) that they could not stop. They then steered the aircraft slightly to the right to avoid the lights at the end of the runway. Departing the end of the runway at a groundspeed of 28 kt, the aircraft entered muddy ground and travelled another 30 m in a right turn before coming to a stop (Figure 2). The aircraft was undamaged and the pilot, flight nurse and patient were uninjured. After advising ATC of the situation and shutting down the aircraft, the patient was transferred to ground transport and the aircraft was recovered to a hanger.

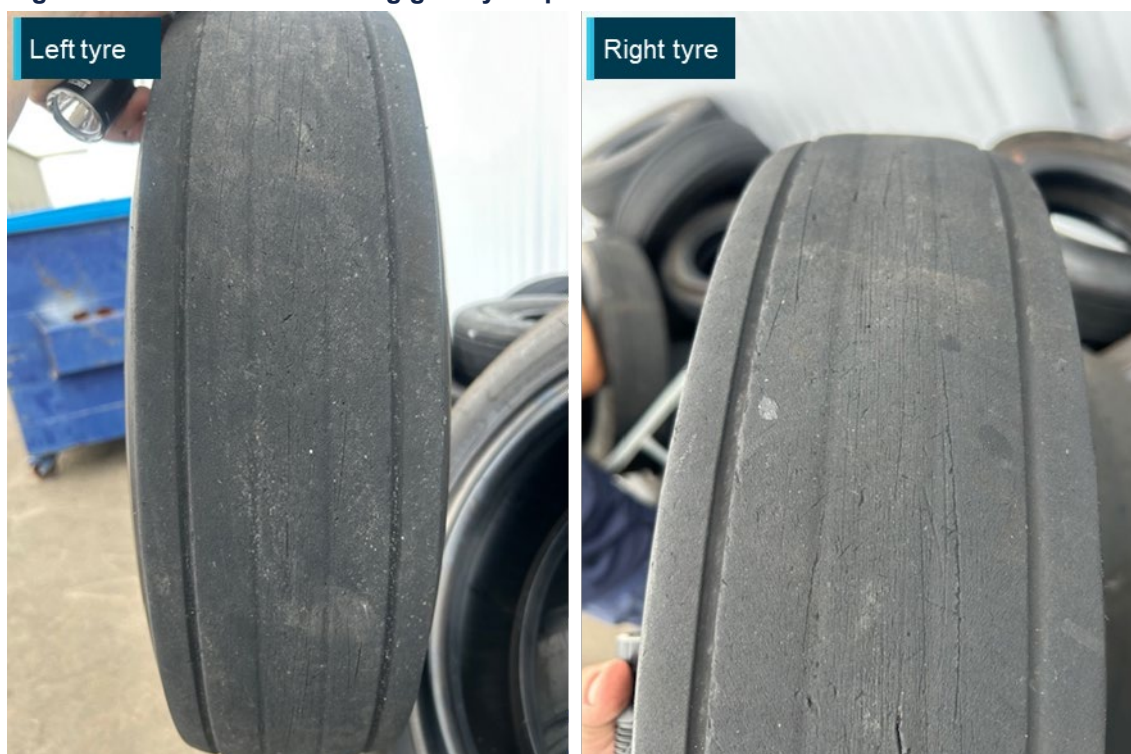
**Figure 4: VH-SQY main landing gear tyres post-incident**

VH-SQY was equipped with 2 Michelin main landing gear (MLG) tyres. Maintenance records showed that both MLG tyres were last replaced in October 2024, after conducting 255 landings. Since that time, the aircraft had conducted 239 landings including the incident flight.

During the post-incident inspection, the maintainer determined that both main landing gear tyres were worn to limits (Figure 4) and identified evidence of flat spotting, potentially due to the wheels previously locking up under braking. The maintainer further advised that the tread remaining on the left and right MLG tyres was measured to be 0.013 inches (0.3 mm) and 0.019 inches (0.5 mm) respectively. Comparatively, the tread of a new tyre was reported to be 0.26–0.29 inches (about 7 mm), indicating that 4–7% of the original tread was remaining. Both tyres were subsequently replaced before the aircraft was released back to service.

On the wet runway, a gradual degradation in braking effectiveness was experienced up to about the 80 percent worn tire tread condition, where the wet-runway friction coefficients dropped markedly.

The completed worn tire was observed to develop, at higher speeds, only about one-half the braking effectiveness of a new tire.

AirMed also provided training to all crew addressing the effects of tailwind, correct anti-skid use, tyre limits and landing technique. In addition, it updated defect reporting procedures to encourage earlier reporting of anticipated maintenance requirements, and implemented a policy of tyre replacement when tread reaches 2 mm, representing 80% tyre wear.

Air Link amended training material for the C510 type rating to ensure that the correct landing distance factoring was applied and taught. In addition, past students were contacted to ensure that they understand performance requirements relating to the C510. Furthermore, it is in the process of including a new section in the endorsement training around wet weather operations, and has also implemented a policy of tyre replacement when tread reaches 2 mm.

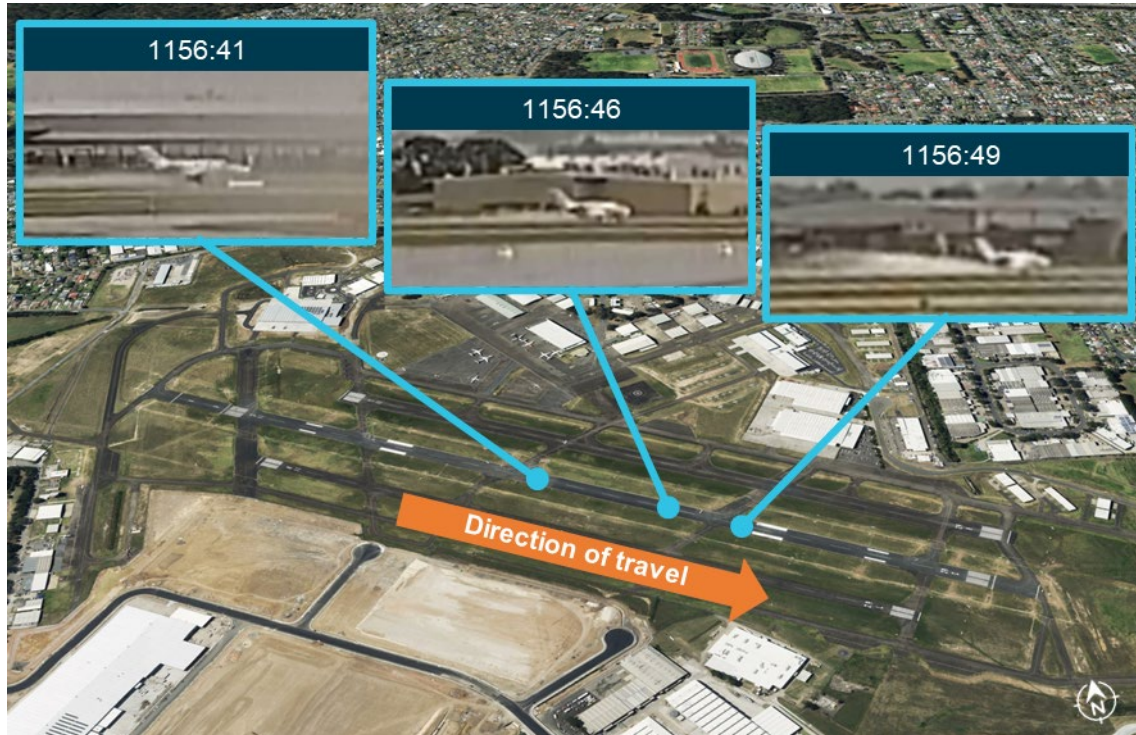
**Figure 7: CCTV images of water spray during landing**

While the runway surface condition was reported as wet on the ATIS, the ATSB identified evidence of standing water on the runway at the time VH-SQY landed. CCTV footage recorded the latter portion of the landing, during which spray was observed being ejected from beneath the aircraft during its ground roll (Figure 7).

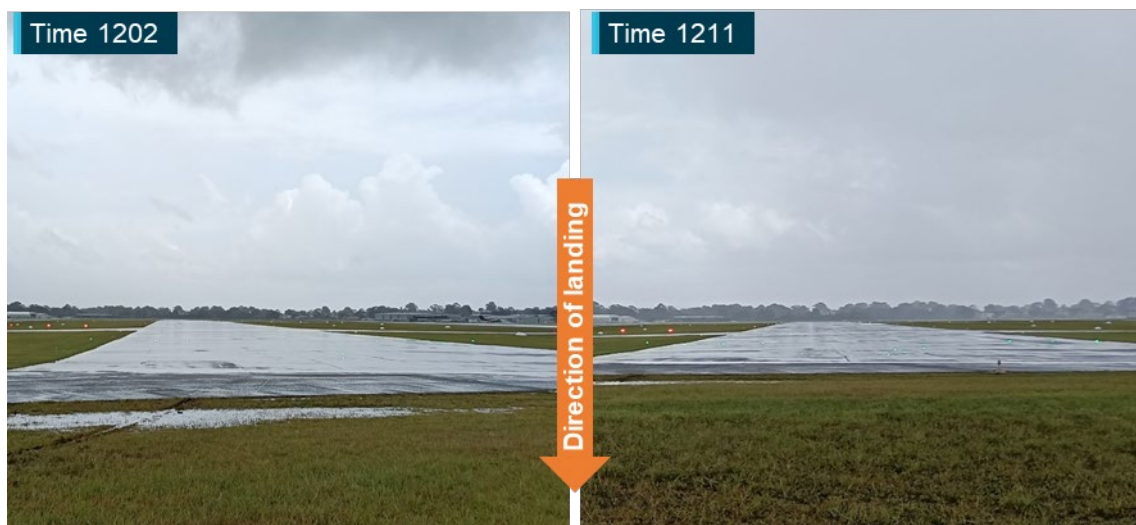
**Figure 8: Runway 11C surface after incident**

Additionally, a photograph of runway 11C taken at 1202, 6 minutes after the runway excursion, showed water on the runway (Figure 8). A subsequent photograph taken 9 minutes later showed that the amount of water on the runway had visibly reduced over this time.

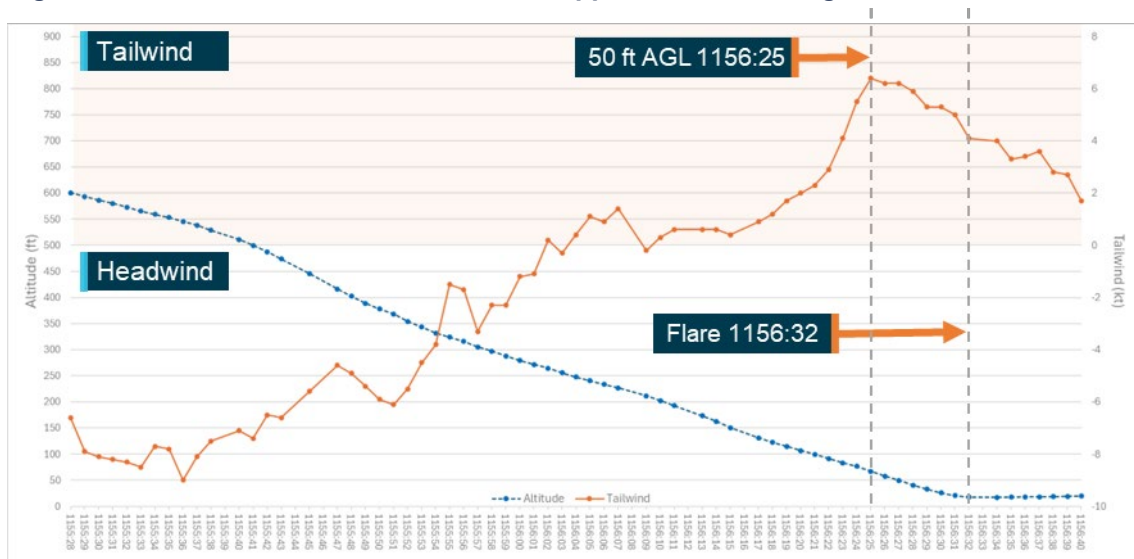
**Figure 10: VH-SQY calculated wind on final approach and landing**

The data recorded both the indicated airspeed and groundspeed of the aircraft, enabling the headwind and tailwind component of the wind to be determined (Figure 10). At approximately 550 ft, the aircraft was experiencing a headwind of 9 kt. As the aircraft descended on the approach, the headwind decreased prior to switching to a tailwind at approximately 250 ft. As the aircraft continued its descent, the tailwind increased up to a maximum of 6.3 kt when the aircraft was 50 ft AGL, consistent with the wind recorded at the airport. After peaking at 50 ft, the tailwind decreased throughout the remainder of the landing.

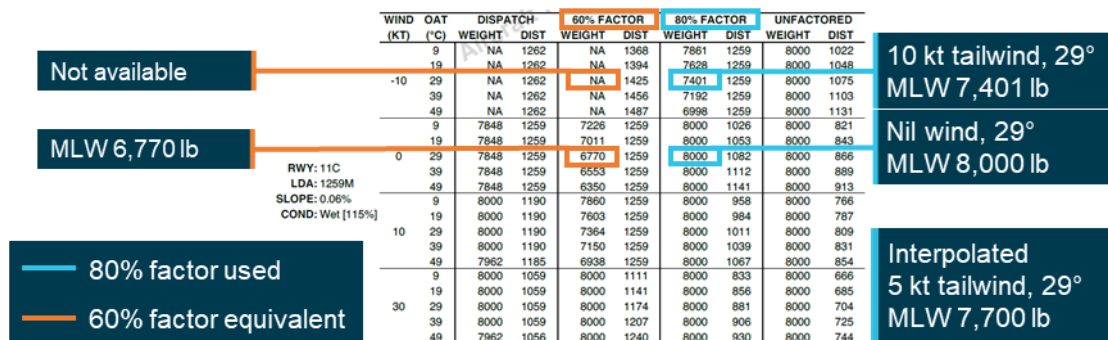
Figure 13: Pre-departure landing distance calculation

The pilot reported that prior to departure, as part of their pre-flight planning process they assessed the landing distance available at Bankstown using the APG tabulated landing distance data. Given the forecast conditions (see the section titled *Forecast conditions*), they determined that the runway would likely be wet on arrival, therefore they consulted the section of the data for a wet runway. Rather than using the wind forecast from the TAF, they used for a more conservative 5 kt tailwind on arrival. Using the 80% landing distance factor in accordance with operator procedures, a more conservative temperature of 29° and interpolating between the values for nil wind and a 10 kt tailwind, they determined that the maximum landing weight was approximately 7,700 lb for runway 11C at Bankstown (Figure 13).

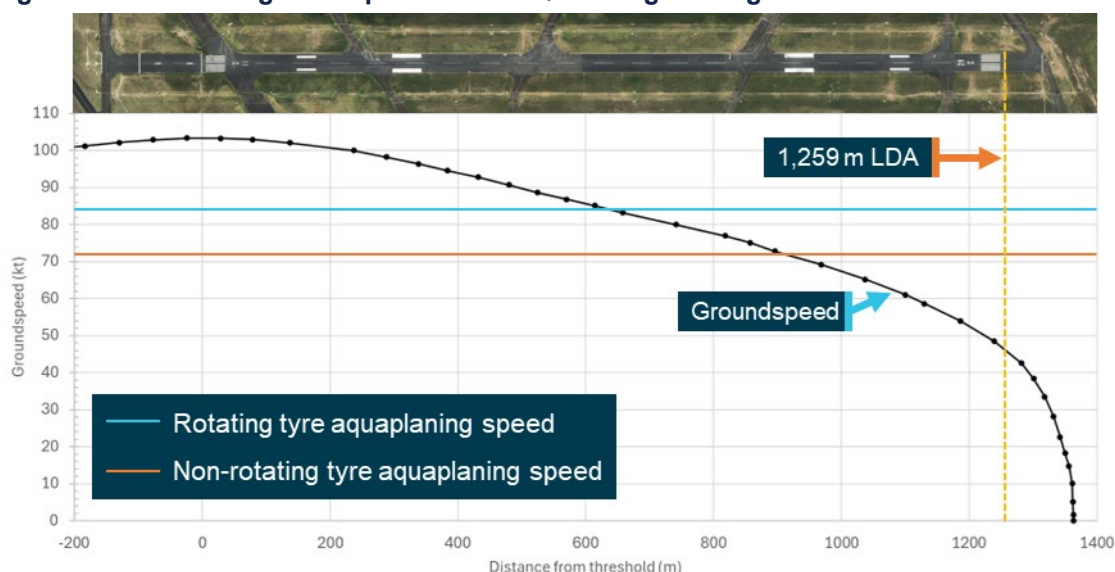
**Figure 14: Recorded groundspeed of VH-SQY during landing**

Recorded data showed that the groundspeed of the aircraft was above both the rotating and non-rotating tyre minimum aquaplaning speed until approximately 360 m of LDA remained (Figure 14).
