Collision with terrain involving Cessna 150M, VH-WWU

40 km north-west of Northampton, Western Australia, on 21 March 2025

Aviation Occurrence Investigation (Short)

AO-2025-014

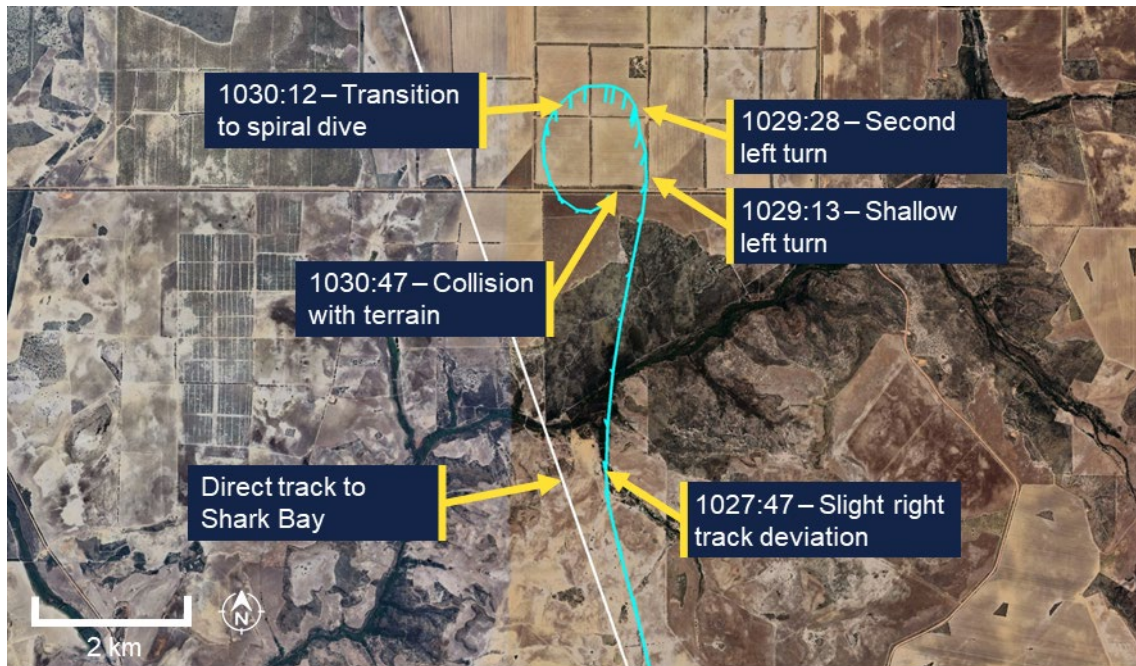
Figure 3: Track deviation and spiral dive

At 1027:12, the aircraft crossed to the right of the direct track to Shark Bay (343°M), while maintaining a track of 347°M (Figure 3). At 1027:47, 25 seconds after crossing the direct track, the recorded data showed a right turn to a track of 011°M .

At 1028:41, while maintaining a track of 011°M , the aircraft commenced a slight descent and 22 seconds later (at 1029:13) entered a shallow left turn. The aircraft then re-acquired the previous track of 347°M which was maintained for 15 seconds. At 1029:28, another left turn occurred as the slight descent continued. This turn transitioned into a spiral dive with the descent steepening significantly at 1030:12. The spiral dive tightened and steepened until a collision with terrain at 1030:47. The pilot was fatally injured and the aircraft was destroyed.

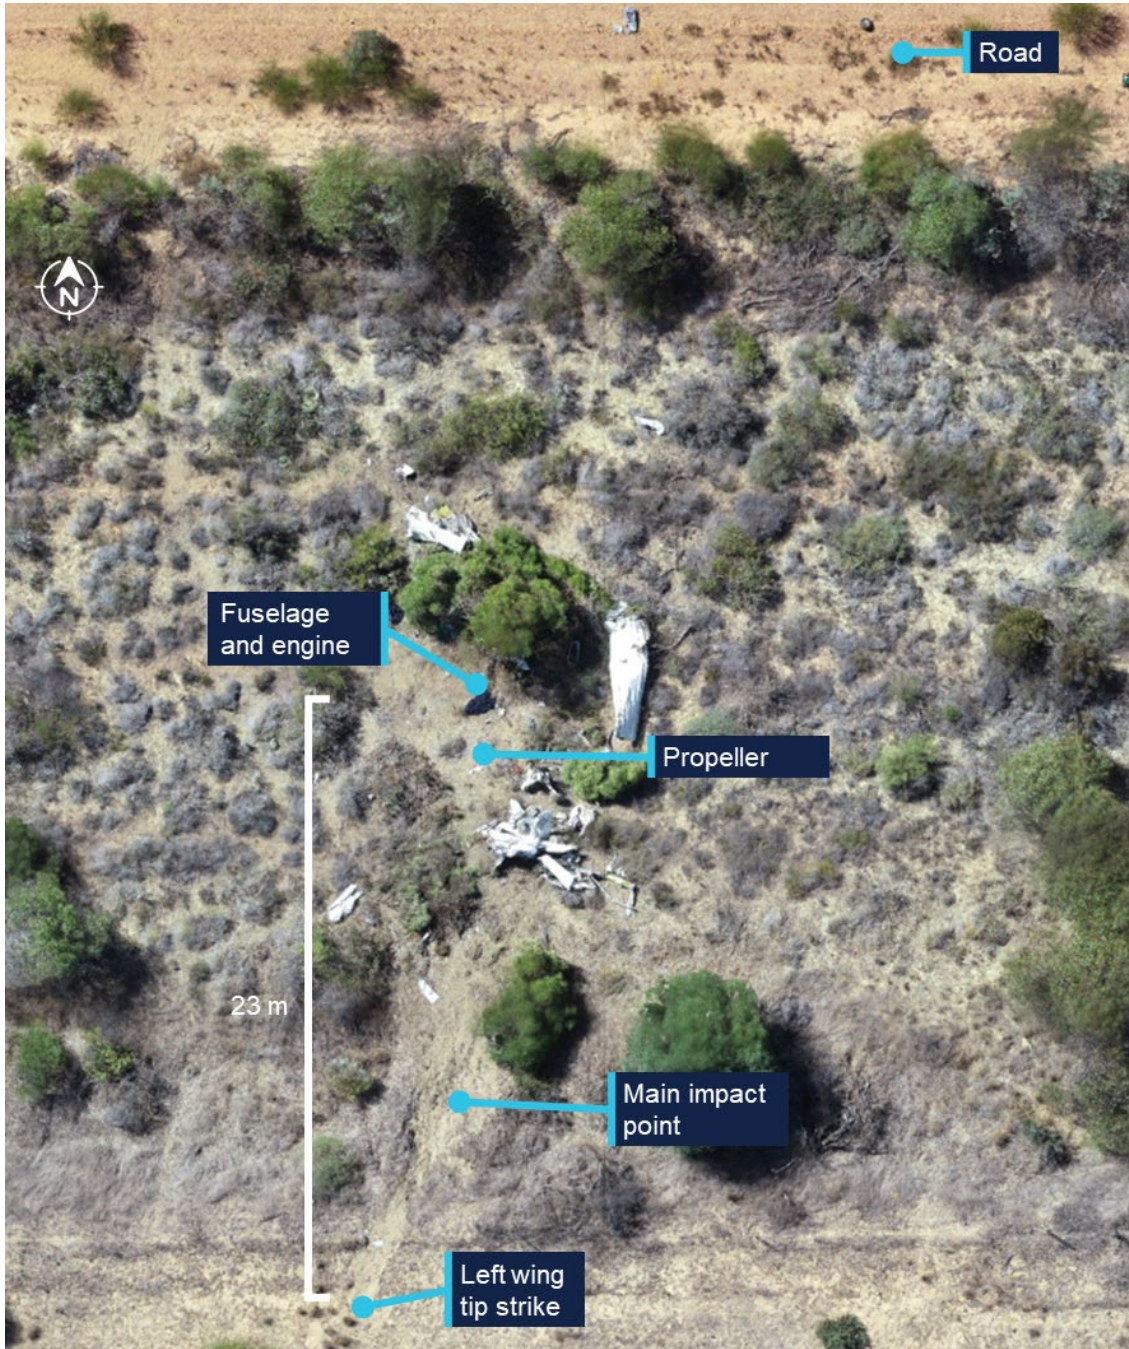
Figure 4: Overview of VH-WWU accident site

The wreckage was located about 20 m south of an east-west road. The wreckage trail extended in a north-easterly direction, about 23 m from the initial impact point to where the main wreckage, including the wings, empennage, engine and propeller had come to rest (Figure 4). There was no fire. Fuel could be smelt in the area.

Ground impact marks and damage to the airframe indicated that the aircraft impacted the terrain in a left wing-low, steep, nose-down attitude at high speed (Figure 4). All major aircraft components were accounted for at the accident site. Damage to and deformation of the propeller was consistent with the engine running at the time of impact. There were no identified pre-accident aircraft defects, although disruption to the airframe precluded a full assessment of the aircraft's serviceability immediately prior to the accident and prevented the ability to measure remaining fuel on board.
