# Ditching in floodwater involving Robinson R22 Beta, VH-KNG

Adavale, Queensland, on 27 March 2025

Aviation Occurrence Investigation (Short)

AO-2025-016

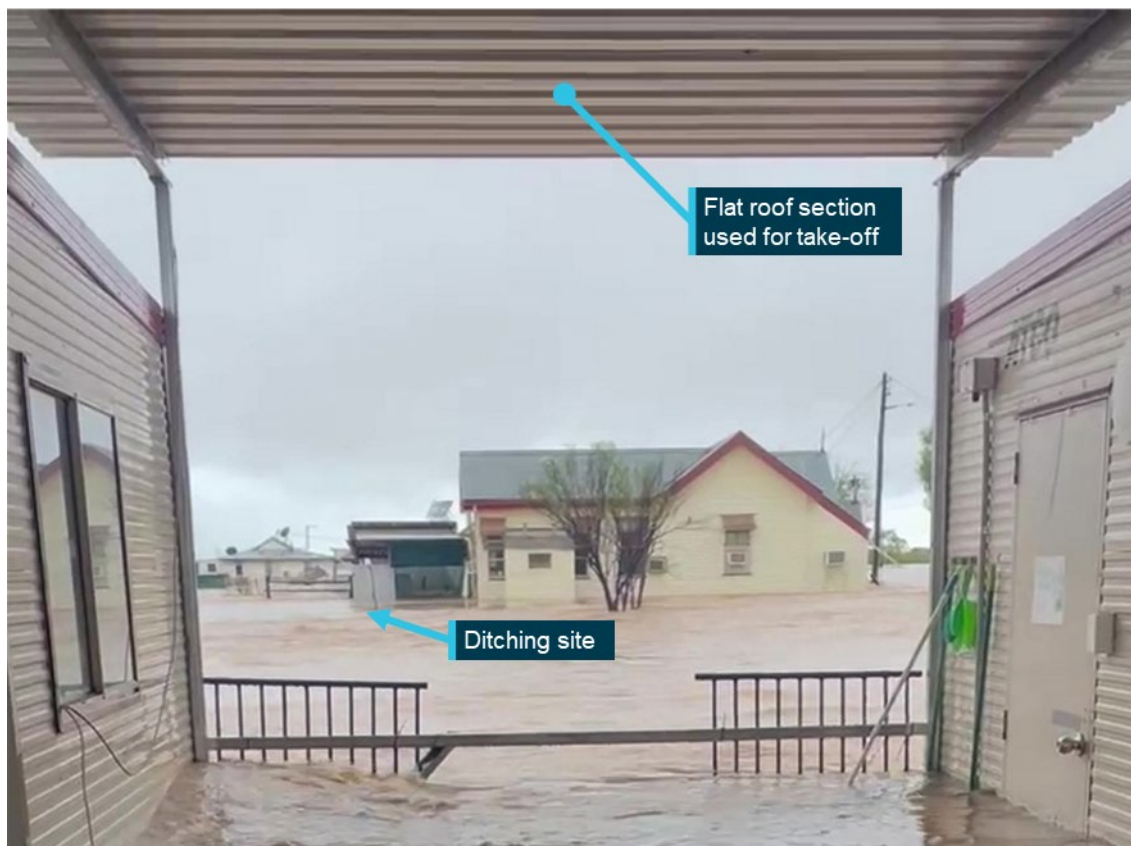
**Figure 1: View underneath roof**

On approach to the rescue site, the pilot recalled that they assessed that the building was at immediate risk of being washed away, and that the roof strength was insufficient to carry the full weight of the helicopter. The pilot then opted to maintain lift on the main rotor while picking up the passenger to reduce the load on the roof sheeting. The helicopter touched down on the flat roof between the two demountable buildings (Figure 1). The pilot kept the helicopter flying throughout the passenger embarkation, with only part of the skids lightly touching the roof.

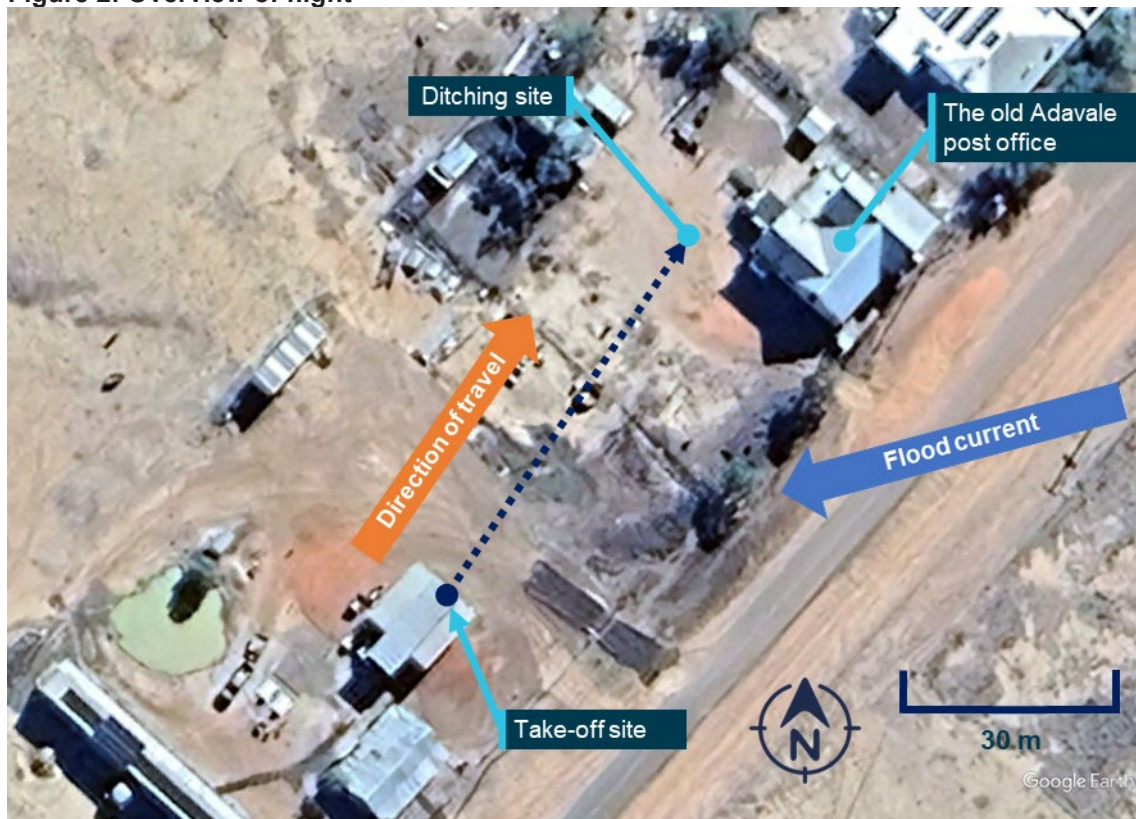
**Figure 2: Overview of flight**

The pilot lowered the collective<sup>6</sup> and applied aft cyclic<sup>7</sup> and quickly concluded that the helicopter would not be able to clear approaching obstacles such as trees, buildings and powerlines during the take-off run. They then selected an area sheltered from the floodwater current, behind a building about 60 metres away, and conducted a controlled ditching.

Photos, video and satellite imagery of the take-off site show several obstructions in the form of power lines and trees in the departure direction (Figure 2). These obstructions were high enough to limit departure using the recommended take-off profile and to require a confined area take-off.

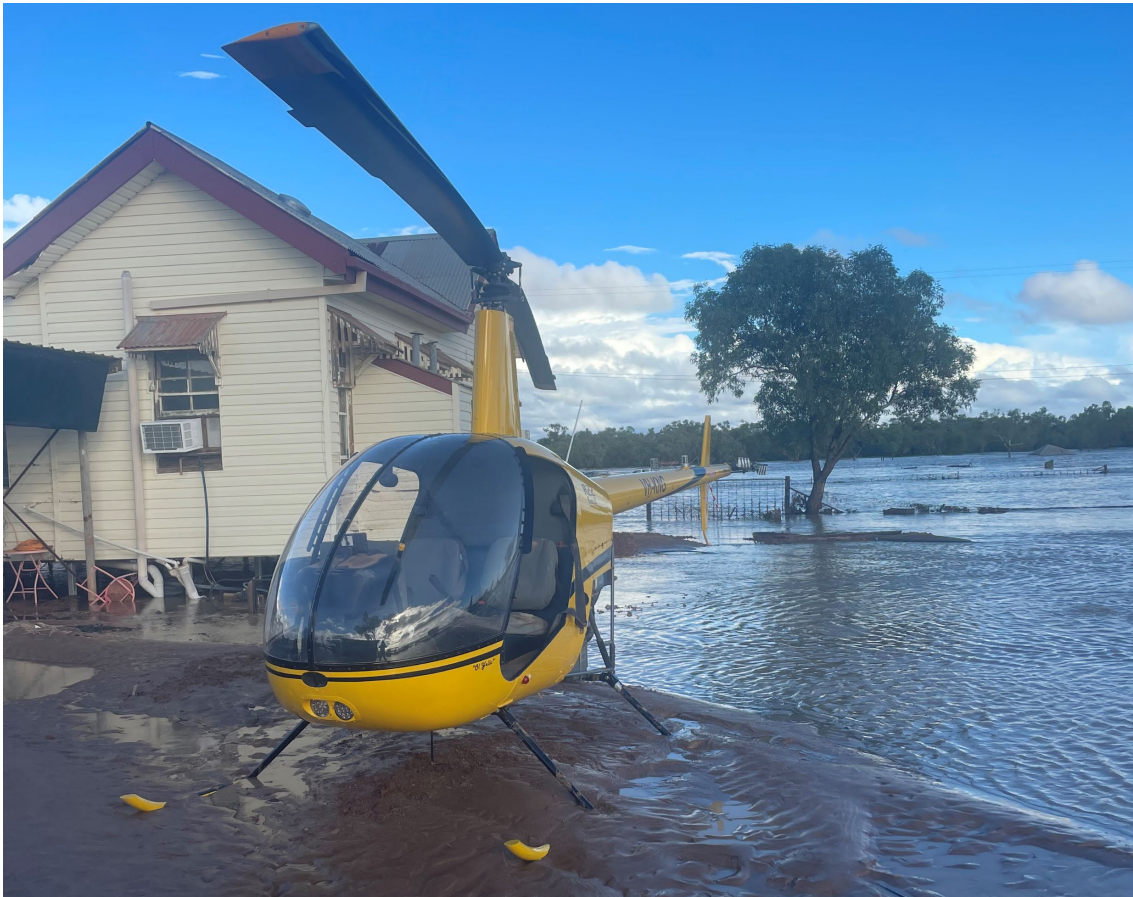
**Figure 4: VH-KNG after the accident**

The helicopter was substantially damaged by the floodwater.

After ditching, the helicopter became submerged in floodwater, stopping the engine. Due to the lee of the building protecting the helicopter from the main current, it remained upright, allowing both the passenger and pilot to egress into the chest deep water.

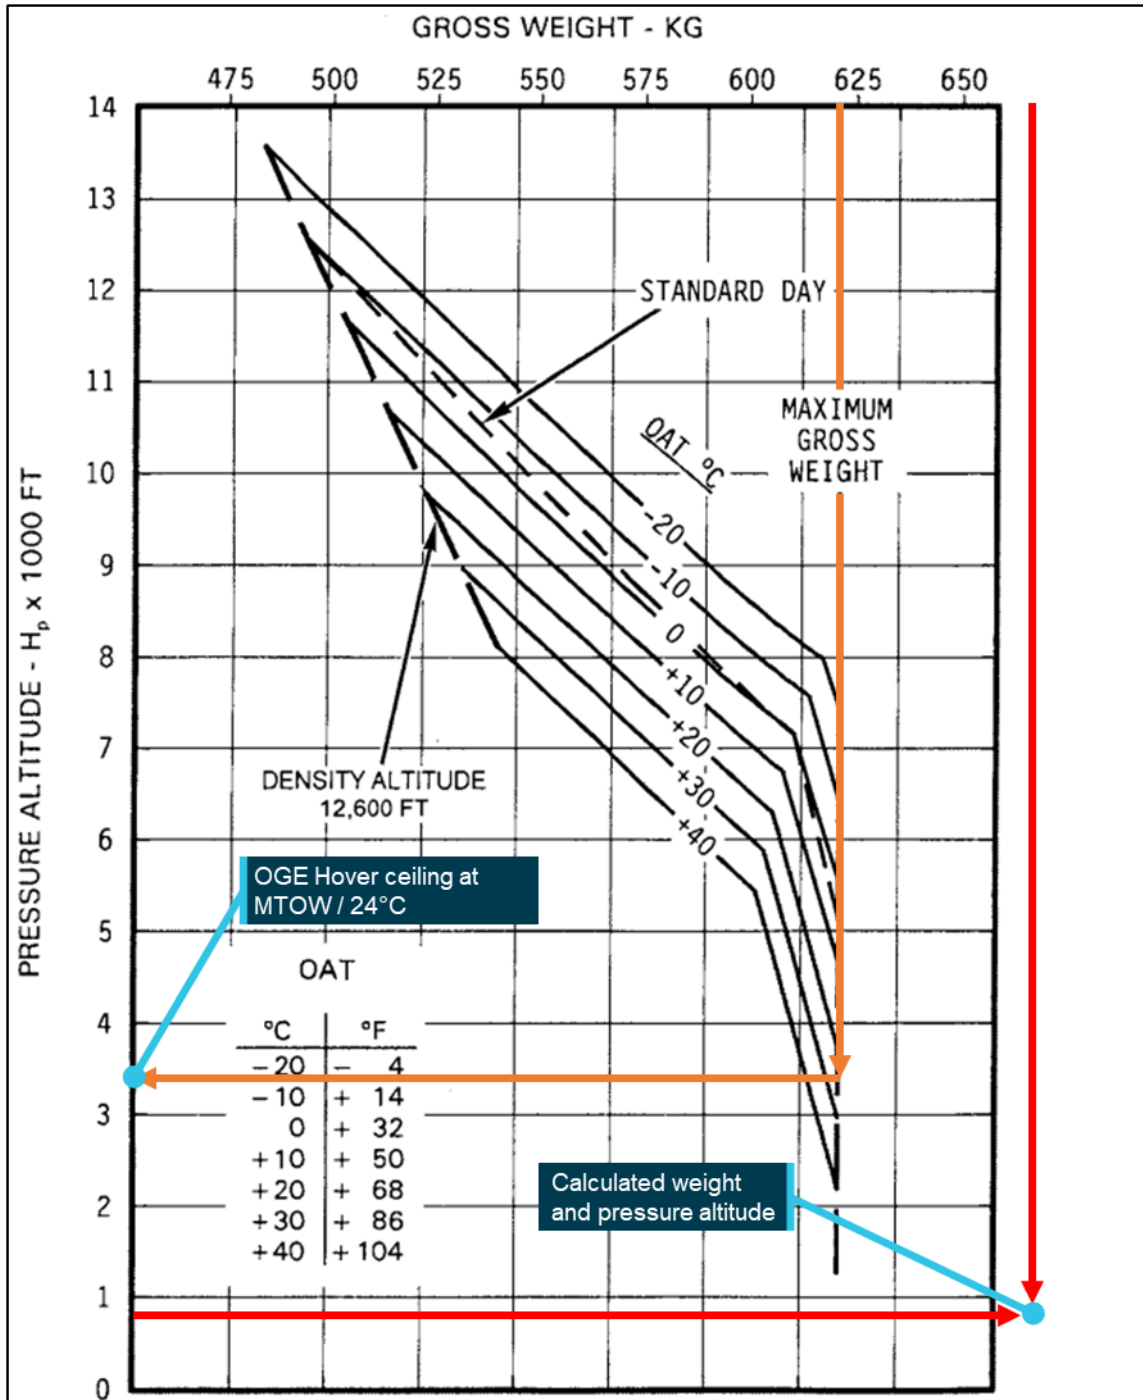
Figure 5: OGE hover ceiling vs gross weight

Performance data provided by the Robinson R22 pilot’s operating handbook (POH) indicated that, at its maximum take-off weight (MTOW) of 622 kg and the temperature at the time of the accident of 24°C (see *Meteorological conditions*), the helicopter should have had sufficient available performance to hover in ground effect (IGE) up to a pressure altitude of about 7,900 ft and an out of ground effect (OGE) up to a pressure altitude of about 3,400 ft (Figure 5).

This performance is based on ‘ideal conditions’, however, in this case, high humidity would likely have further decreased the available performance by as much as 3 or 4% (FAA, Federal Aviation Agency, 2021). However, this should still have allowed OGE hover at maximum take-off weight, at the calculated pressure altitude of 811 ft at the time and location of the accident.

Figure 5 shows the maximum pressure altitude for flight out of ground effect at maximum take-off weight (orange line) and the calculated helicopter weight and actual pressure height (red line).

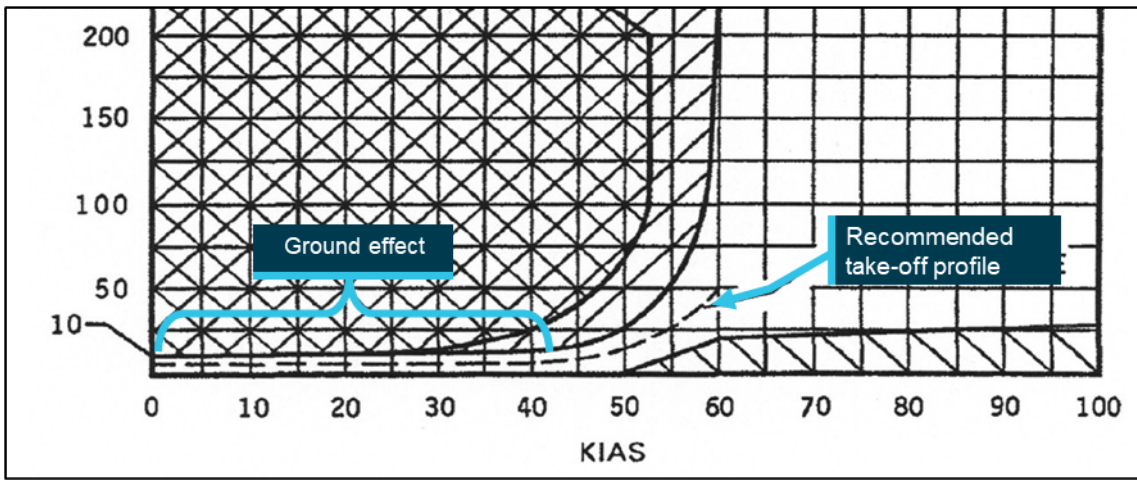
**Figure 6: Height velocity diagram Robinson R22**

The manufacturer’s recommend take-off profile, as defined in the POH (Figure 6), involves accelerating in ground effect before pitching up into a climb. This technique ensures sufficient energy and reaction time available at any stage of the take-off to enter autorotation in case of an engine or tail-rotor failure. For the R22, this required acceleration to 45 kt indicated airspeed in ground effect before starting to climb.
