VFR into IMC and collision with trees involving Cessna 182T, VH-TSS

57 km south-east of Mount Surprise, Queensland, on 16 June 2025

Aviation Occurrence Investigation (Short)

AO-2025-028

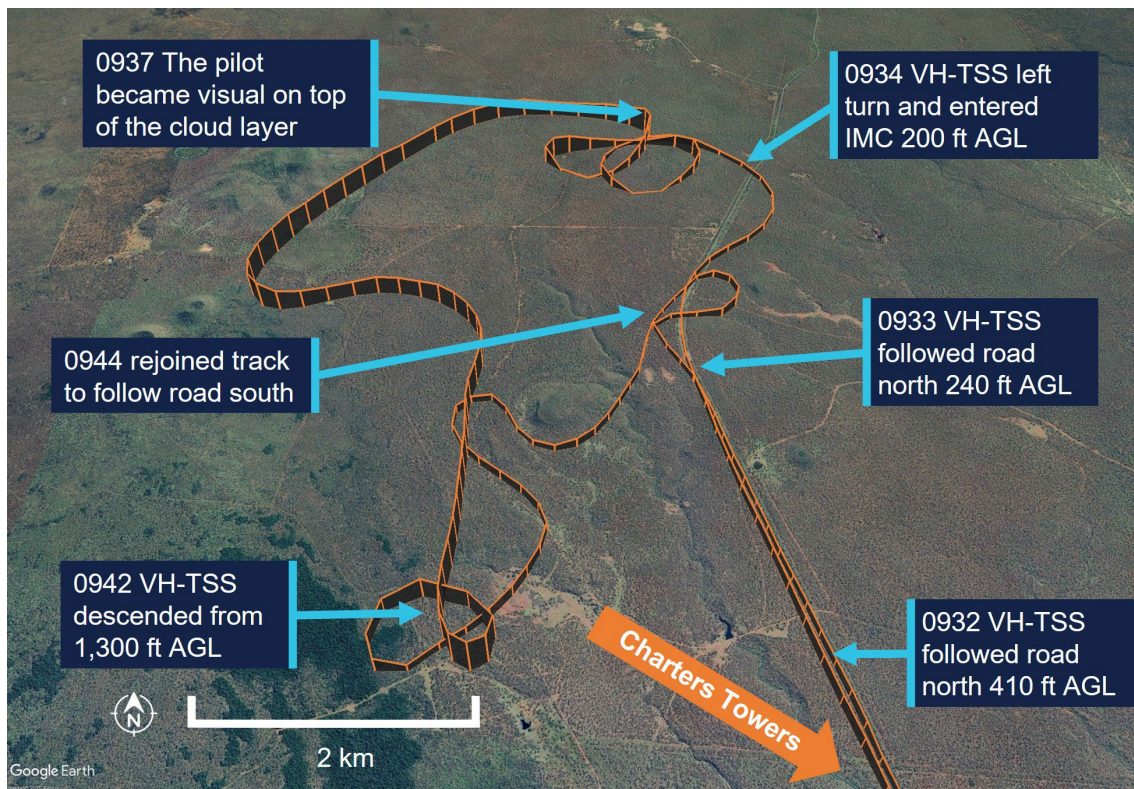
Figure 2: VH-TSS flight track between 0932 and 0946

About a minute later at about 200 ft AGL and 140 kt airspeed (Figure 2), the pilot recalled commencing a left turn and reduced the aircraft's engine power to try to avoid flying into 'white-out' conditions ahead. However, during the turn, the pilot recalled that they entered cloud.

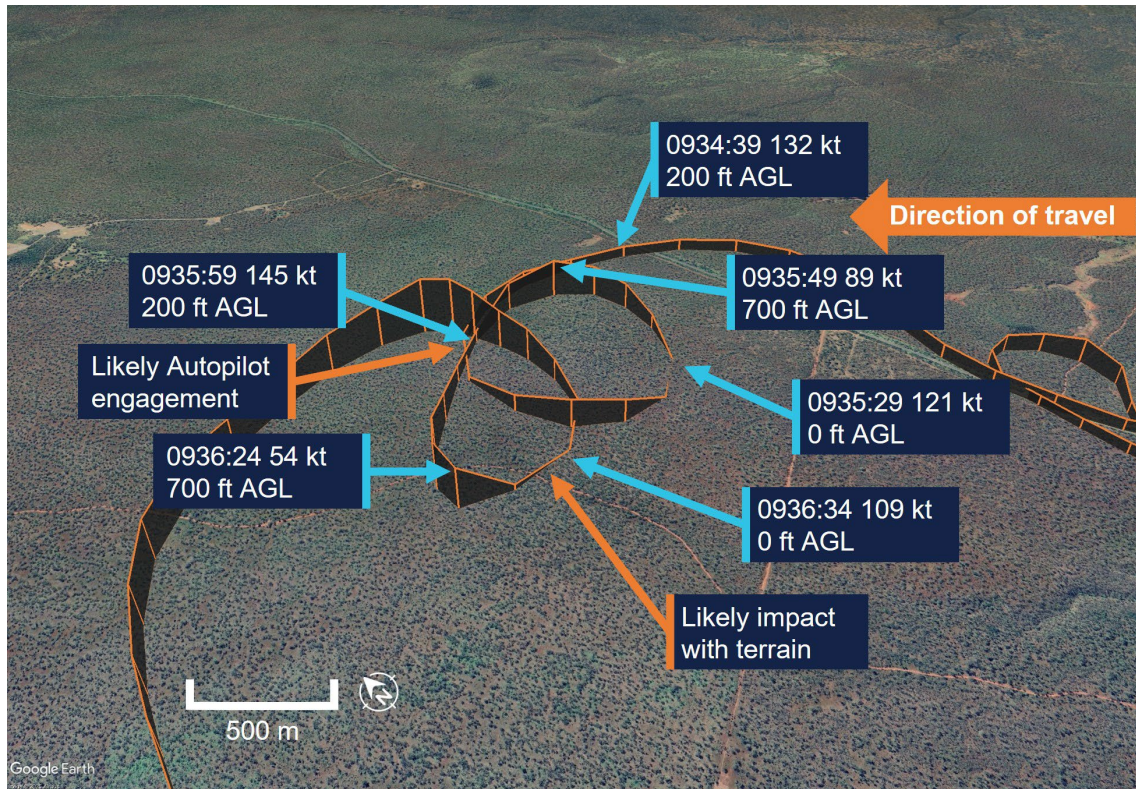
Figure 3: VH-TSS flight track between 0934 and 0938

At 0936, having descended a third time to about 200 ft, the aircraft began to maintain a constant heading for about 20 seconds during which time it had a high rate of climb consistent with the engagement of the autopilot (*see Autopilot*). The aircraft climbed from about 200 ft to 700 ft AGL and reduced groundspeed to 54 kt. The pilot recalled they engaged the autopilot after entering cloud (this was likely after about 1–2 minutes after entering cloud) and then commanded a 180° left turn, in an attempt to reverse their track and navigate out of the instrument meteorological conditions (IMC) (Figure 3). During the next 10 seconds, the aircraft turned sharply left and descended rapidly. The pilot recalled the aircraft instrument panel went red and displayed a terrain warning and immediately applied right rudder and attempted to level the aircraft during the recovery, as it descended almost to ground level.

The pilot reported that they momentarily became visual and heard the aircraft impact trees. They pulled back on the control column and commenced a climb, entering IMC again. The pilot climbed to an altitude of about 1,000 ft AGL and was able to stabilise the aircraft and navigate out of IMC using the instruments. They became visual again once on top of the layer of cloud.

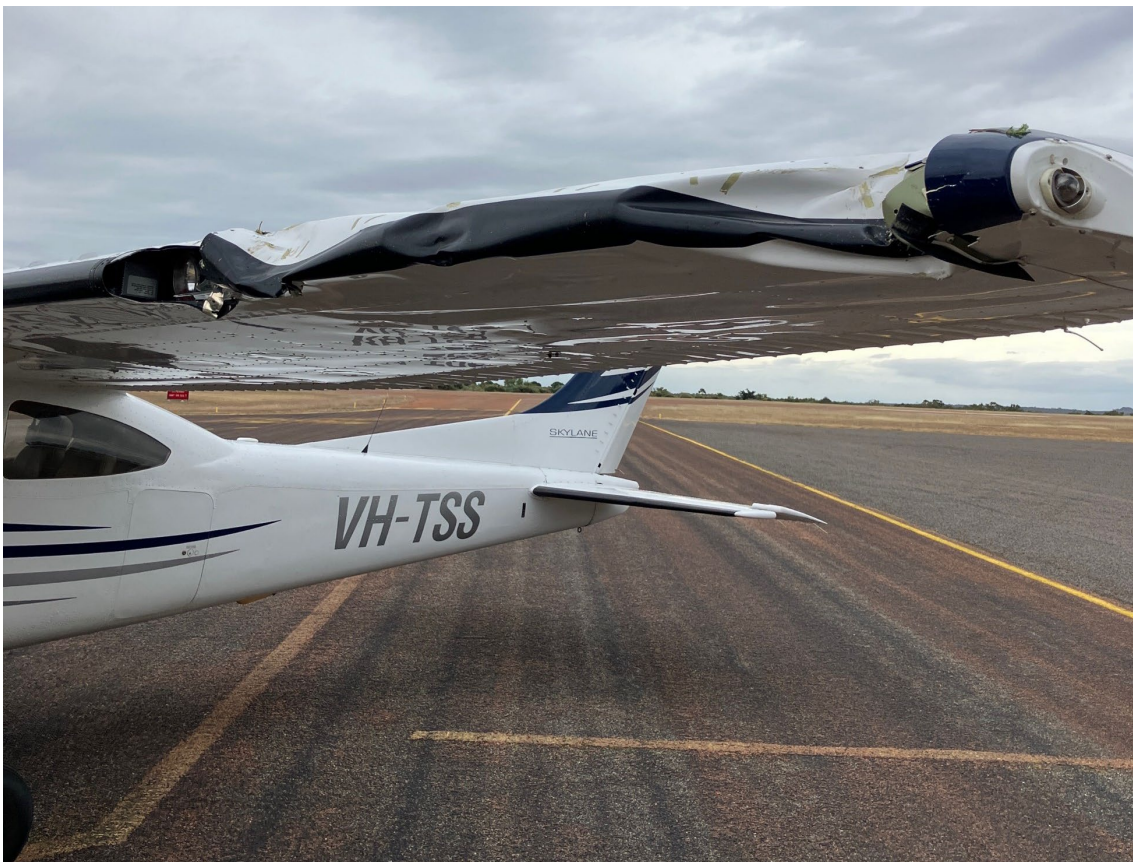
Figure 4: Left wing damage

As a result of the impact with the tree, the aircraft sustained substantial damage to the left wing (Figure 4), with minor damage to the left wing strut and both landing gear struts. No injuries were reported by either occupant.

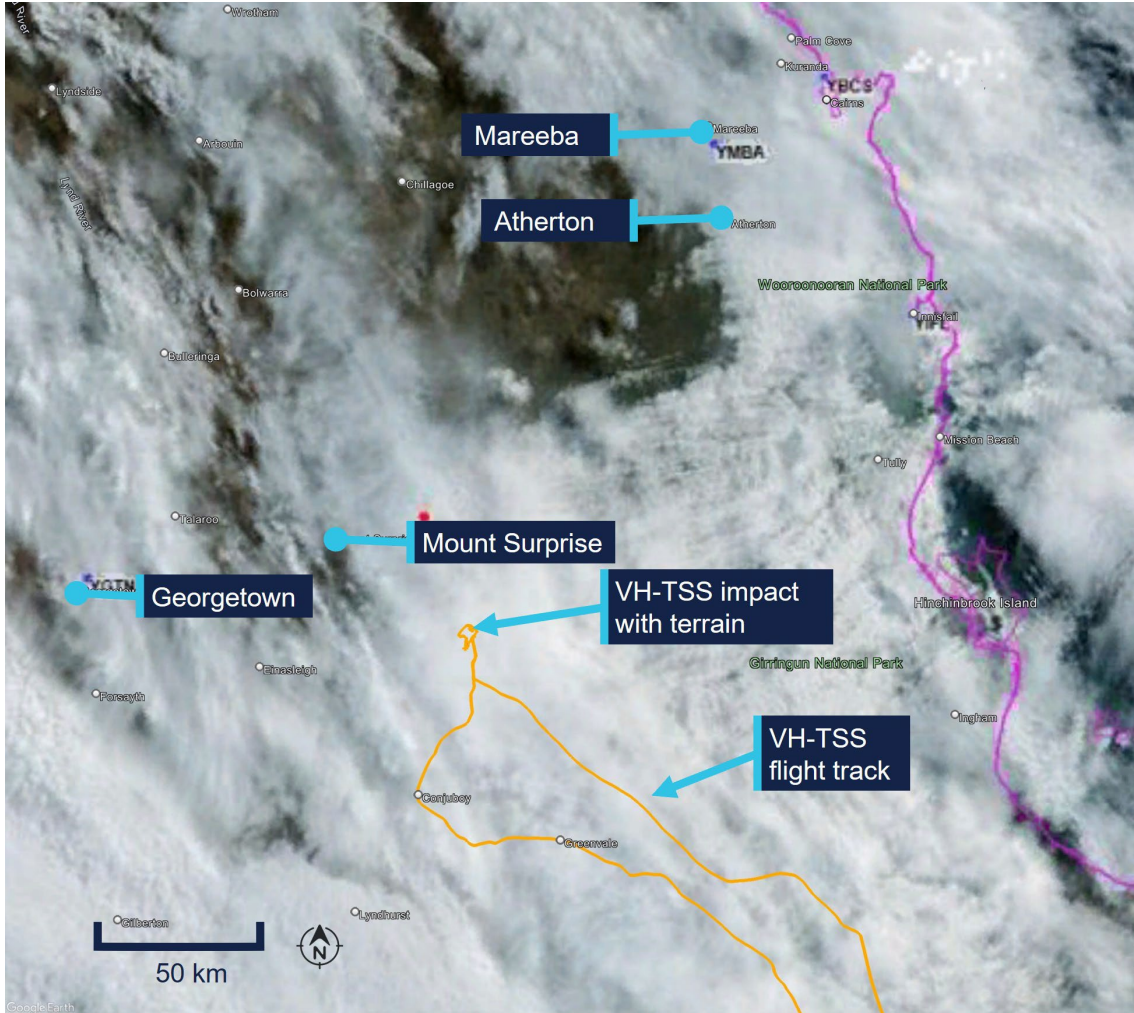
Figure 7: Satellite image 0930 local time

Satellite image taken at 0930 provided by the Bureau of Meteorology indicated cloud cover in the flight planned area and the area the pilot intended to use as a diversion (Figure 7).

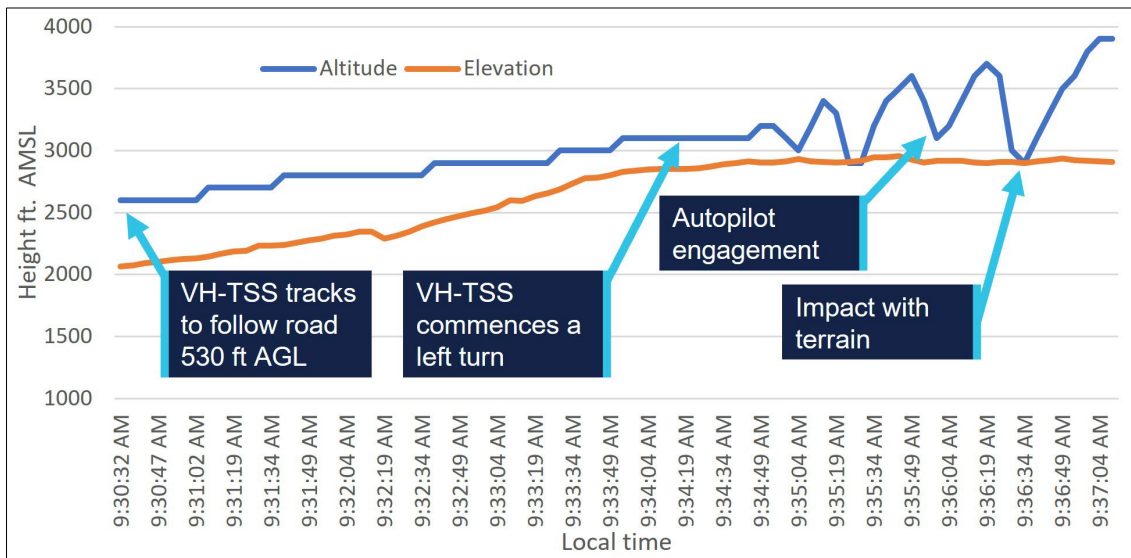
Figure 8: VH-TSS height above terrain

The aircraft height was about 560 ft AGL when the aircraft began to track north along Kennedy Developmental Road which the pilot followed for about 3.5 minutes. At 0934 the aircraft began to deviate away from the road after an increase in altitude of about 500 ft, however due to the rising terrain was about 250 ft AGL (Figure 8).
