Australian Transport Safety Bureau

Collision with terrain involving Air Tractor AT-802, VH-ODX

17 km north of Cummins Town aerodrome, South Australia, on 8 September 2025

ATSB Transport Safety Report
Aviation Occurrence Investigation
AO-2025-053
Preliminary – 23 October 2025

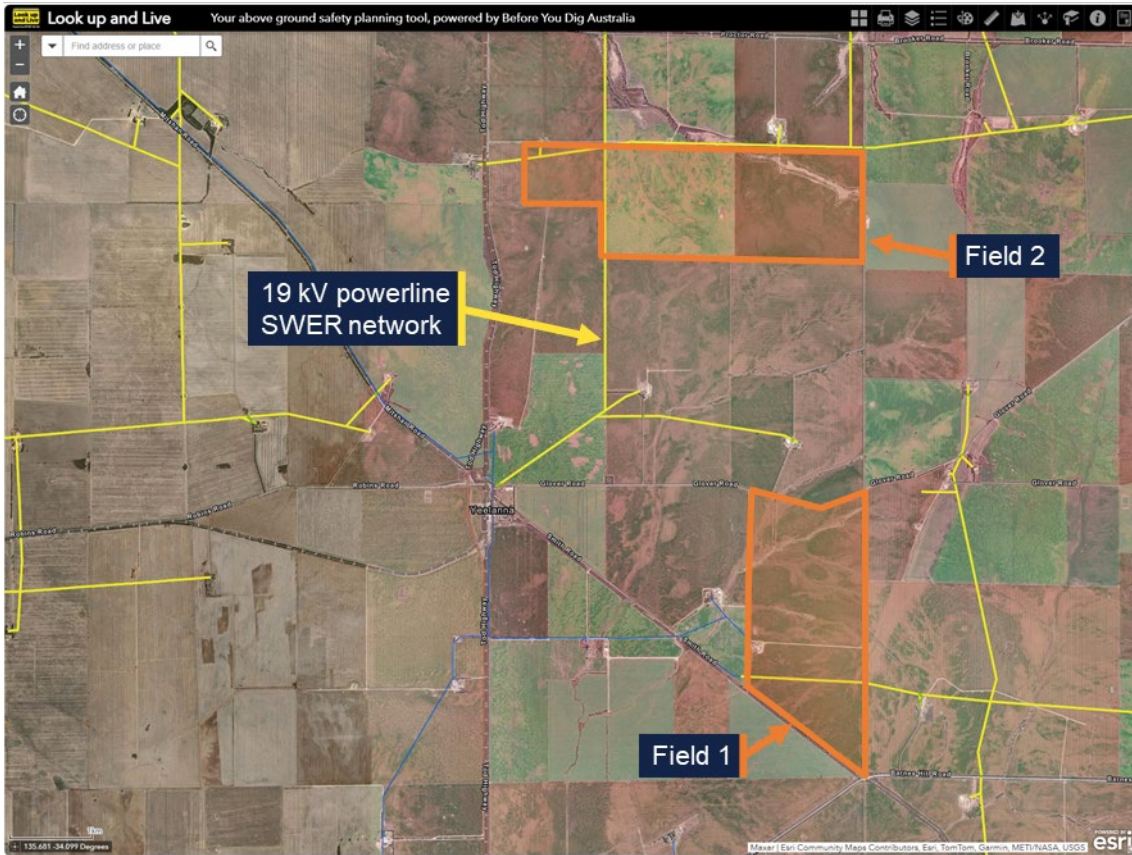
Figure 1: Fields that were sprayed (outlined in orange) and the surrounding powerline network (yellow lines)

Electrical powerlines spanned the fields of the property being sprayed. The first field featured a 19 kV single-wire earth return powerline crossing the southern section in an east-west direction (Figure 1 and Figure 2). The data showed that the pilot flew mostly under this powerline but occasionally flew over it where there was a power pole, or, where the powerline merged close to the edge of the field.

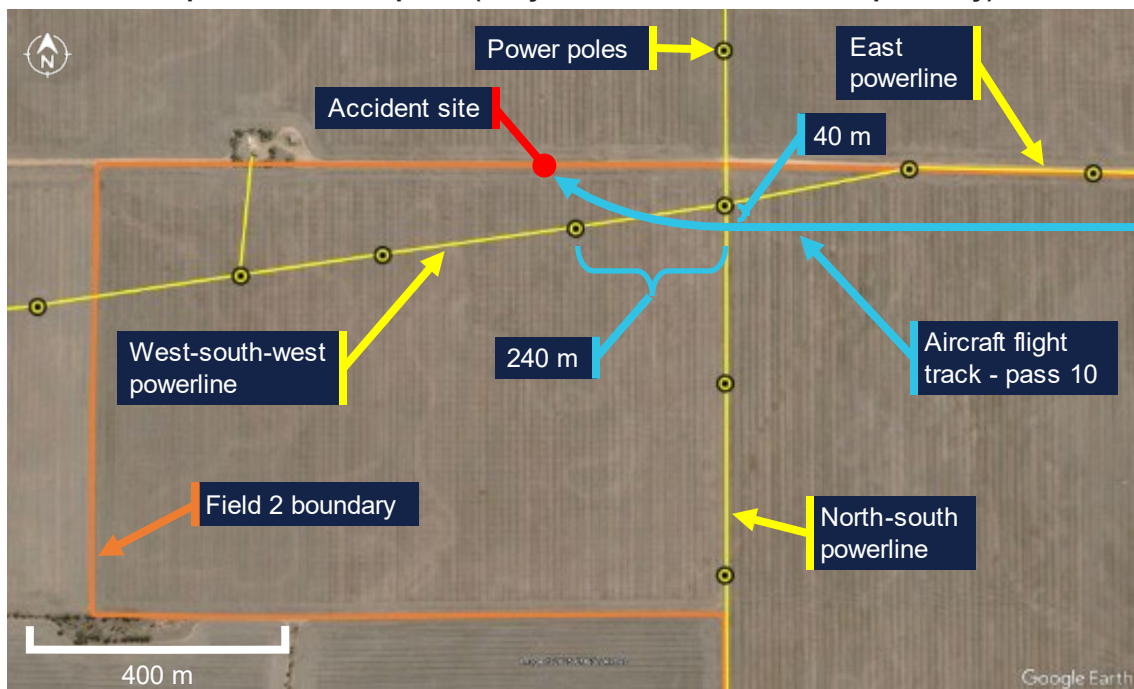
Figure 3: Final pass within field 2 showing the flight path (in blue) and accident site relative to the power lines and poles (the yellow lines and circles respectively)

Two 19 kV single-wire earth return powerlines were positioned in the second field and measured to be around 12 m above the ground. A north-south powerline bisected the field, and the other powerline ran partially to the east along the northern border (Figure 3 in orange) of the field and partially to the west-south-west crossing the north-west corner of the field. The recorded data showed the pilot mostly flew the aircraft under the north-south powerline running perpendicular to the spray pass direction, except where the powerline ran adjacent to the edge of the field, where they flew over the powerline.

At about 1307, the pilot departed the supply point and continued spraying the second field. A further 9 passes were completed and approximately 16 minutes into the run, while heading west on pass 10, the pilot flew under the north-south powerline. At this point, the west-south-west powerline crossed the north-south powerline 40 m to the north (Figure 3). That spray run also aligned with a power pole on the west-south-west powerline, 240 m beyond the north-south powerline. Recorded data showed the aircraft conducted a right turn underneath the second power line after which it collided with terrain at 1323. The aircraft wreckage came to rest on a farm road about 150 m beyond the second power line.

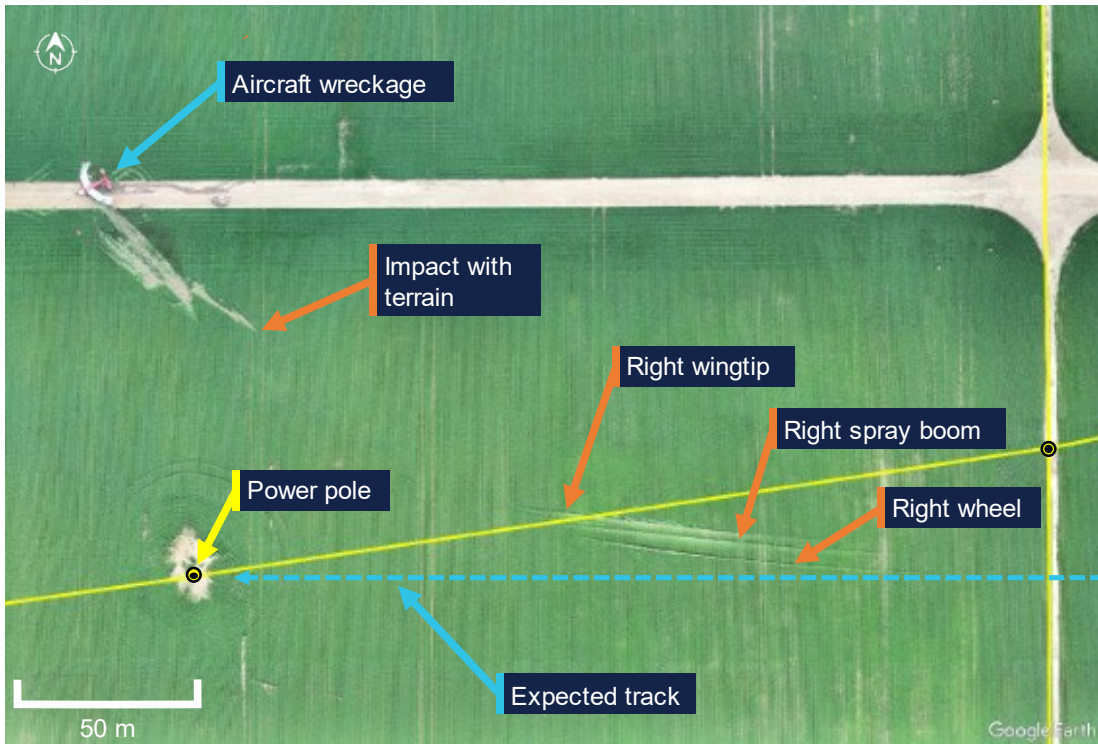
Figure 5: Crop witness marks at the accident site

Witness marks matching the right wheel, right spray boom and right wingtip indicated they had passed through the approximately 0.5–1.0 m high wheat crop 260 m prior to the accident site, with the right wheel running along the ground for about 22 m (Figure 5). The crop markings started on a heading of 264° (magnetic) and finished just beyond the west-south-west powerline on a heading of 273° after about 125 m. The markings showed that the aircraft was in a significant right skid. Later in the crop markings, the right aileron also left a mark indicating a significant down (left roll) deflection.

Another crop and ground scar from the aircraft had been produced 88 m beyond the initial markings that continued to the wreckage ('Impact with terrain' to 'Aircraft wreckage' labels in Figure 5). Numerous indicators such as component locations in the debris field, orientation of wheat strands caught in the aircraft structure, and damage signatures to the airframe indicated the aircraft impacted terrain in an inverted orientation, left wing first at a near wings-level and nose-down attitude.

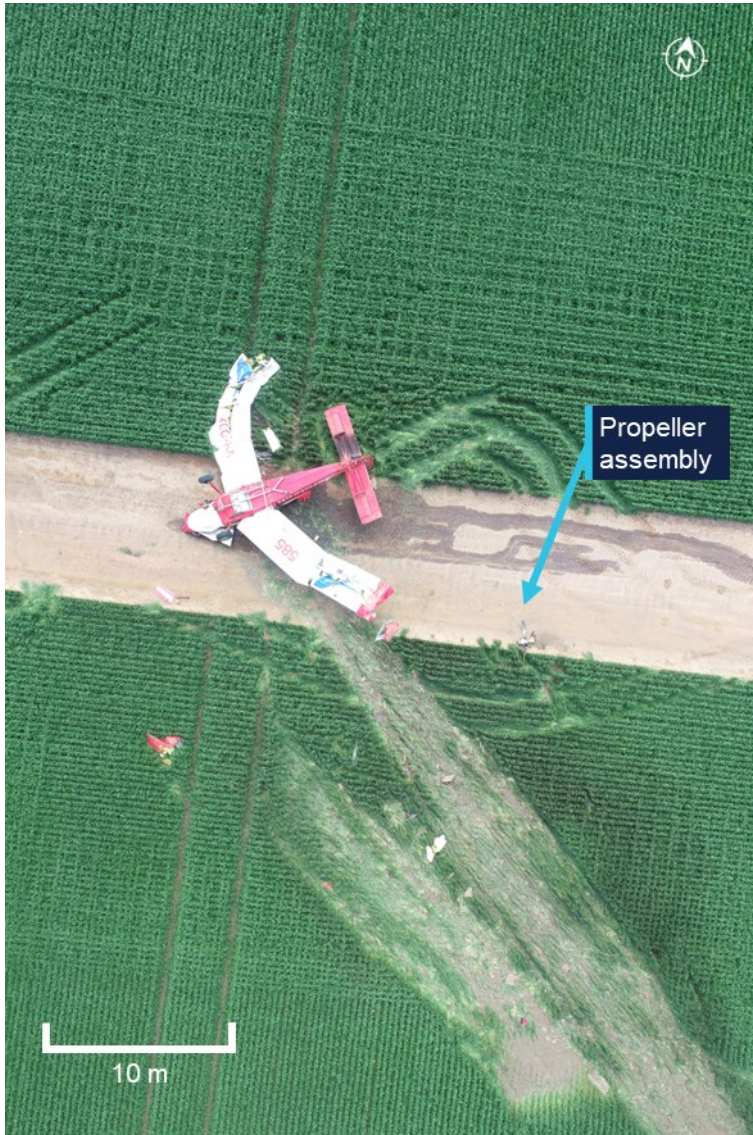
Figure 6: VH-ODX wreckage

All major aircraft components were accounted for at the accident site (Figure 6). There was no evidence of pre-impact defects with the flight controls or aircraft structure. The propeller assembly separated from the engine during the impact sequence and was located on the farm road, about 18 m behind the front of the fuselage. Two propeller blades had ejected from the propeller hub and one blade had fractured mid-length. The damage sustained to the propeller assembly was consistent with the engine operating at the time of the ground impact. The wing integral fuel tanks had ruptured during the accident sequence. A residual aroma from spilled fuel was detected at the accident site that persisted for several days.

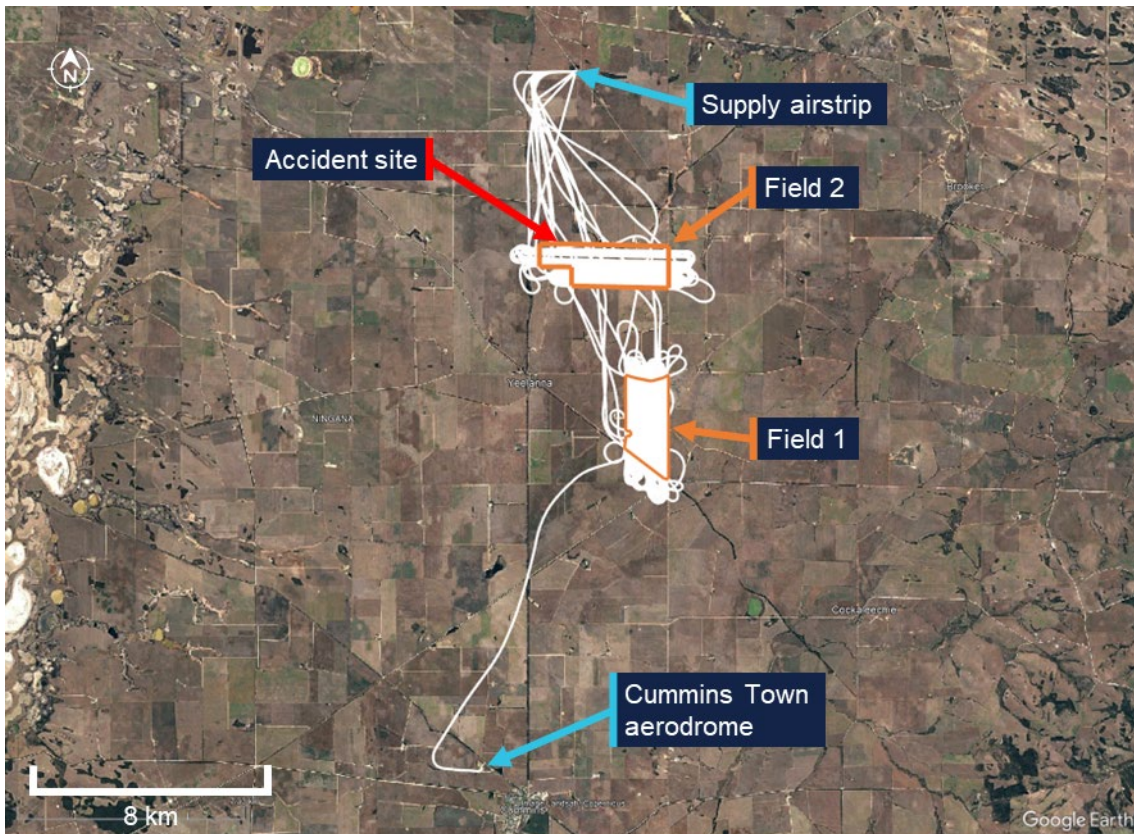
Figure 7: TracPlus RockAIR broadcast data for VH-ODX on 8 September 2025

A TracPlus RockAIR portable tracking device had been fitted to the aircraft and was recovered from the accident site. The device was transferred to the ATSB's technical facilities in Canberra, Australian Capital Territory, where it was interrogated. The recorded data provided the aircraft's position, altitude, speed and track angle data at 1-second intervals up until the time of the accident (Figure 7). The data showed the take-off from Cummins Town aerodrome, the transit to and from the supply airstrip and the completed spray runs in fields 1 and 2. Location and time parameters from the flight data were correlated to identify that the accident occurred at 1323:40.
