Loss of propulsion of *FMG Nicola*

Port Hedland, Western Australia, on 7 February 2025

ATSB Transport Safety Report

MO-2025-007

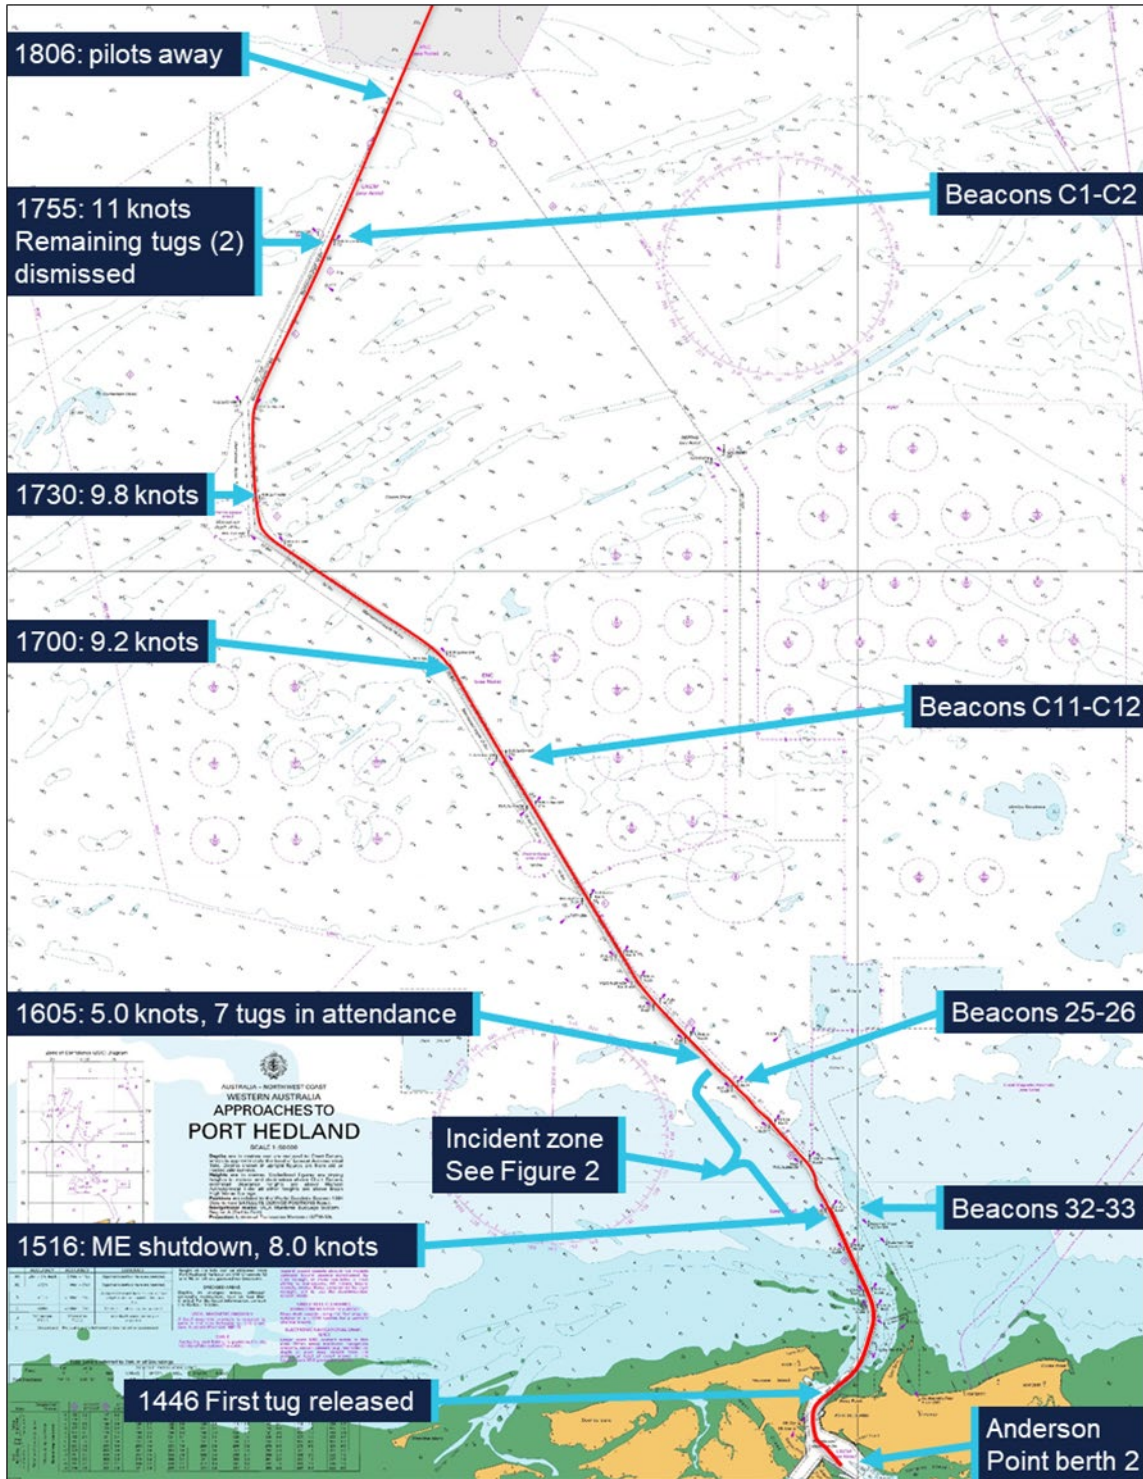
Figure 1: Overview of *FMG Nicola's* track through shipping channel

By 1412, all mooring lines had been cast off and the ship departed the berth (Figure 1). There was a 25-knot north-north-west wind with waves of up to 1.5 m on a 0.5 m swell in the area, including the port’s single shipping channel.

At 1514, as the ship approached beacons 32-33 (Figure 1), the pilot ordered a heading³ of 334°. At about this time, *FMG Mako's* master requested the pilot for its towline to be let go as there were choppy seas on the ship's port side. The pilot concurred, and the towline was let go at 1515.

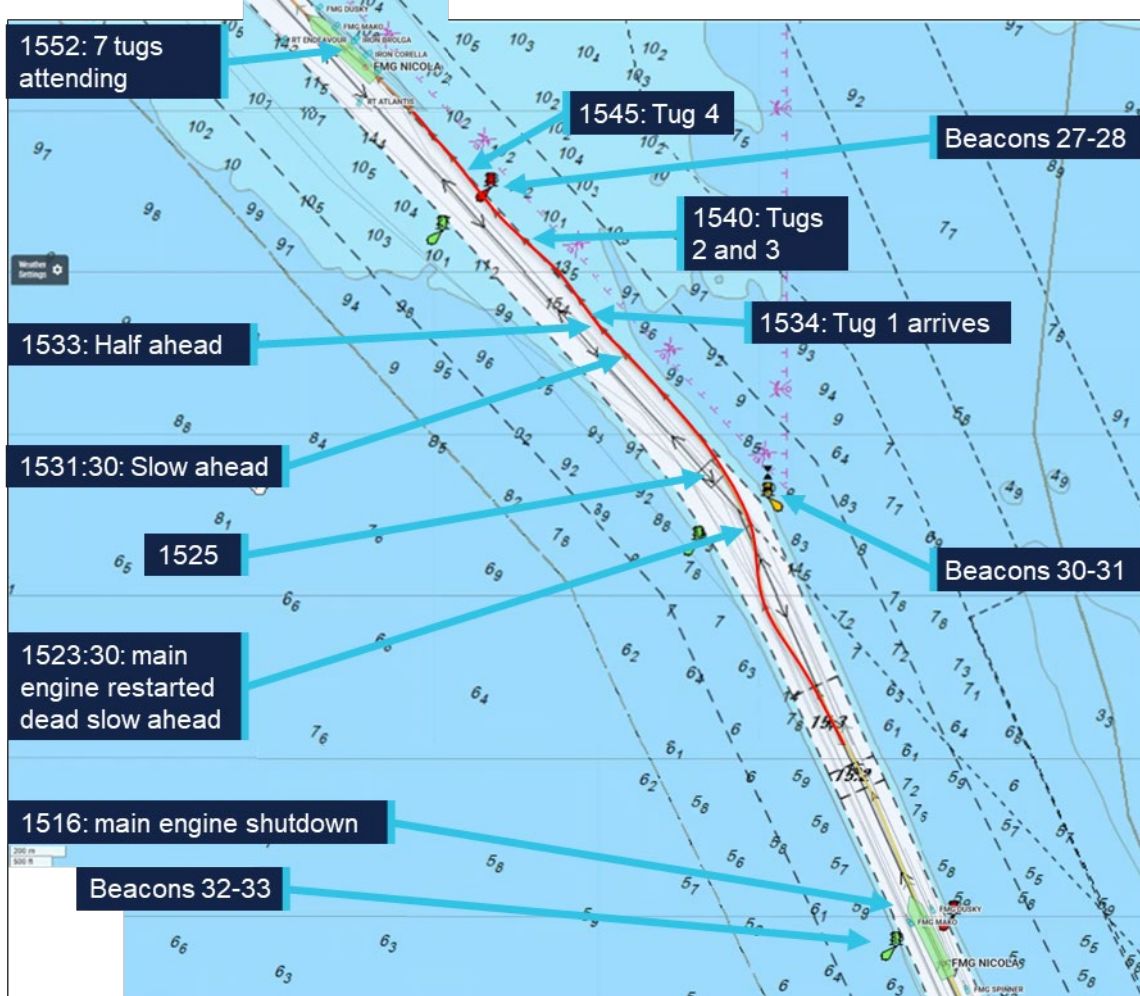
Figure 2: *FMG Nicola* track from about 1516 to 1552

Soon after, at about 1516, *FMG Nicola's* main engine suddenly shut down as it was passing beacons 32-33 (Figure 2). The ship's speed was 8.3 knots and the pilot ordered the rudder midships. The pilot informed the tug masters that the ship had lost propulsion and directed them to help keep it in the channel.

The ship continued to move along the side of the channel (Figure 2). At 1534, the first of the additional tugs arrived and was tasked to push up on the ship’s starboard side. In the following 10 minutes, 3 more tugs arrived and assisted as required by the pilot. At 1540, the ship passed close to beacon 28 while moving along the side of the channel at a speed of 2.5 knots.

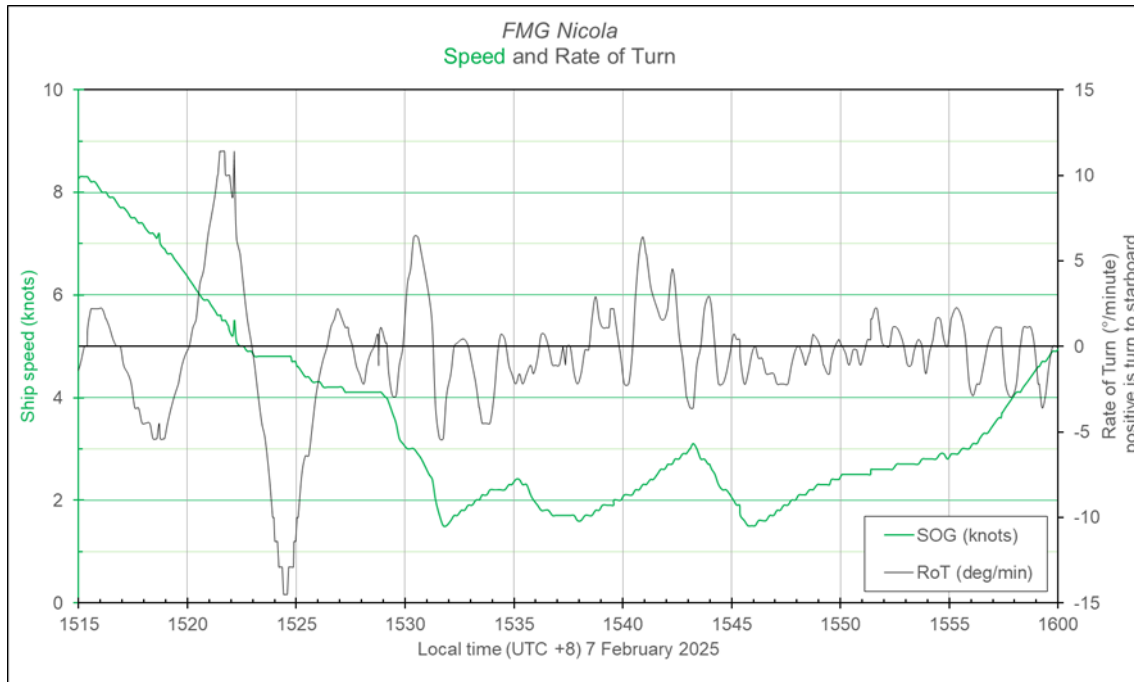
Figure 3: *FMG Nicola* speed and rate of turn at the time of the incident

At 1518, the pilot notified Port Hedland vessel traffic service (VTS) of the emergency and requested additional tugs. The pilot gave helm orders and used the tugs to follow the channel. The ship's speed had decreased to 7.4 knots and it was getting closer to the

western side of the channel and with a slow rate of turn of about 4° per minute to port (Figure 3).

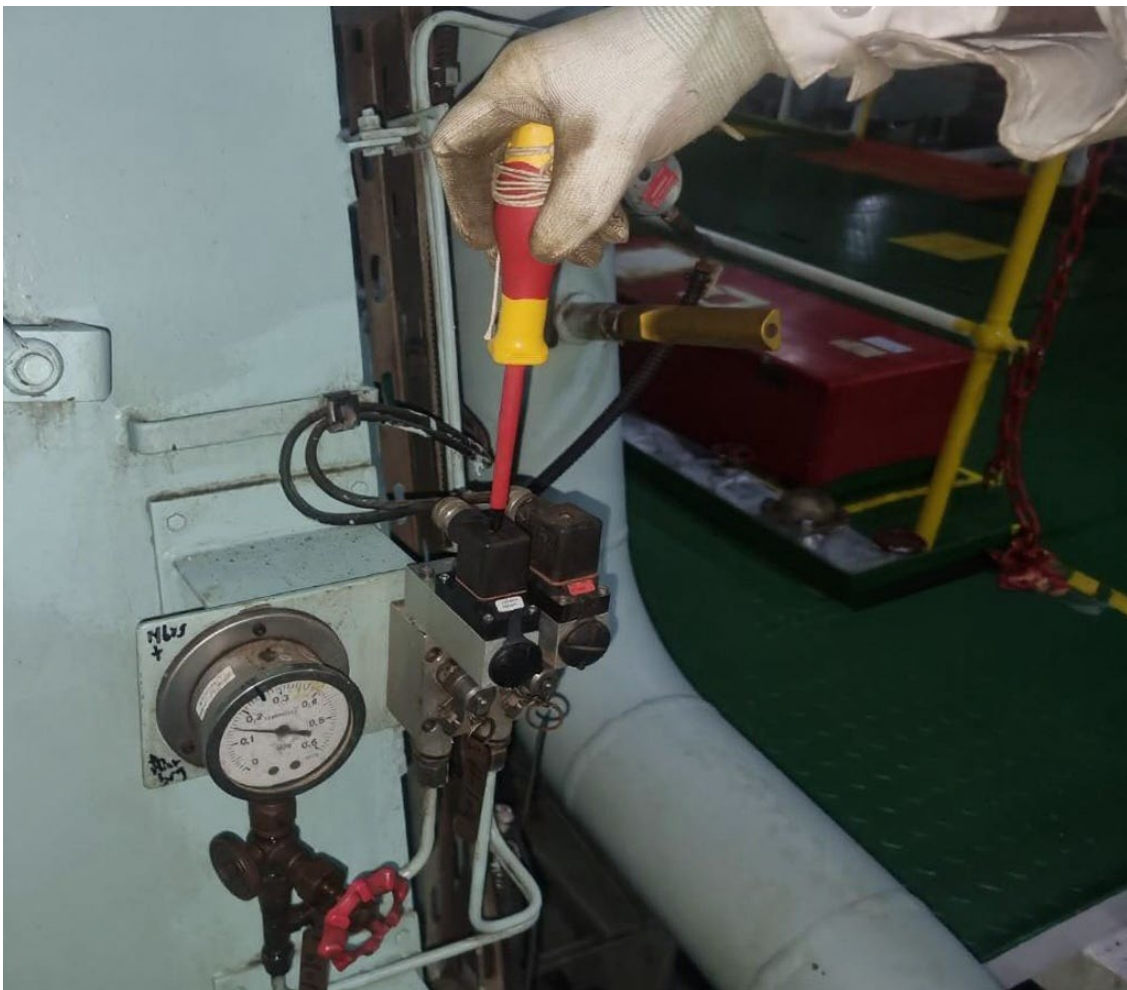
Figure 4: Main engine lubricating oil pressure sensing and switches

The main engine lubricating oil (LO) system was fitted with a hierarchy of oil pressure monitoring and alarm controls to limit inadvertent engine stoppage while preventing catastrophic engine damage. In addition to local, analogue indicators and pressure gauges, the LO pressure was monitored via a pressure transducer and pressure switches (Figure 4).

In addition to these triggers and alarms, the main engine LO system had a separate pressure switch set to activate at 160 kPa. This switch, independent of the oil pressure monitoring circuit, was for the main engine low LO pressure shutdown. This initiated rapid shutdown of the engine to prevent catastrophic damage due to complete loss of bearing lubricating oil.

The ship’s managers (BSM) conducted an investigation, which focused on the cause of the main engine shutdown. Other interested parties also conducted independent investigations, which included inspections by the engine manufacturer and an underwater (dive) survey. All investigations concluded that the root cause of the main engine shutdown was a faulty lubricating oil low pressure switch which triggered an engine emergency stop despite all system parameters being normal.

The separation between the LO shutdown system and the pressure monitoring system meant that when the shutdown switch activated, the monitoring system low LO pressure alarm was not triggered, and the pressure display did not show a fluctuation in pressure.

Inspection and testing of the shutdown pressure switch showed it to activate at 185 kPa and to operate erratically. The switch was replaced with a new spare on board and the operating point set to 160 kPa. In addition, the planned maintenance system routines were amended to require calibration of main engine LO pressure switches monthly and replacement of the shutdown switch reduced to 2.5 years (from 5 years).
