# Derailment of train TD1094

Clifton Hill, Victoria, on 13 July 2025

**ATSB Transport Safety Report**  
Rail Occurrence Investigation  
RO-2025-005  
Preliminary – 3 October 2025

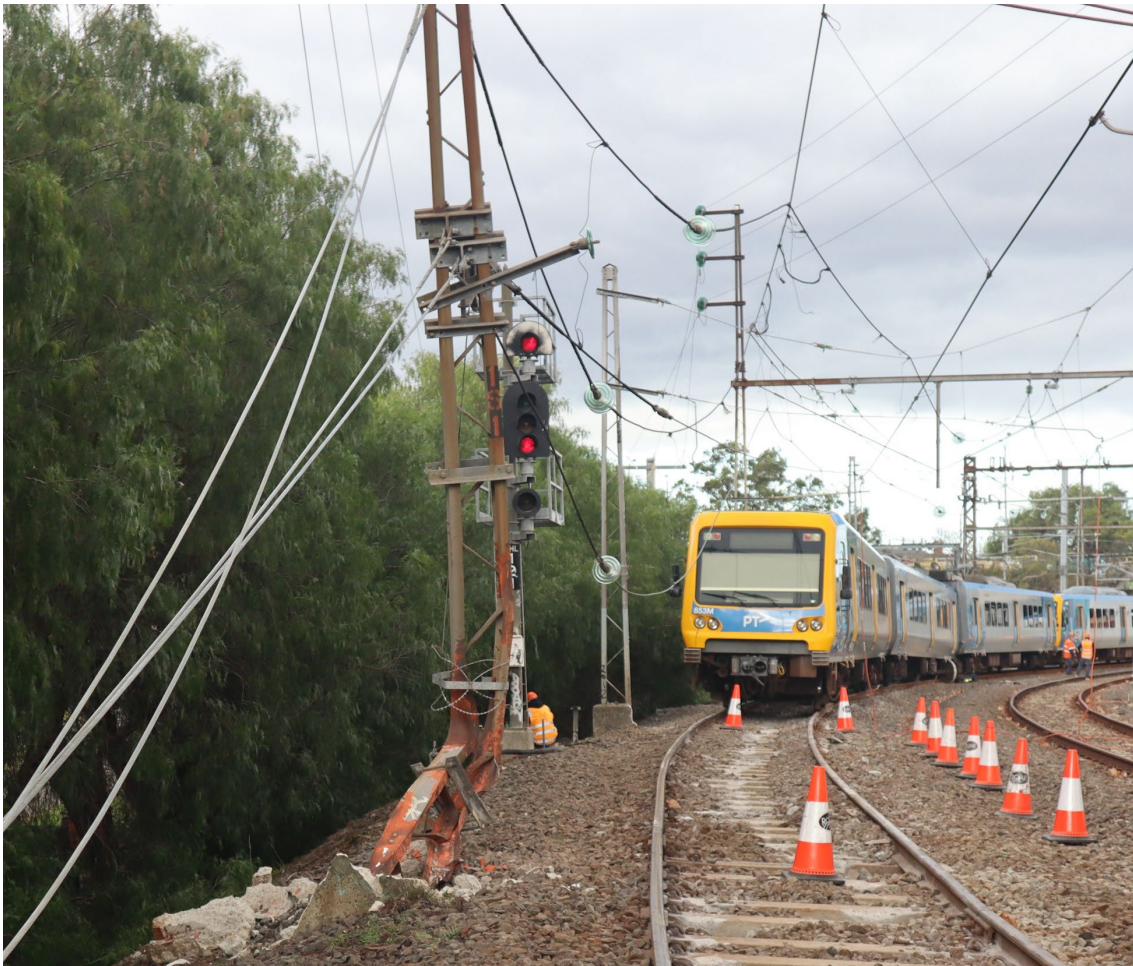
**Cover photo:** Office of the Chief Investigator (OCI)

The stanchion was substantially damaged by the impact (cover photo) which caused the overhead wire that supplied electrical power to trains to move and lose tension. This resulted in electrical arcing between the overhead wire and the train, most probably the pantograph<sup>5</sup> mounted on top of the 5th car.<sup>6</sup>

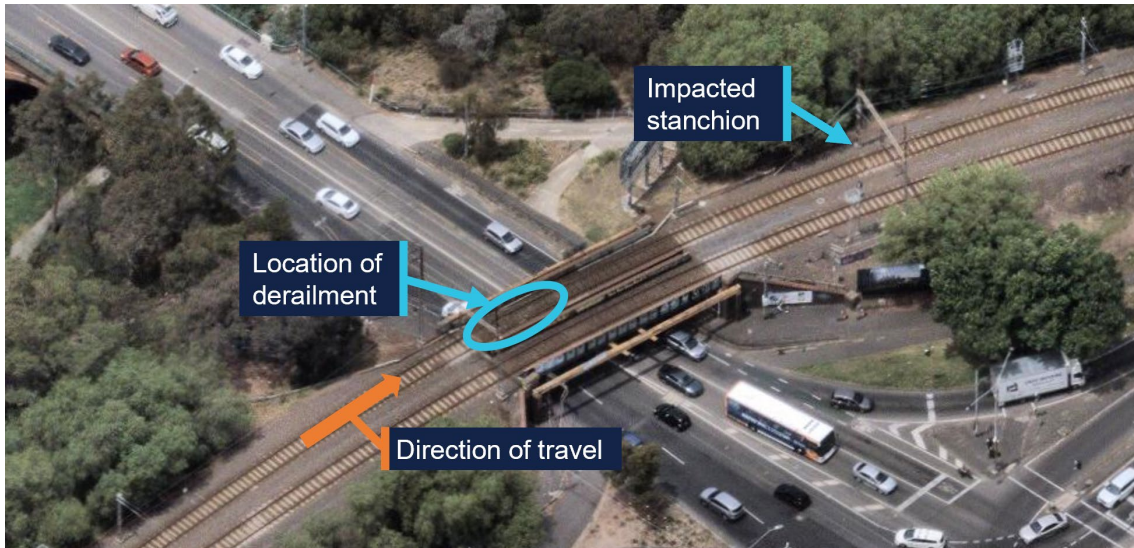
**Figure 3: Location of derailment on the High Street bridge**

After its departure from Rushall, the train initially accelerated to about 38 km/h. The driver then reduced the train’s speed in preparation for the right curve over the High Street bridge.<sup>3</sup> It was this driver’s normal practice to slow to about 30 km/h for this curve, which had a 40 km/h permitted speed. At about 2228 the train was proceeding through the curve at about 28 km/h when the leading wheelset of the first bogie of the 5th car derailed on the bridge (Figure 3). The left wheel of this wheelset had climbed over the left rail toward the outside of the right curve.

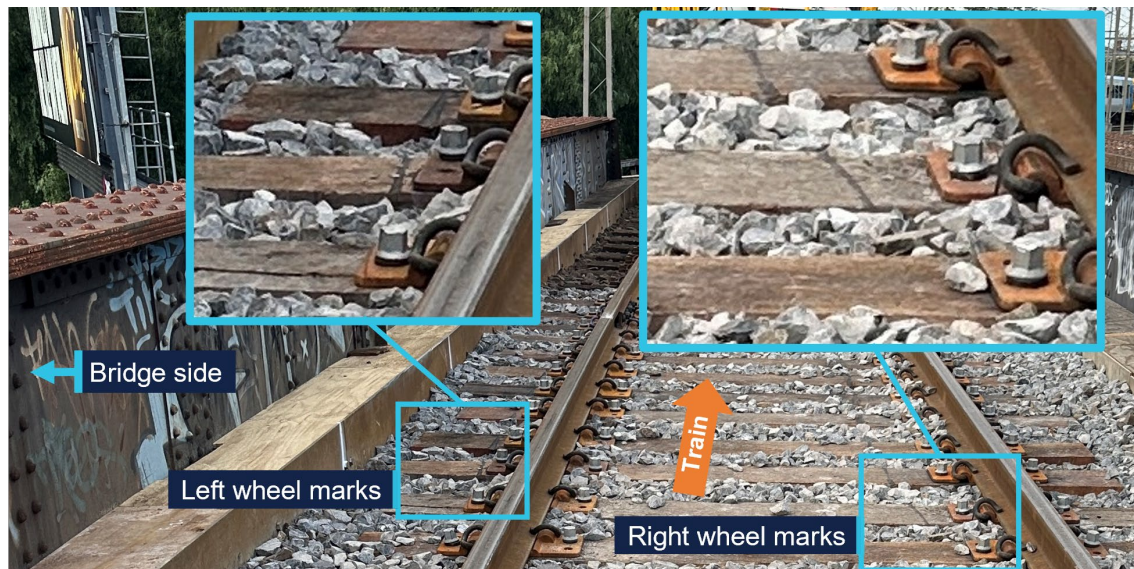
**Figure 4: Marks made on sleepers by the derailed wheels**

As a result of the leading wheelset moving to the left, the right wheel dropped to the inside of the right rail. The train continued to cross the bridge with the derailed wheelset impacting rail fixtures and sleepers. Witness marks on sleepers were consistent with the initial derailment being a single axle (Figure 4).

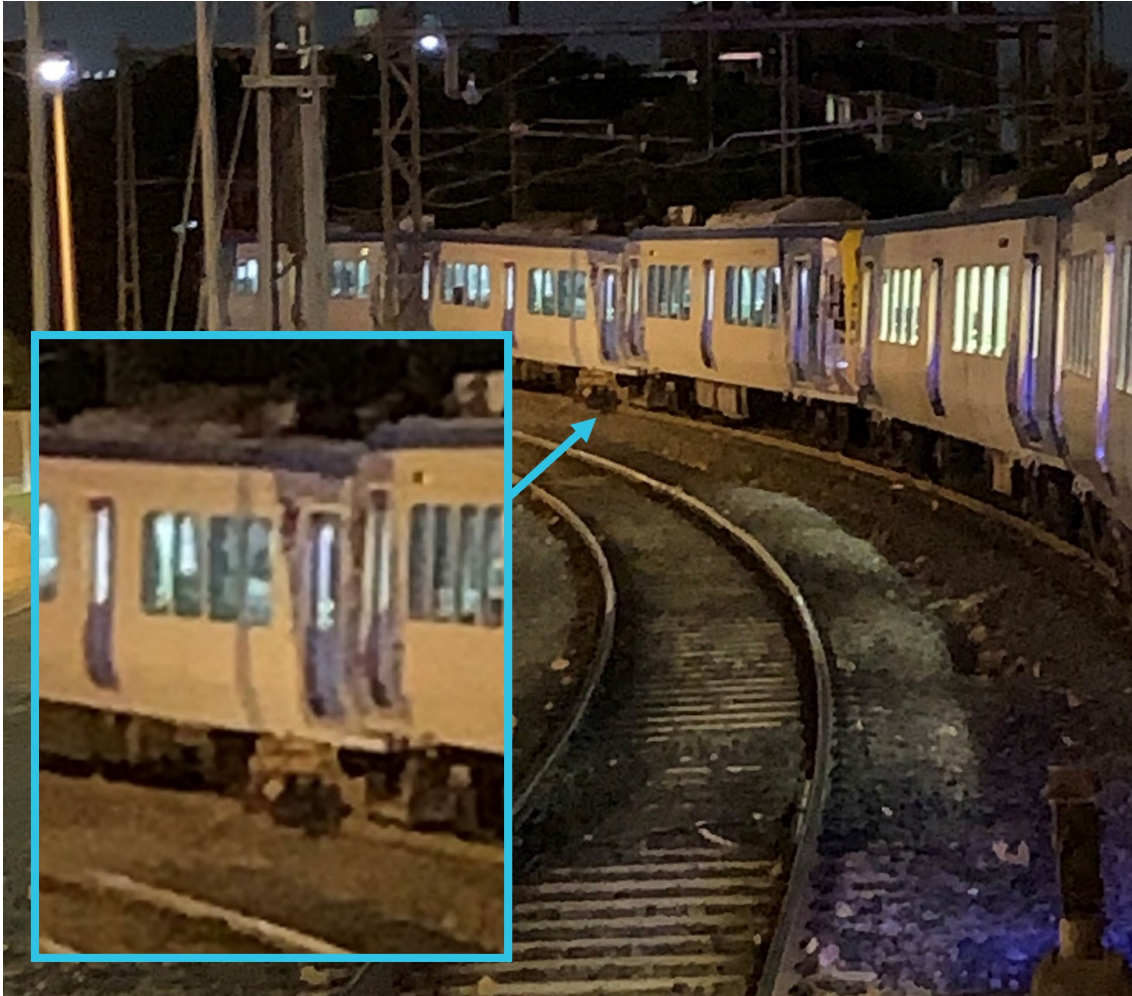
Figure 5: View of derailment from the front of the train

While the principal driver was inspecting the train from its left side, the driver who remained in the driving cab looked down the right side of the train and observed the trailing axle of the leading bogie on the 5th car derailed to that side (Figure 5). They reported the derailment to Metrol by train radio at 2239.

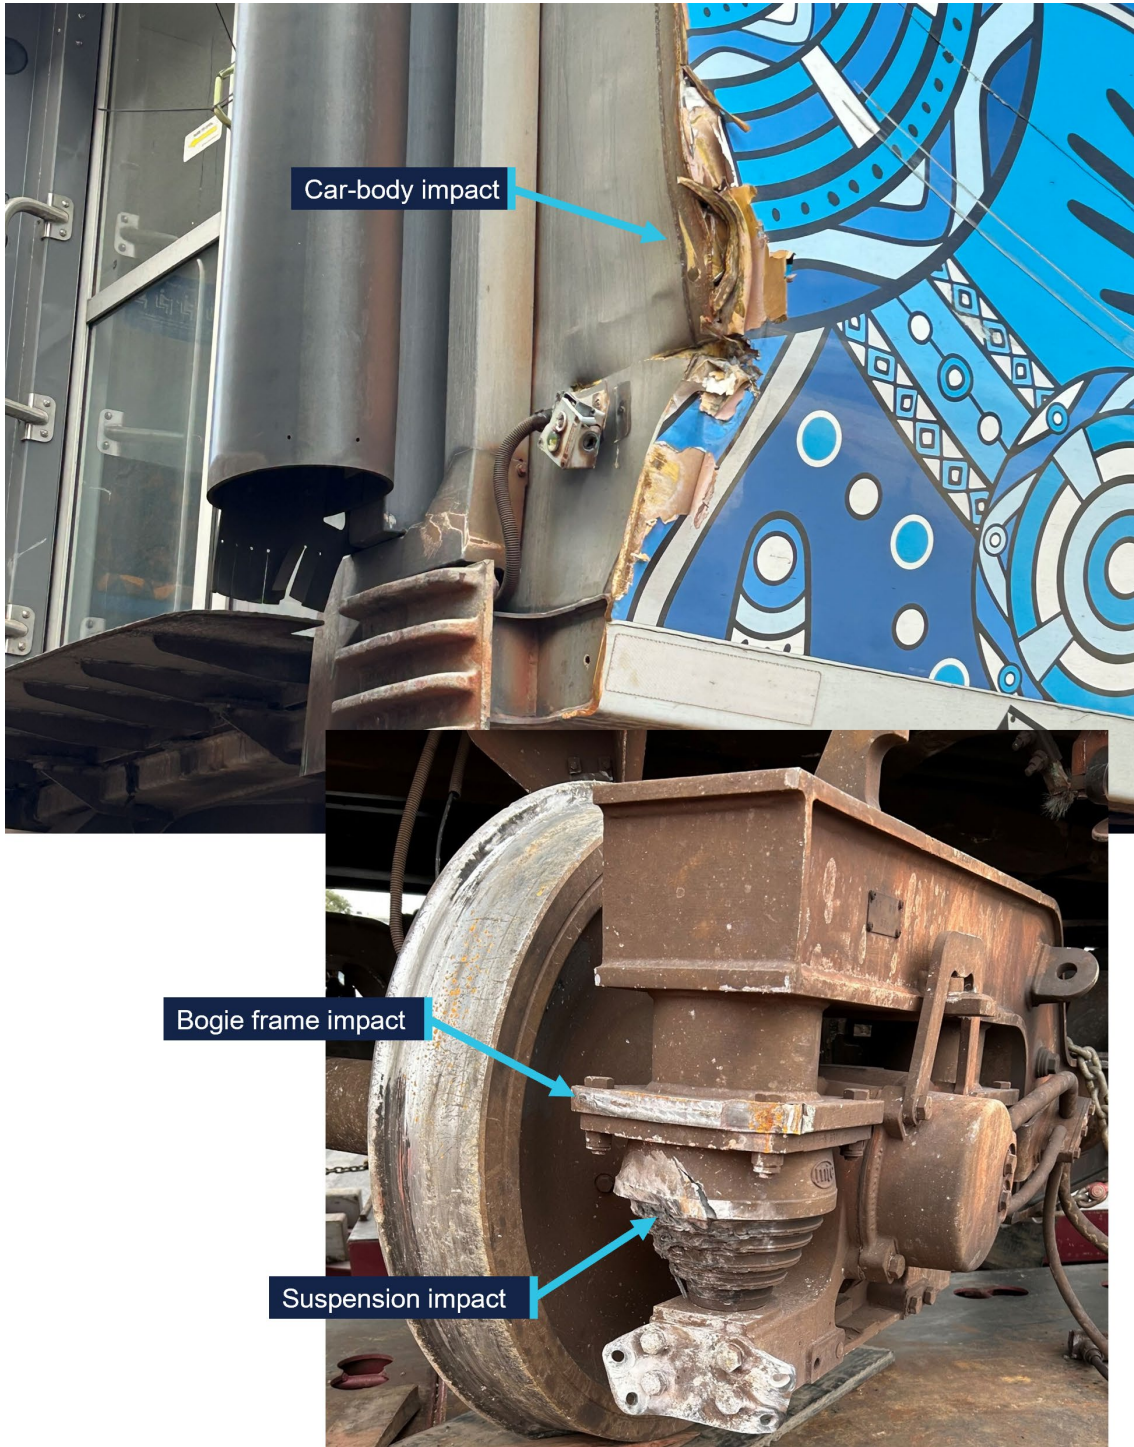
Figure 7: Impact damage to the car-body, bogie frame and suspension of the 5th car

Damage to the 5th car was consistent with the derailment sequence including impact damage to the leading left corner of the car-body, bogie frame and suspension components (Figure 7). The impact with the stanchion also resulted in extreme rotation of the derailed bogie. This rotation damaged further suspension components and resulted in the rear left corner of the bogie frame impacting and piercing a battery box mounted to the underfloor of the car body. Rolling stock component testing and assessment is ongoing.

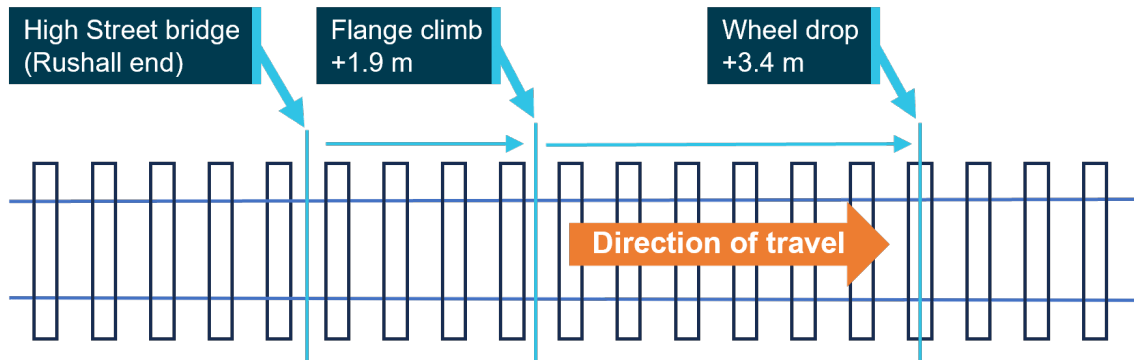
**Figure 8: Distances of left wheel derailment from the Rushall end of the bridge**

Post-derailment track inspection identified witness marks consistent with a left wheel climbing the left rail near the Rushall end of the bridge. The point of flange climb was about 1.9 m from the start of the bridge and the wheel dropped to left of the rail after travelling about 3.4 m along the top of the rail (Figure 8).

*The derailment occurred on the High Street bridge. The approximate distances from the Rushall station end of the bridge are shown for key events.  
Source: OCI*

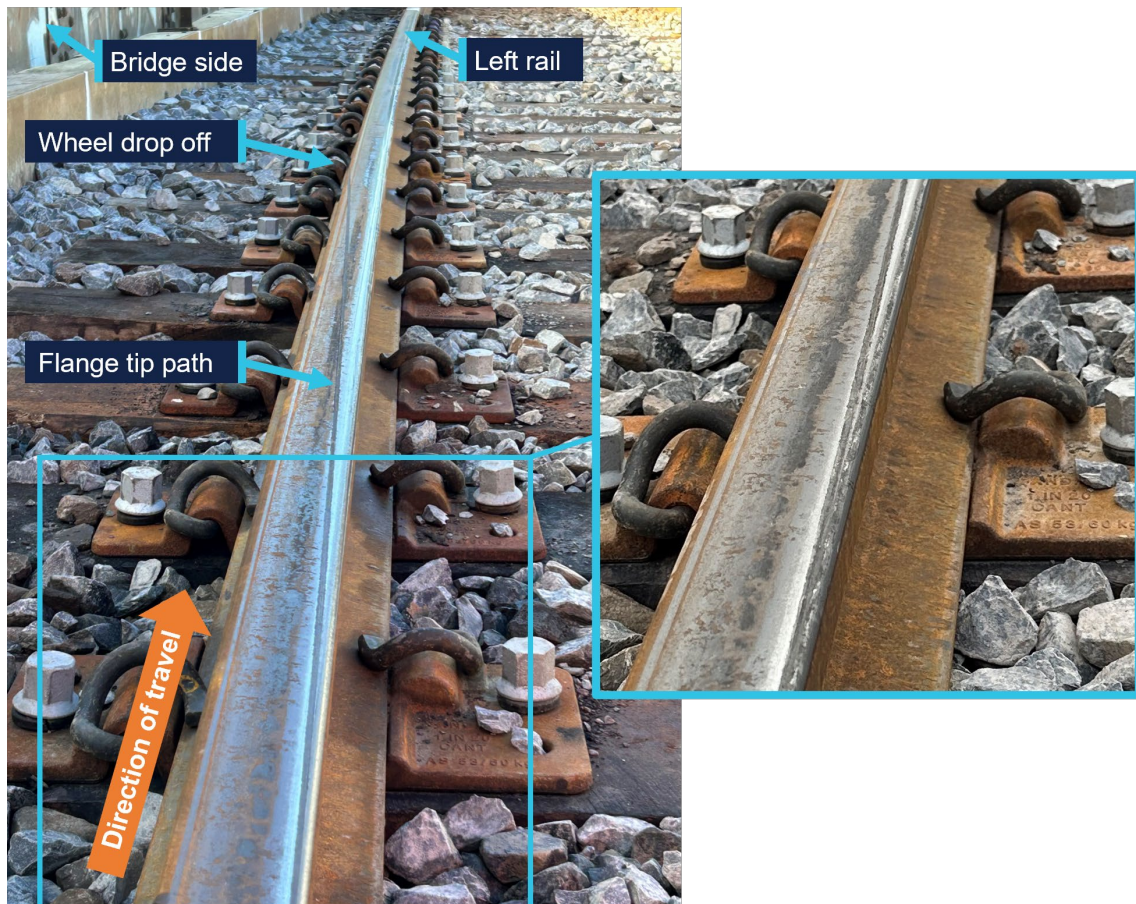
**Figure 9: Witness marks along the head of the left rail**

The witness marks were consistent with the tip of the flange of the left leading wheel of the 5th car climbing onto the top of the rail from the inside (right) and running diagonally along the rail head before dropping to the left (Figure 9).

The presence of the wheel flange tip mark indicated that the initial derailment was by the action of flange climb. Flange climb occurs when lateral forces between the wheel and the rail exceed the capacity for vertical forces to restrain, either through excessive lateral force alone, or a combination of increased lateral force and reduced vertical force. The location of the derailment was in a tight radius curve. Therefore, the lateral force on the flange of the leading outside wheel was already high, as it was required to provide the force to turn through the curve.

*The figure shows the flange climb mark made by the tip of wheel flange looking in the train's direction of travel. The inset shows additional detail along the rail gauge corner.*  
Source: OCI
