# Misaligned take-off occurrences on runway 06 at Perth Airport, Western Australia

involving Boeing 737, VH-IWQ, on 12 June 2023

AO-2023-027

Final – 20 November 2025

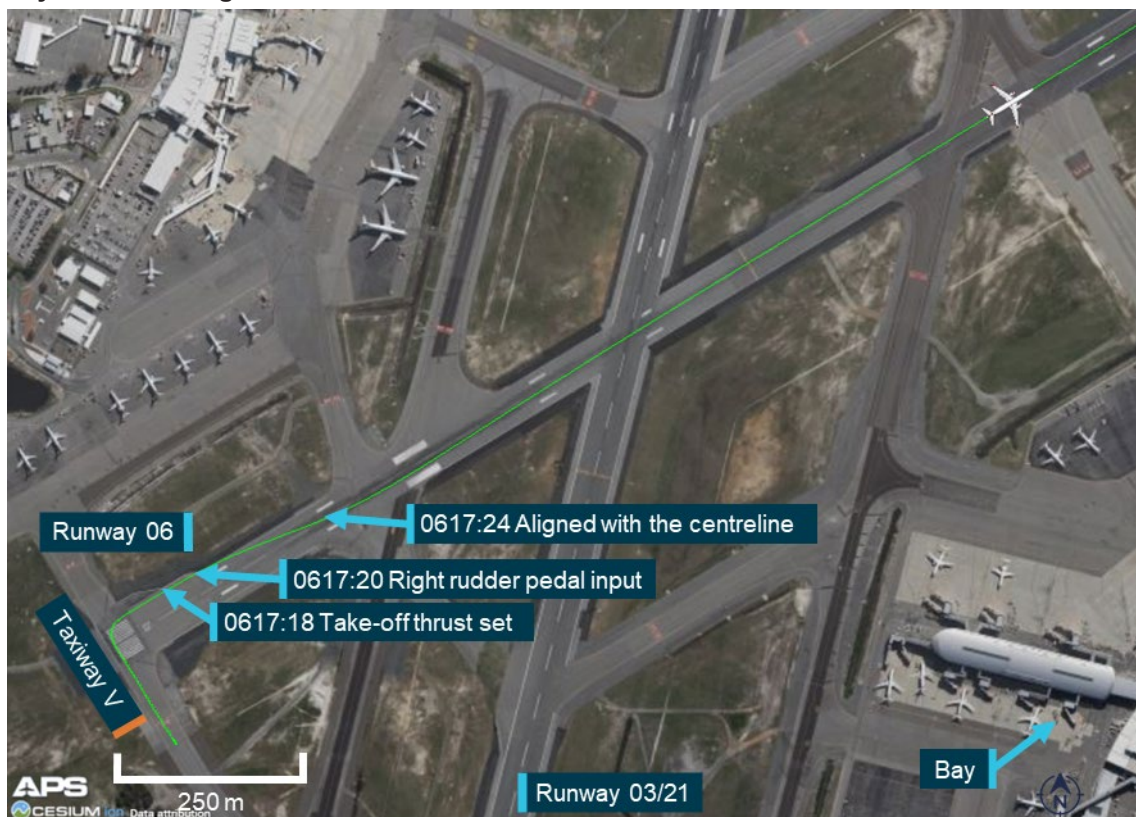
**Figure 1: Overhead of Perth Airport and showing the aircraft's line up on runway 06 with key events during the take-off for incident 1**

At 0616:50, as the aircraft was lined up, the controller issued a take-off clearance to the flight crew, and the FO focused on preselecting the next radio frequency for departure. At this time, the captain handed over control of the aircraft to the FO, who was the designated pilot flying<sup>4</sup> for the sector. At 0617:18, the captain set take-off thrust. In interview later, the FO reported that, during the commencement of the take-off roll they noticed a raised edge light and realised the aircraft was lined up on the runway edge. In response, they manoeuvred the aircraft toward the centreline as evidenced by the right rudder pedal input at 0617:20. Shortly after, at 0617:24 the aircraft was aligned with the runway centreline. The FO recalled asking the captain to confirm whether to continue with the take-off, which the captain confirmed as they believed they were above the take-off decision speed.<sup>5</sup>

Taxi and take-off roll during the departure is shown in green.

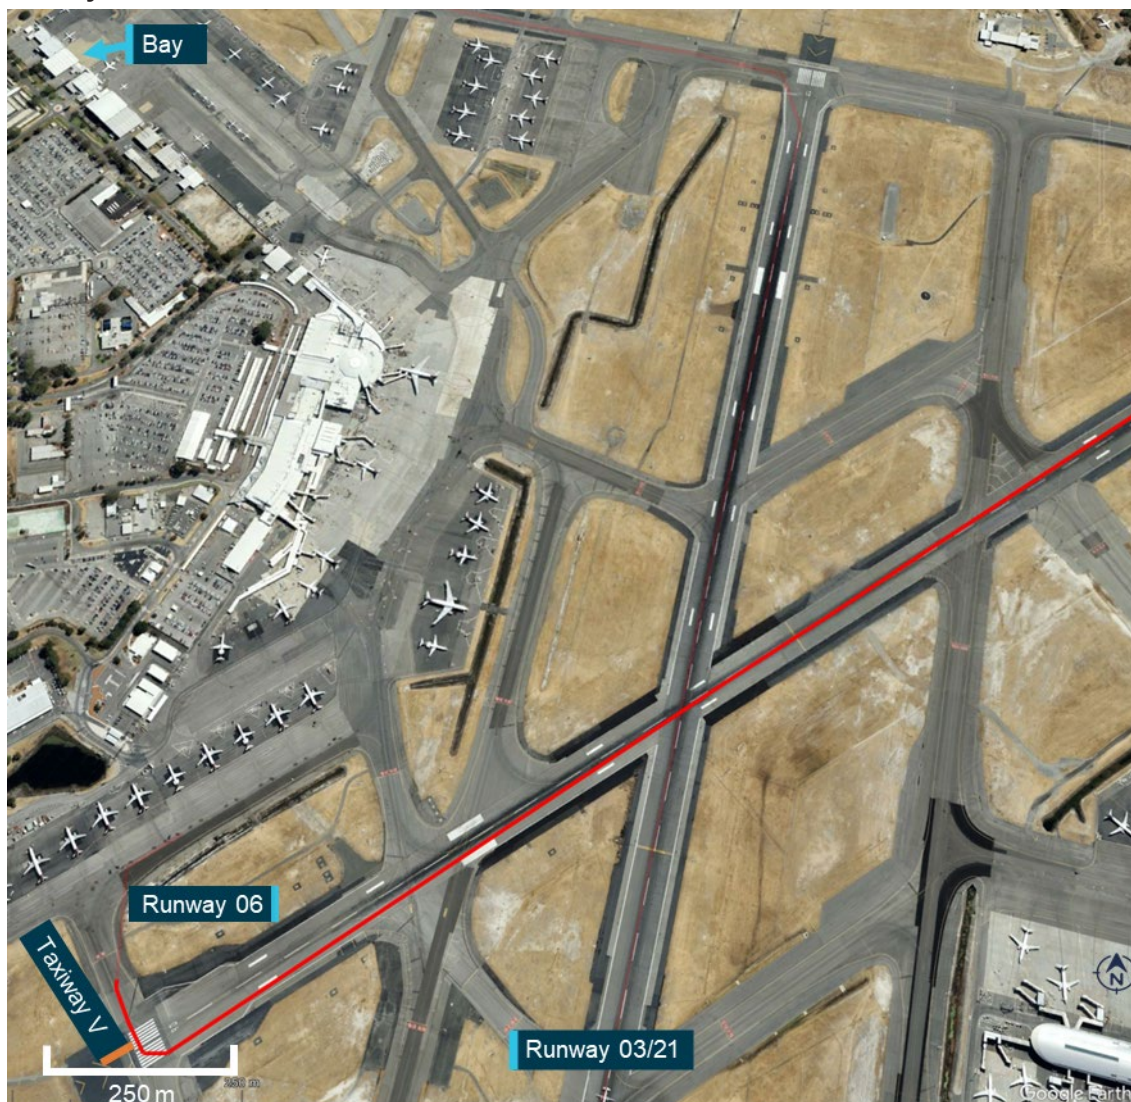
**Figure 2: Overhead of Perth Airport showing the aircraft's line up and take-off on runway 06 for incident 2**

Air traffic control recorded data showed that the aircraft taxied past the centreline of the runway and lined up along the right edge lighting (Figure 2). During interview, the pilot recalled that the runway markings were 'scuffed' and difficult to see, but they believed they were lined up on the runway centreline lighting. They also noticed 'plenty' of runway to their right and reported not realising there were no centreline lights on runway 06.

At 0512, the aircraft was cleared for take-off. During the take-off roll, the pilot heard an impact outside the aircraft and suspected a birdstrike had occurred. The pilot decided they were above the rejected (decision) take-off speed so continued with the take-off, but manoeuvred the aircraft to the left, toward the centreline. After the aircraft was airborne, the pilot contacted air traffic control to request a return to Perth. A runway inspection identified damage to several runway edge lights. There was no damage to the aircraft.

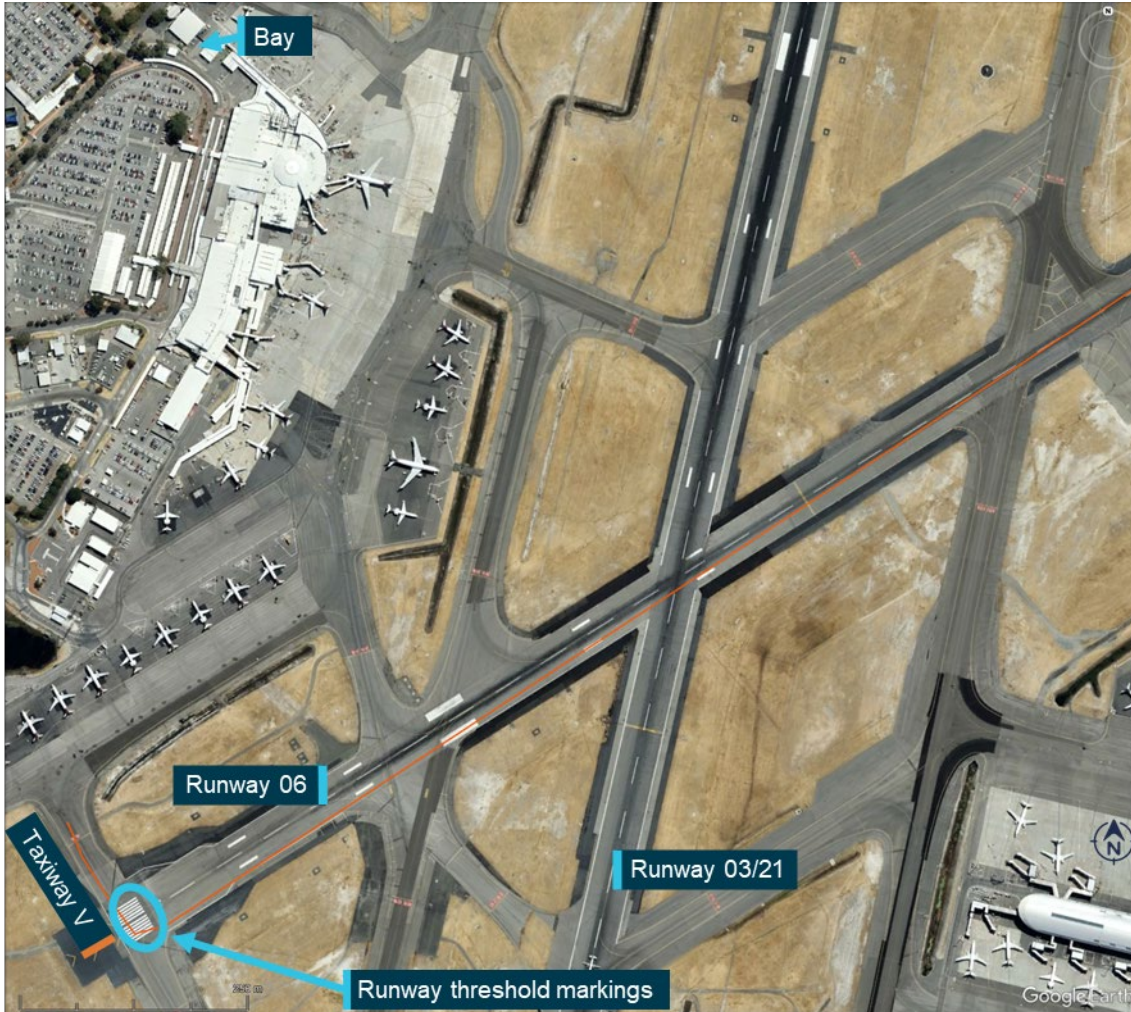
**Figure 3: Overhead of Perth Airport showing the aircraft's line up and take-off on runway 06 for incident 3**

Air traffic control recorded data showed that the aircraft taxied past the runway centreline and lined up along the edge lighting on the right side of the runway (Figure 3). At 0523, air traffic control issued the take-off clearance. During the take-off roll, the pilot reported hearing a noise and believed that the sound originated within the cabin, so continued the take-off. They also reported that they checked their engine indications, which were normal. The pilot departed and completed the planned flight.

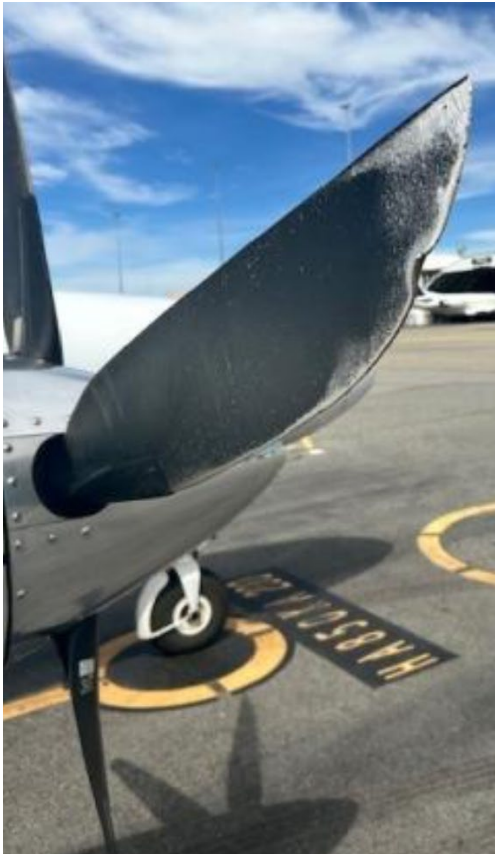
**Figure 4: Damage to propeller blade on right engine**

Later in the morning, Perth Airport contacted the operator to advise that several runway edge lights were damaged, which they determined were coincident with the aircraft's departure based on recorded departures and closed-circuit television footage. At 1208, the aircraft returned to Perth and during the walk around inspection, the pilot noticed damage to one propeller blade on the right engine (Figure 4).

The pilot in the April 2024 occurrence did not identify they had lined up the aircraft on the runway edge lighting and subsequently completed multiple flights. As a result of the misaligned take-off, the aircraft had sustained damage to the right propeller and several runway lights were damaged, which was not detected until later that day. Damage from a foreign body impact to a propeller blade could lead to gouges, dents and deformation, or cracks and blade failure if left undetected (Federal Aviation Administration 2005), although in this instance there was no reported effect on flight from the sustained damage.

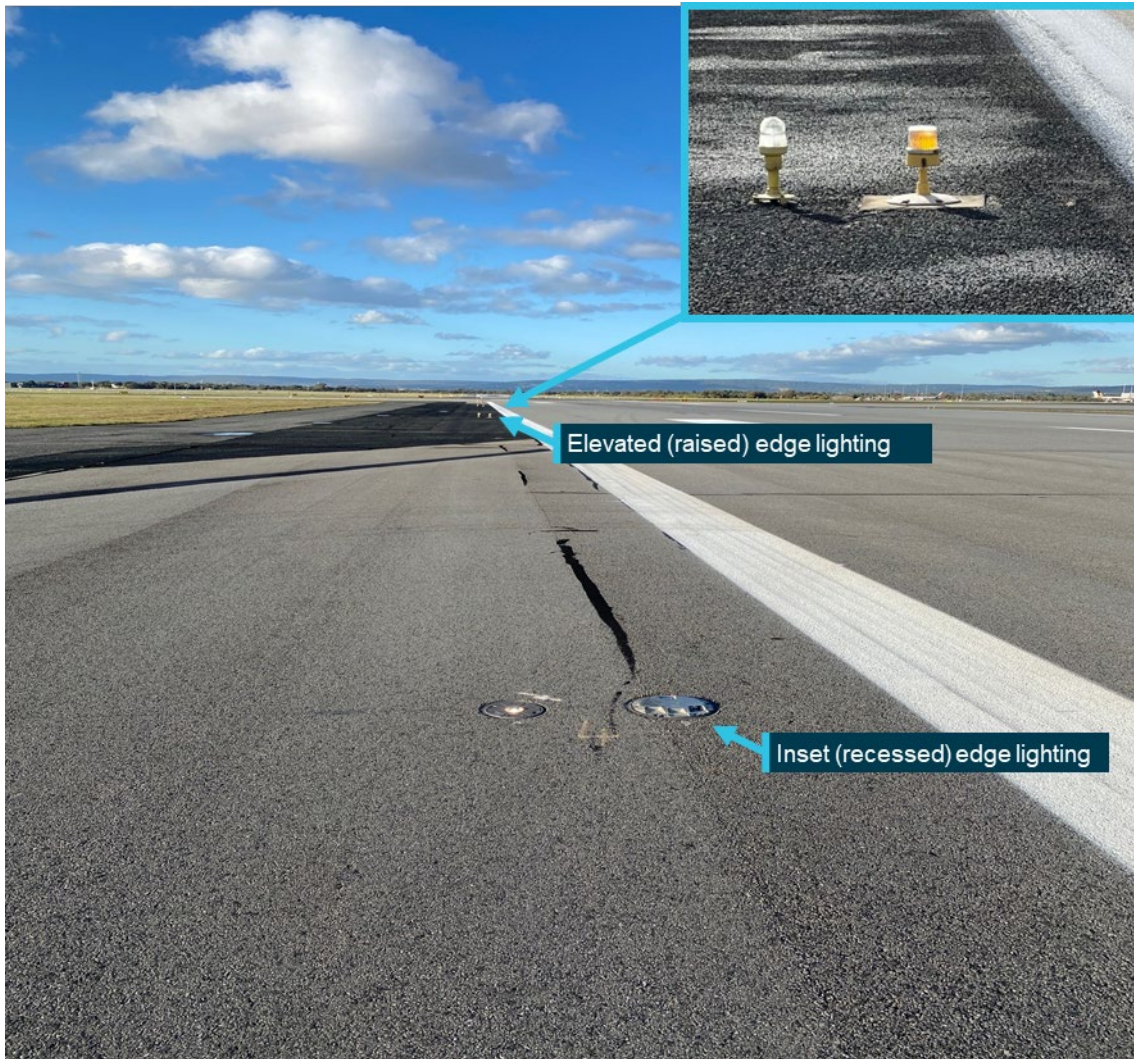
Figure 7: Runway 06 edge lighting (left side)

edge of the runway to delineate the area available to pilots for landing and take-off at night in reduced visibility. Consistent with the MOS requirements, the runway 06/24 edge lights were white (Figure 6 shows these lights for runway 03). The first 2 edge lights on runway 06 were inset into the runway, and the remainder of the lights were elevated (Figure 7).

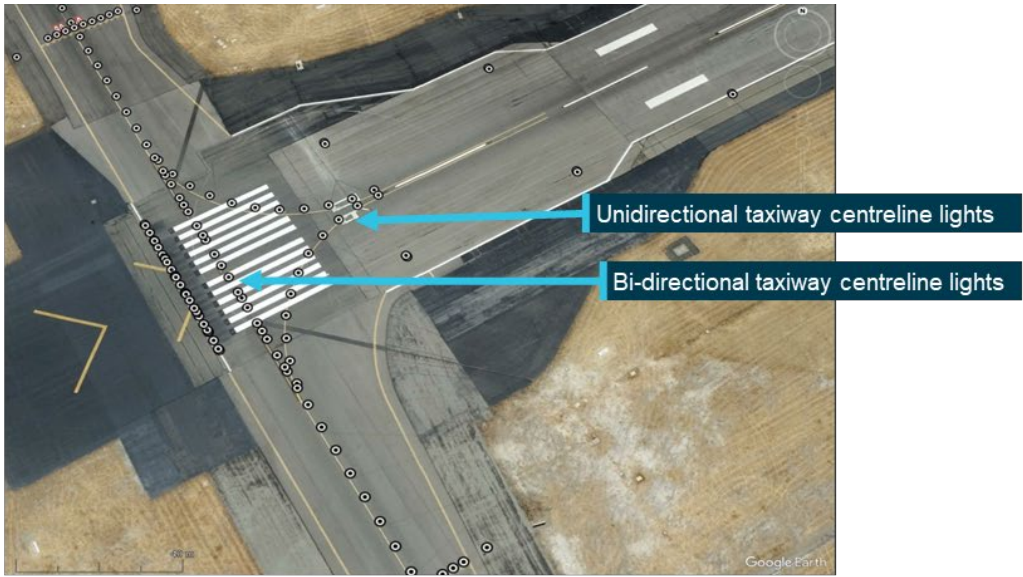
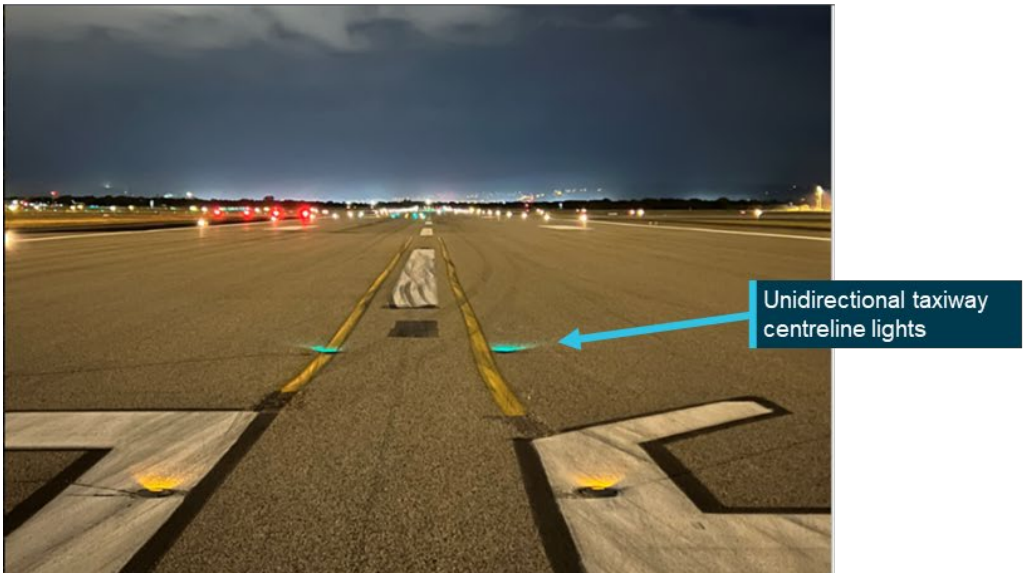
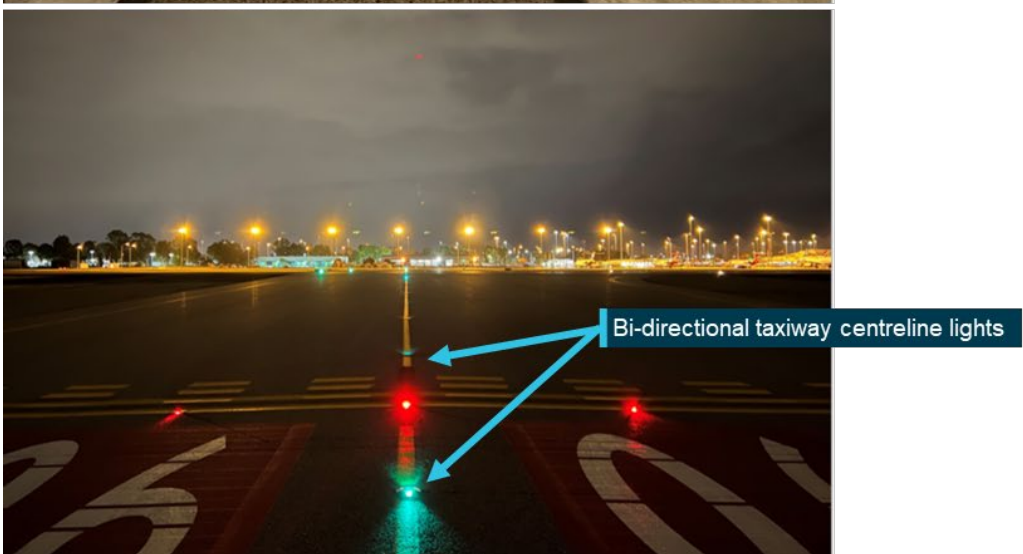
Figure 8: Runway centreline lights (top), view from the runway centreline of runway 06 (middle) and view from taxiway V holding point, facing towards the opposite side of the taxiway (bottom)

The MOS also stated that, where taxiway centreline lights were used for both runway exit and runway entry purposes, the colour of the lights viewed by the pilot must be green for entering the runway and alternately green and yellow for exiting the runway. Taxiway V had lights from the centreline of the runway to the centre of the taxiway (Figure 8). These lights were alternating yellow and green unidirectional lights visible only when exiting the runway, known as lead-off lights. Lights visible when entering the runway were known as lead-on lights. Taxiway V did not have lead-on lights that joined from the taxiway to the runway centreline, but there were green bi-directional taxiway centreline lights spanning across the runway threshold in the middle of taxiway V (Figure 8 top and bottom).

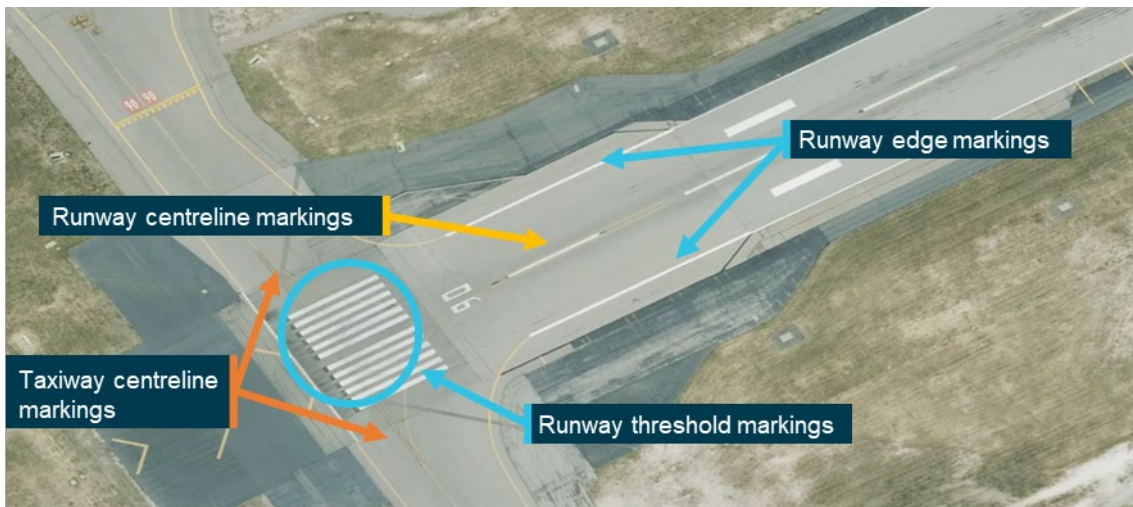
**Figure 9: Runway markings on Runway 06 (as of March 2023)**

Runway 06 had runway markings as per the MOS requirements. The runway edge markings were an unbroken white line and centreline markings were broken white lines. The markings were painted with non-reflective paint. There was no regulatory requirement to use reflective paint for runway markings. All taxiways including taxiway V had continuous yellow taxi centreline markings (Figure 9).

Although the runway had all the required markings in accordance with regulations, they were reported by 2 of the pilots as being difficult to see at night and were 'scuffed', thereby reducing the contrast and visibility of the markings. It was also noted that, while not required, reflective paint was not used for the markings to improve conspicuity at night.
