# Runway excursions on take-off involving Airbus A330-323, 9M-MTL, and Boeing 787-9, VN-A819

Melbourne Airport, Victoria, on 7 and 18 September 2023

Aviation Occurrence Investigation (Systemic)

AO-2023-043

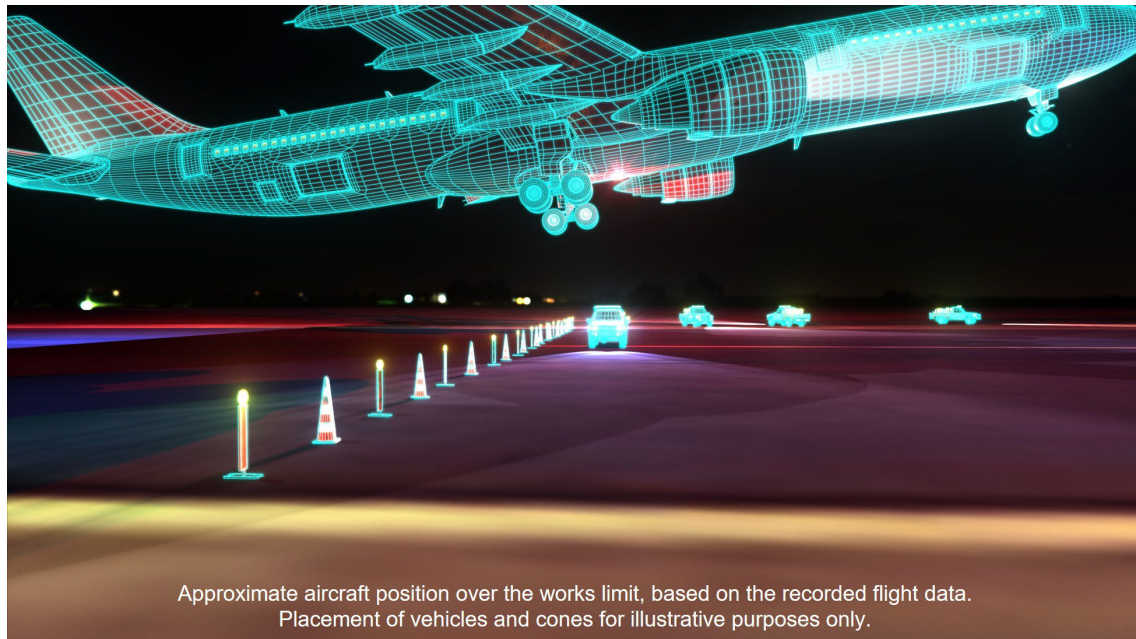
**Figure 4: Visual impression of 9M-MTL over works limit**

The jet blast from each aircraft impacted runway unserviceability lights, works lights and marker cones at the works limit. Personnel were active in the works area at the time of both occurrences however none were physically injured as a result. There was no damage to either aircraft, or injuries to passengers, and both continued with their planned flights.

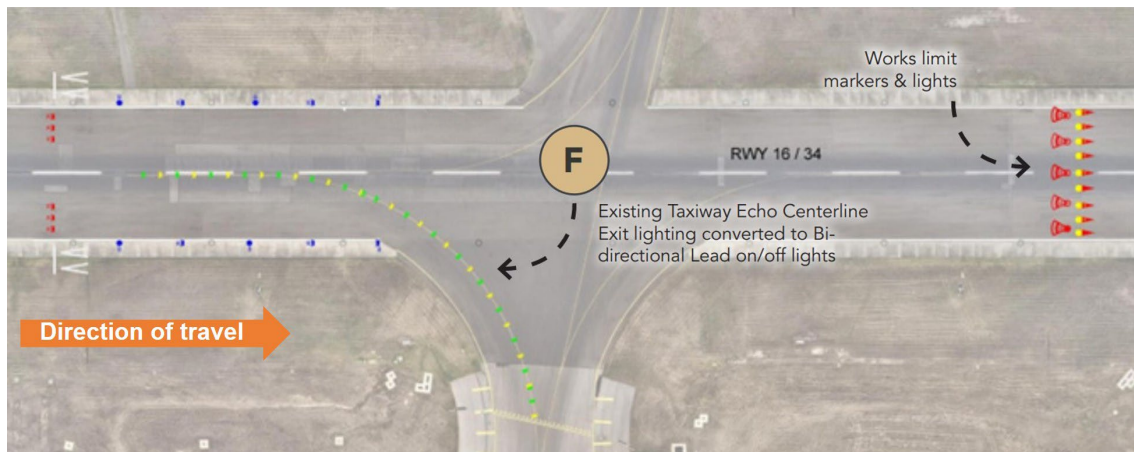
**Figure 12: Temporary runway 34 end and works limit arrangement**

- The runway centreline lighting was not available (switched off) and the runway edge lights were not colour-coded for the displaced threshold.<sup>57</sup>
- Temporary runway 34 end lights were installed, consisting of 6 lights, in 2 groups of 3 with a central gap. This was due to the presence of the declared stopway/starter-extension, to allow aircraft to pass through for departure from the runway 16 displaced threshold.
- A row of evenly-spaced, low-intensity,<sup>58</sup> unserviceability lights were placed across the works limit line.

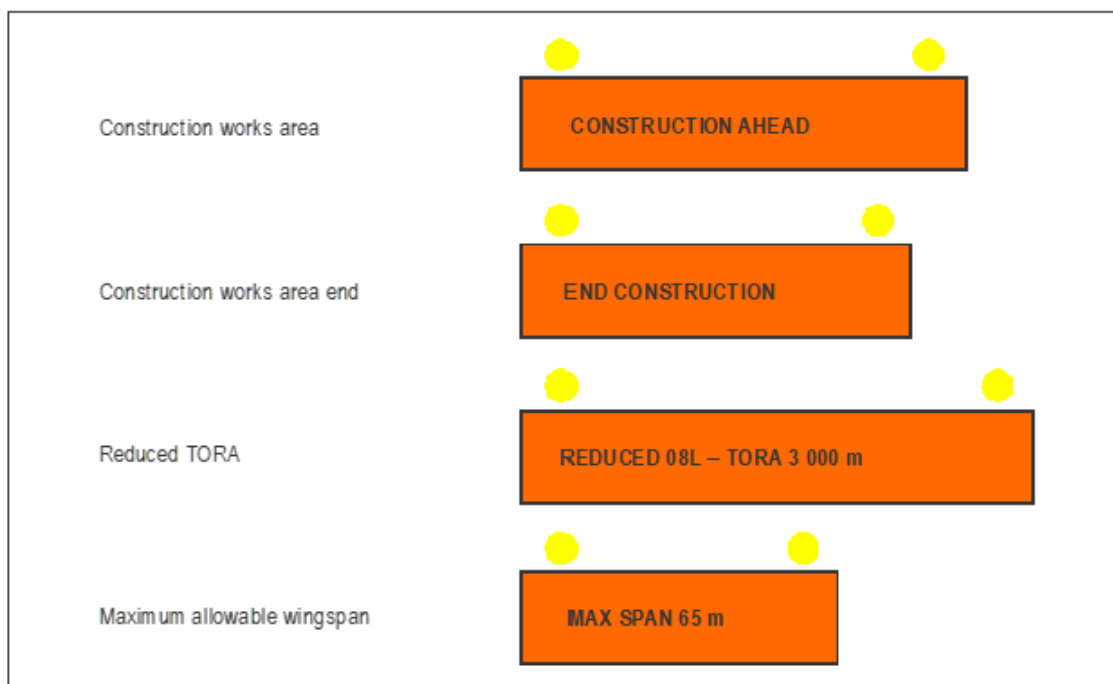
**Figure 20: Examples of unserviceability signs in Amendment 18 to Annex 14**

7.4.3.13 **Recommendation.**— *Where there is a need to enhance the conspicuity of unserviceability signs, they should be supplemented by two red or yellow simultaneously flashing lights.*

Suitably conspicuous visual aids, such as the signage proposed to be introduced to ICAO Annex 14, can also assist as a final defence by providing an indication of changes to the runway conditions, where the runway would otherwise appear normal to flight crews.
