Runway incursion involving De Havilland Aircraft of Canada Limited DHC-8, VH-QOD, and Piper PA-28, VH-XDK

Wagga Wagga Airport, New South Wales, on 15 July 2024

AO-2024-041

Final – 13 November 2025

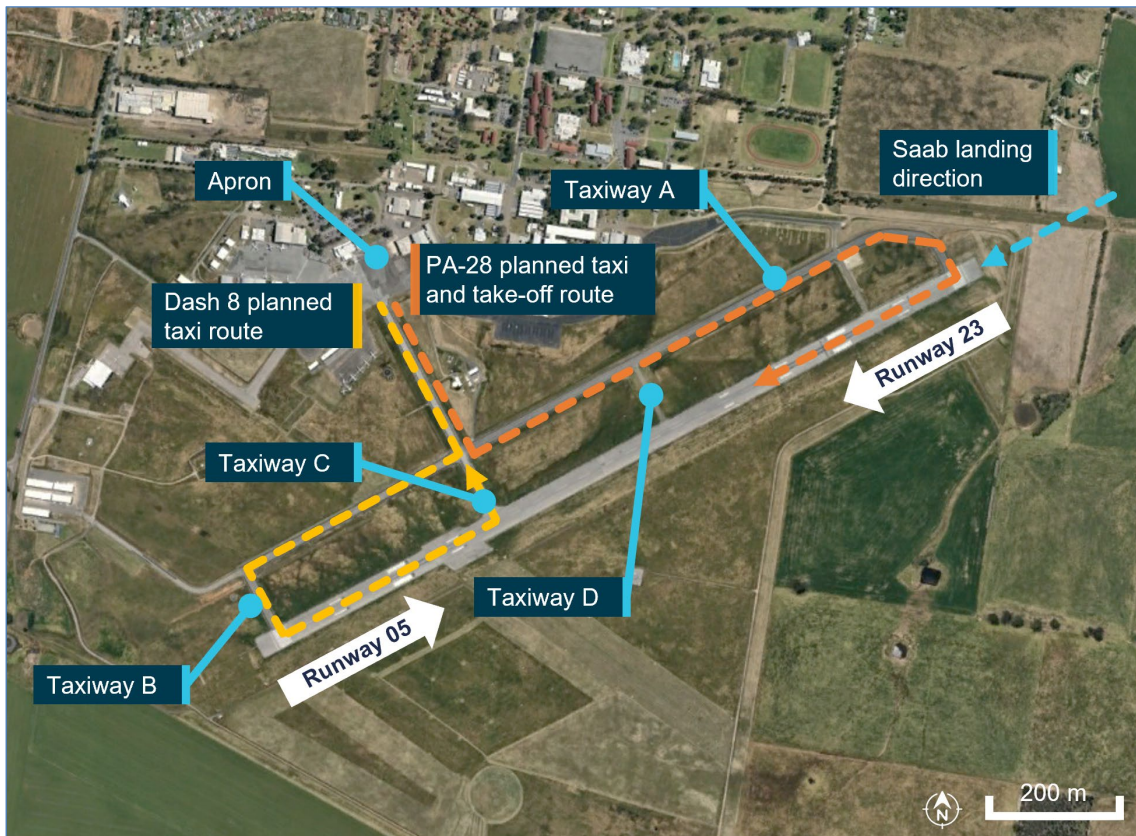
Figure 1: Intended taxi routes for aircraft

At about the same time, the 2 crew members of a QantasLink De Havilland Aircraft of Canada Limited DHC-8-402 (Dash 8), registered VH-QOD, were on board the aircraft at the Wagga Wagga Airport apron. The crew were making preparations to reposition the aircraft from the apron to another bay (on the apron) by taxiing the aircraft via the runway (Figure 1). The Dash 8 crew reported they spent about 5 minutes¹ preparing the aircraft on the flightdeck prior to taxiing. However, they did not recall hearing the initial taxi call and callsign repeats from the PA-28, but did recall hearing the 10 NM inbound call from the Saab 340.

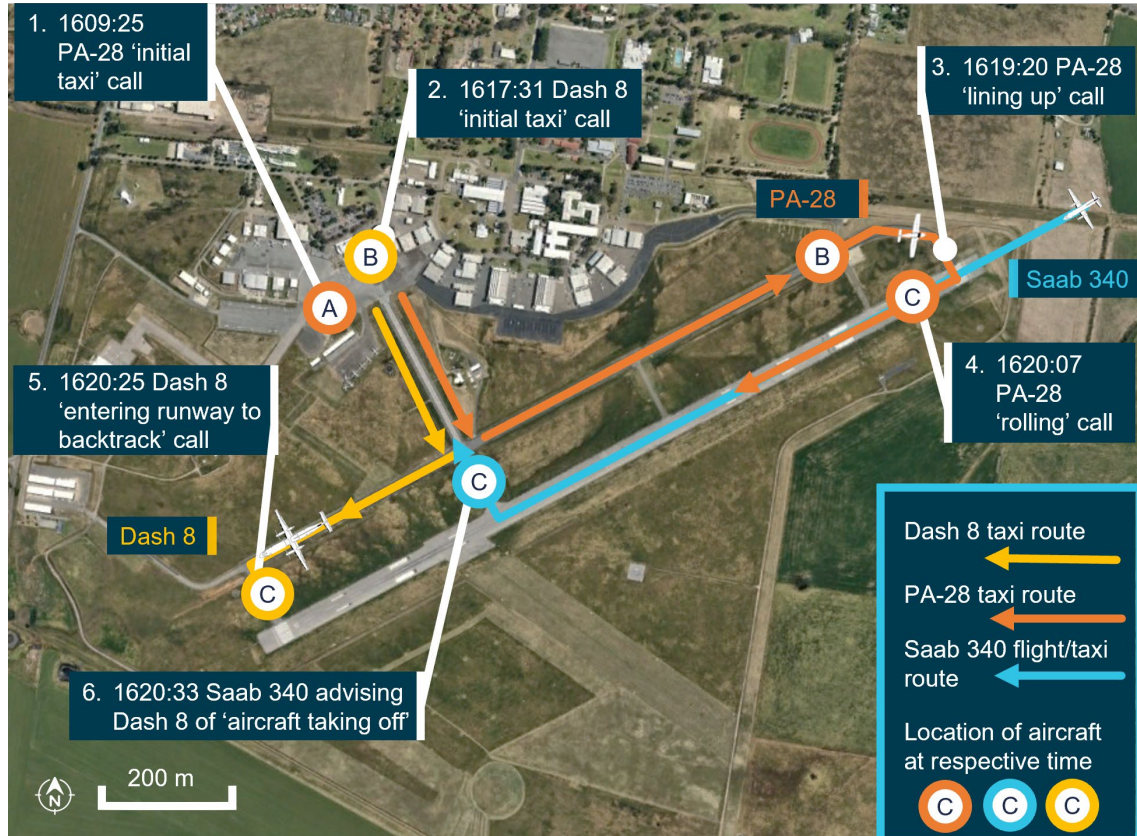
Figure 2: Position of respective aircraft at given times

At 1616:27 the Saab 340 crew broadcast that they had joined a 5 NM final for runway 23. At 1617:31 (Figure 2, position B, Dash 8) the Dash 8 crew broadcast that they were taxiing for runway 05. At this time, the PA-28 was on taxiway A, approaching runway 23 (Figure 2, position B, PA-28).

Being aware only of the inbound Saab 340, the Dash 8 crew communicated directly with them. This was to gain an understanding of the Saab 340 crew's intentions on landing and exiting the runway. While still taxiing towards the runway at 1618:32, the Dash 8 crew told the Saab 340 crew of their intent to enter and backtrack from the threshold of runway 05, keeping out of the way of the Saab 340's landing.

At 1619:20, the PA-28 was positioned on runway 23, with strobe lights on, behind the landed Saab 340 and the instructor made a 'lining up and holding' call (Figure 2, position B, PA-28). About 30 seconds later the Saab 340 crew made a broadcast that they were clear of the preferred runway (Figure 2, position C, Saab 340). The PA-28 instructor then broadcast their 'rolling call' (Figure 2, position C, PA-28) and commenced take-off at 1620:07.

At 1620:25, the Dash 8 crew gave an entering call for runway 05 with intentions to taxi to taxiway C (Figure 2, position C, Dash 8) and then entered the runway.

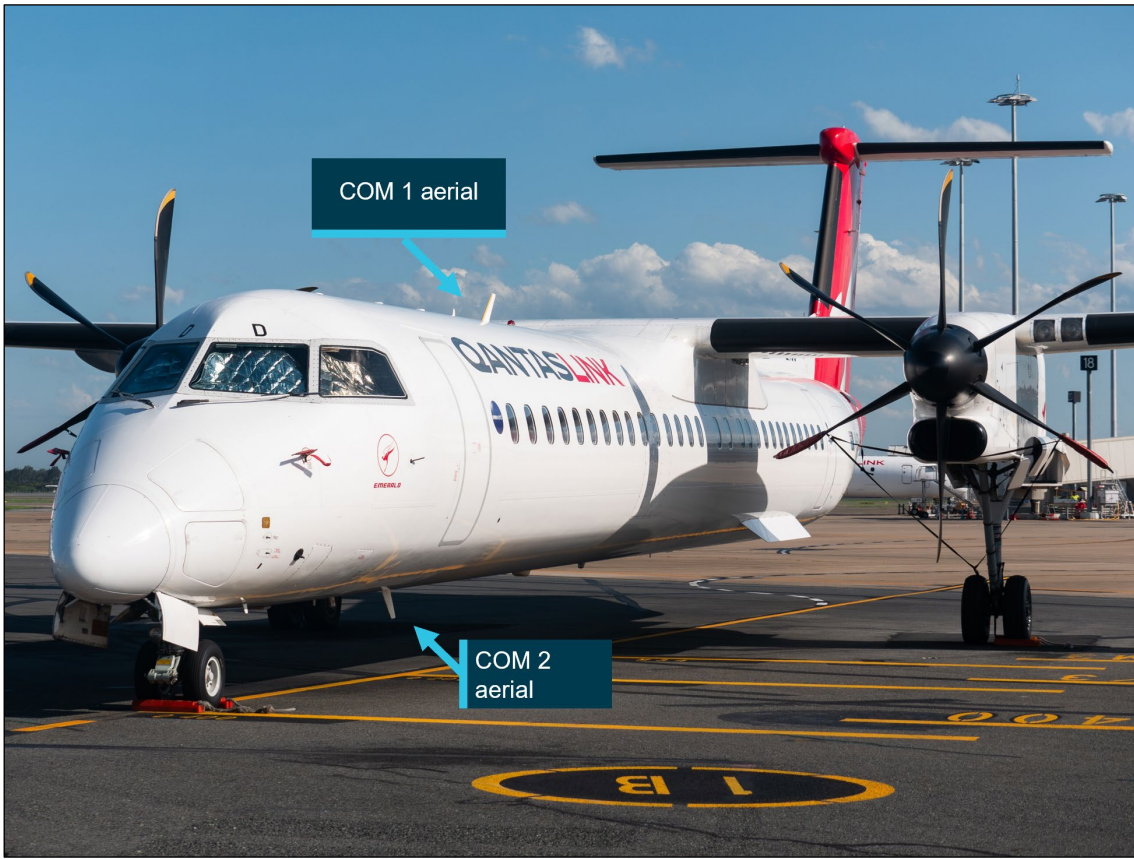
Figure 3: Dash 8 with annotations of VHF antenna locations on airframe

- Number 1 VHF COM antenna (VHF COM 1) mounted on the roof of the aircraft forward of the wings.
- Number 2 VHF COM antenna (VHF COM 2) mounted on the belly of the aircraft.

The testing identified that ground-based Dash 8 signal strength reception could be adversely affected by the aircraft's orientation relative to the other aircraft or antenna locations. Additionally, the average signal strength forward of the aircraft was 8.5 dBm²¹ stronger than the average signal strength behind and to the side of the aircraft. A significant recorded signal strength and clarity reduction on both VHF COM 1 and VHF COM 2 radios was observed when the tail of the Dash 8 was pointed towards the receiver.

In previous ground-based signal strength testing at Mildura Airport (see ATSB investigation report [AO-2023-050](#)), the ATSB identified a significant reduction in the Dash 8 VHF radio transmission strength and readability particularly when greater transmission and reception distances were involved. It was also found that the use of VHF COM 2 reduced ground-based transmission reception strength and clarity in comparison with VHF COM 1.

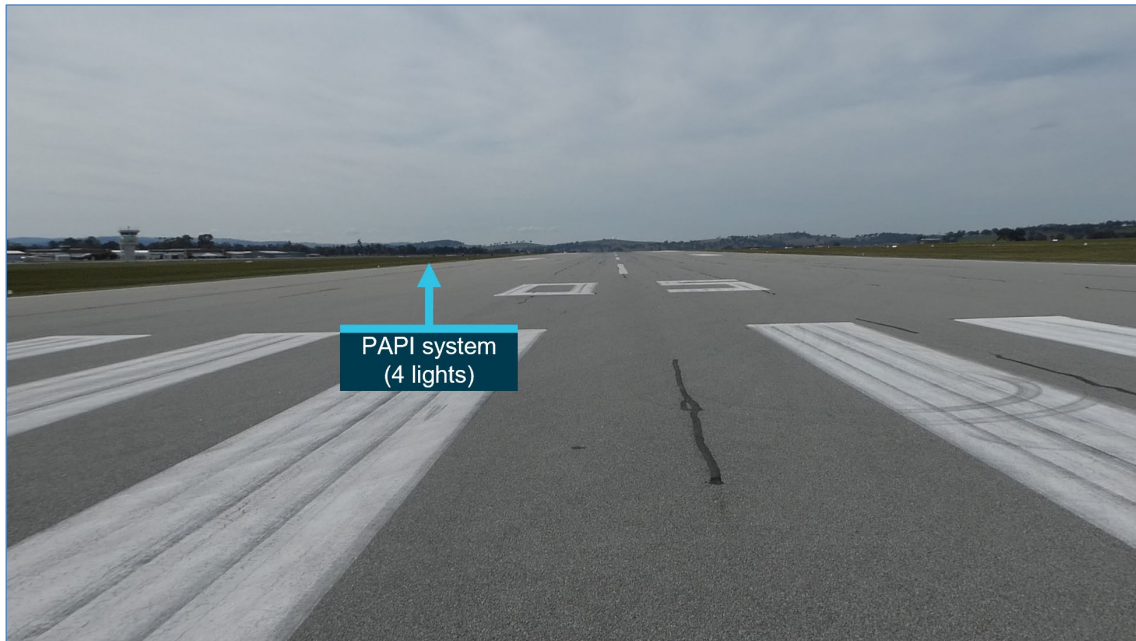
Figure 6: View from ground level, threshold runway 05

Both the FO and the captain commented during interview of a possible obstruction to their line of sight from the PAPI¹² installation. The PAPI installation is positioned to the left of runway 05. The orientation was to the left of the Dash 8 when the aircraft was holding on taxiway B, prior to entering runway 05. PAPI units must be no more than 0.9 m above ground level.

It was noted that the visual range from holding point B to the threshold of runway 23 is greater than 1,700 m over undulating terrain, with the PA-28 presenting a small target for visual identification by the Dash 8 crew.
