# Landing gear malfunction and collision with water involving De Havilland Aircraft of Canada DHC-2 Beaver, VH-OHU

near Whitehaven Beach, Whitsunday Island, Queensland, on 26 October 2024

**ATSB Transport Safety Report**

AO-2024-055

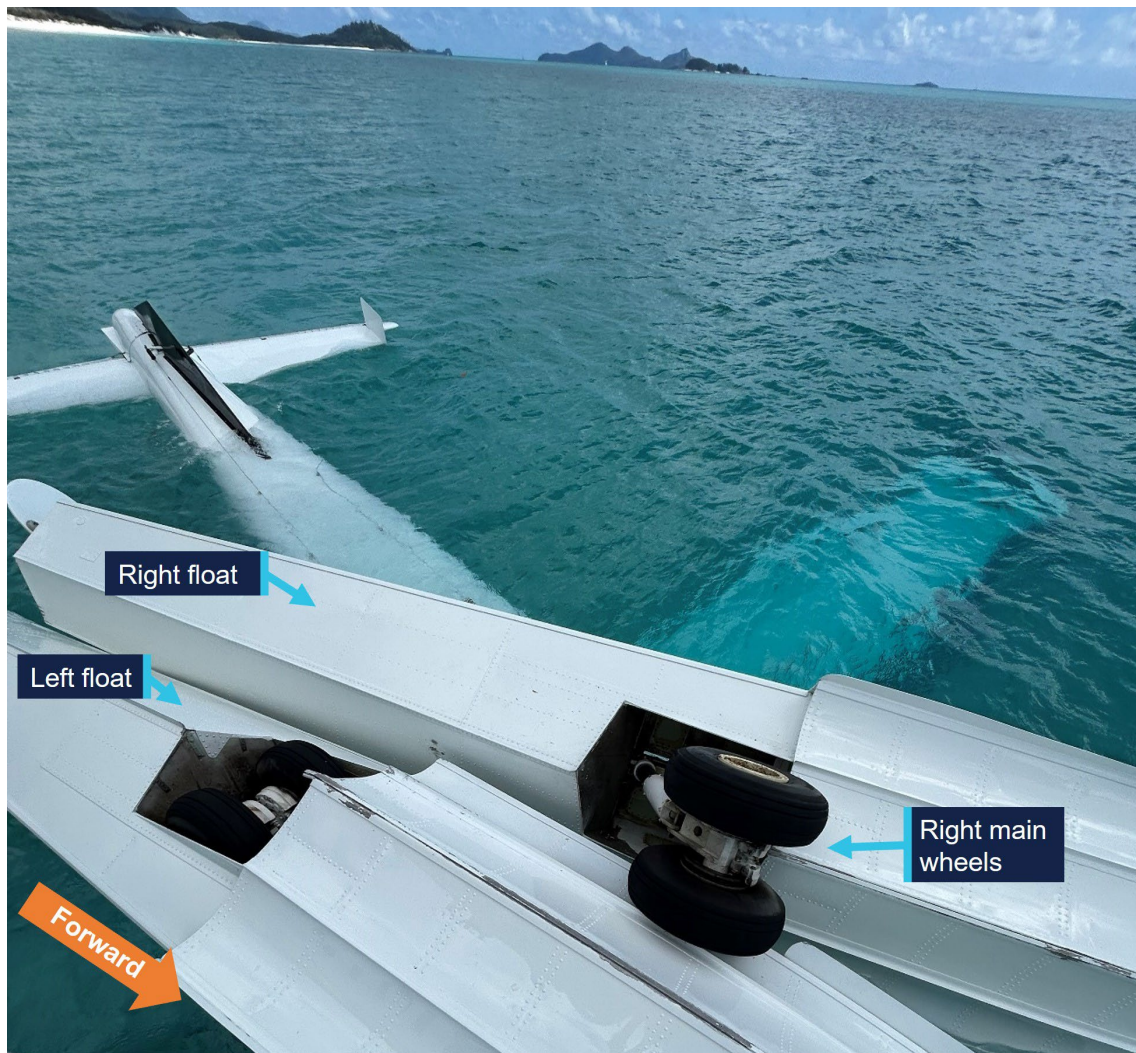
A nearby vessel rendered assistance to the pilot and passengers and transported them to Hamilton Island for medical attention. Once aboard the vessel, the pilot looked at the aircraft and observed the right main gear wheels had not retracted into the float (Figure 2).

**Figure 2: VH-OHU underside of floats, showing right main wheels not retracted**

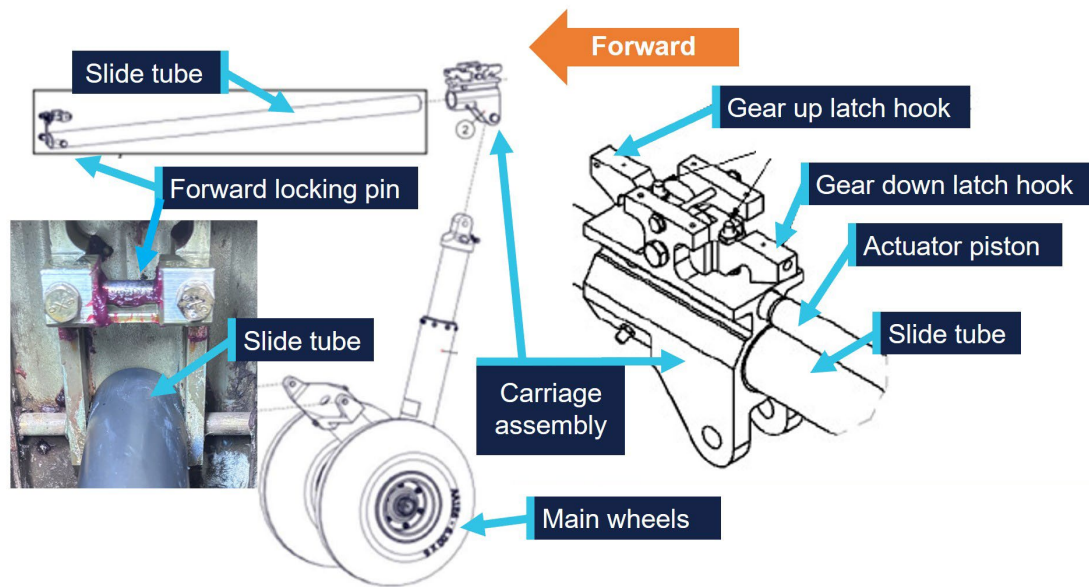
The main gear is mechanically locked in both up and down positions. When the gear is selected to UP, the main gear down hook unlatches from the rear locking pin. Hydraulic pressure exerted on the actuator piston drives the carriage assembly to move forward along the slide tube, with the wheels moving aft, until the gear up hook latches on the forward locking pin (Figure 5). With no further movement once all 4 gear are retracted into the float, hydraulic pressure will increase until the pumps automatically switch off.

**Figure 5: Main gear assembly diagrams, including VH-OHU forward locking pin (inset)**

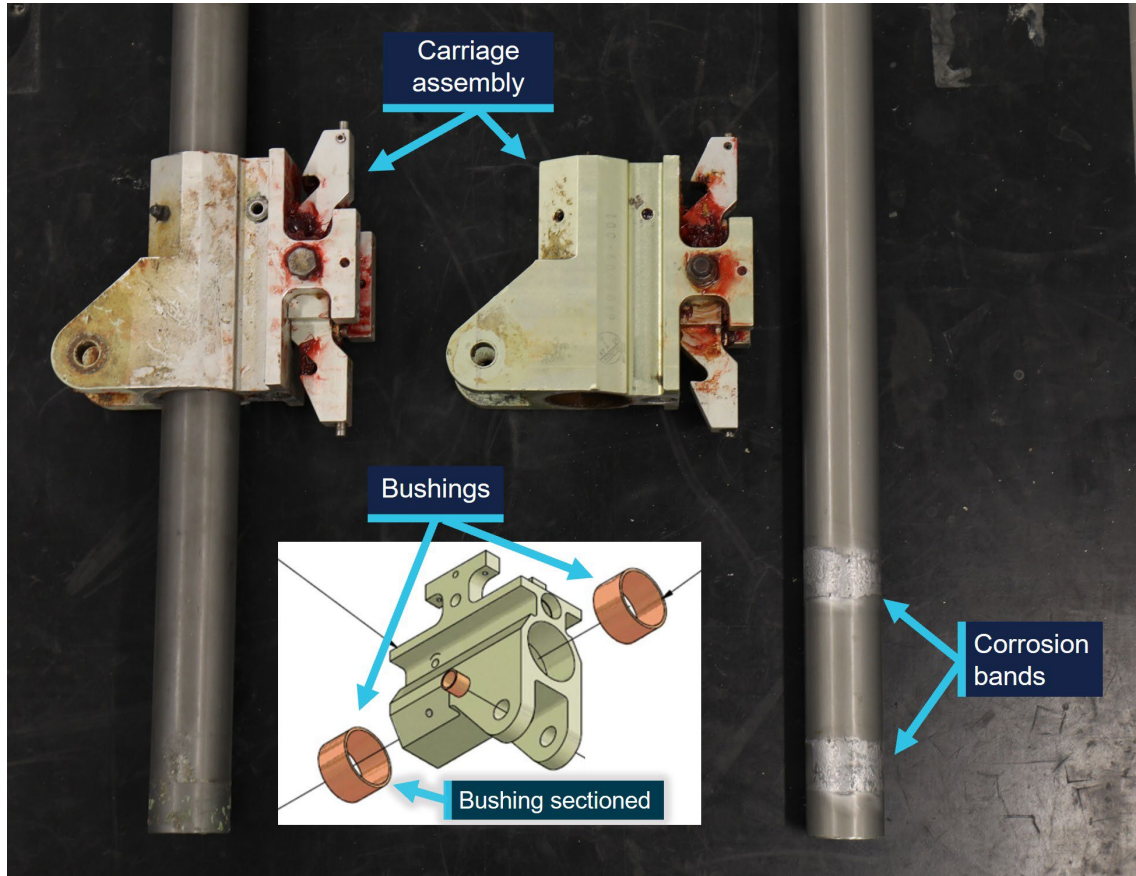
The right slide tube had 2 bands of corrosion that corresponded with the bushing locations in the carriage, at about the fully extended location (Figure 9). The left slide tube showed no similar damage. Both carriage assemblies exhibited grease around the

**Figure 9: Comparison of slide tubes, showing corrosion bands on the right slide tube (on the right) and location of bushings examined by the ATSB**

The slide tube corrosion patterns were consistent with galvanic corrosion between the exposed bushing bronze layer and the aluminium slide tube base metal, in the presence of salt from coastal operations. The difference in wear between the left and right carriage bushings likely influenced the degree of corrosion on the respective slide tubes. The bushings with a higher amount of retained, non-conductive PTFE layer showed significantly less corrosion on the corresponding slide tube.

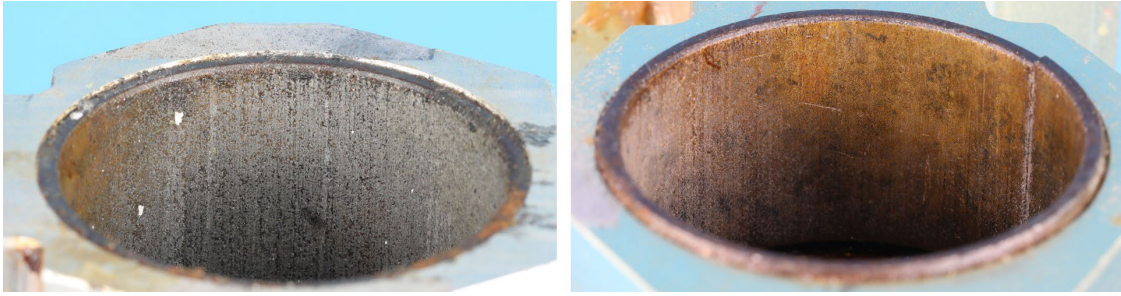
The bushings were a tri-layer construction, with a base layer of steel, with sintered (porous) bronze and then coated in a PTFE<sup>5</sup> 'sliding layer'. The bushing could be replaced and therefore, the carriage time in service did not necessarily correspond to the bushing time in service. The bushings of both carriages were examined, with observations including the internal diameters of all bushings were within drawing tolerances and the right bushings were more worn than the left (Figure 10).

**Figure 10: Difference in bushing wear with the left (left) showing largely intact PTFE layer (grey) and right (right) showing significant exposure of the sintered bronze layer**

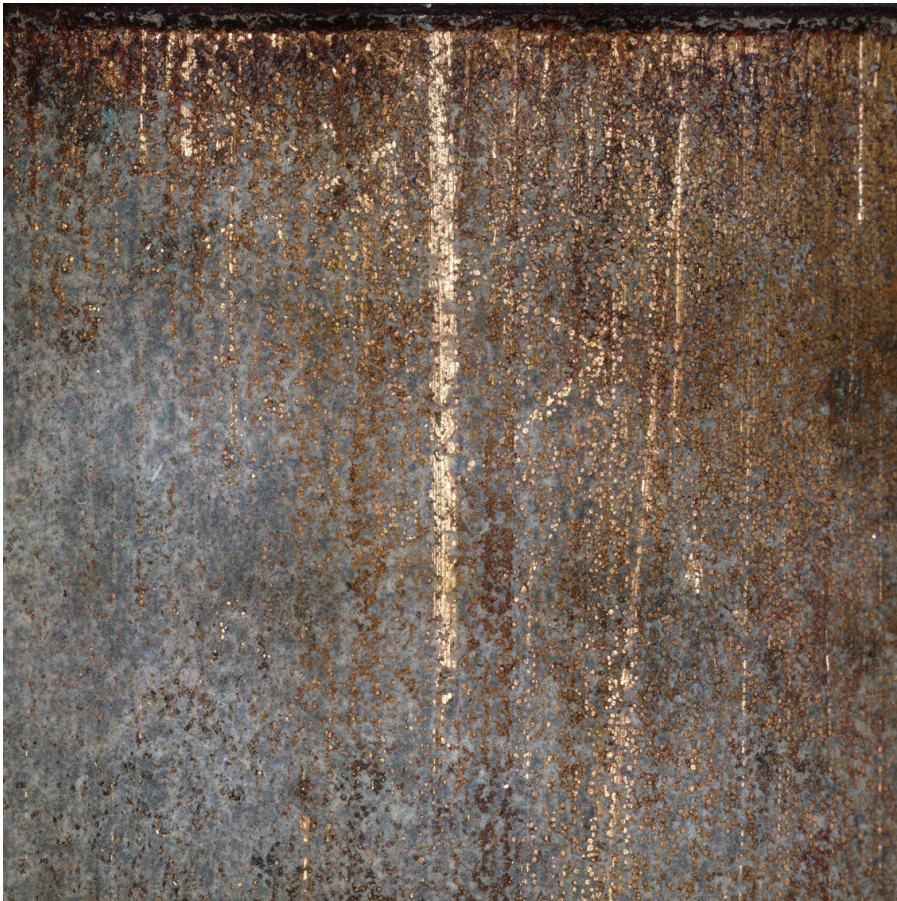
The right carriage bushing located near the grease nipple was sectioned. Examination identified areas where the PTFE layer was not present, exposing the bronze layer and showing some evidence of scoring (Figure 11). The PTFE layer was non-conductive in contrast to the bronze.

**Figure 11: Right carriage bushing surface showing Teflon/lead layer (grey), exposed bronze layer (copper) and some evidence of scoring (bright lines)**

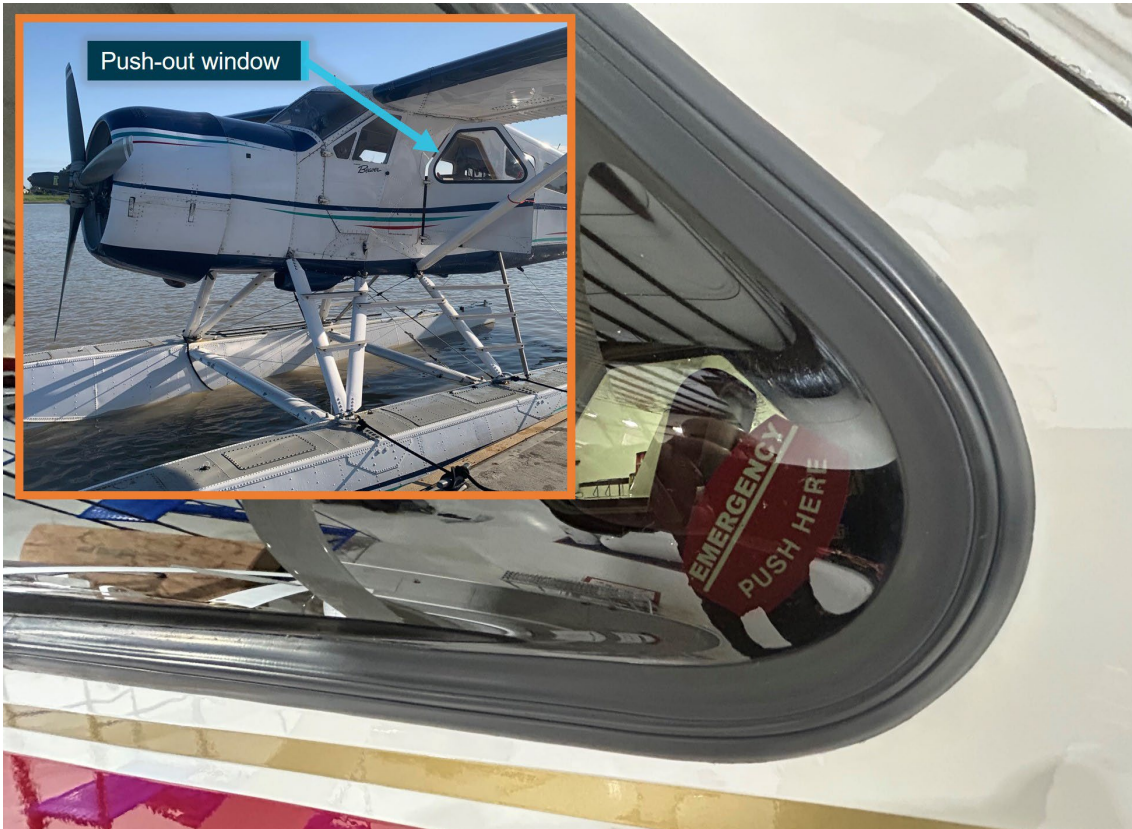
**Figure 12: Example of main cabin door push-out window**

De Havilland Aircraft of Canada advised it has supplied about 130 kits worldwide, with one kit to Australia. VH-OHU was not fitted with the push-out windows, nor was it required by regulations.

Viking Air Limited (the type certificate holder at that time, now held by De Havilland Aircraft of Canada, see *Aircraft information*) developed ‘push-out windows’ (Figure 12) and published service bulletin V2/0003 *New cabin door windows that incorporate a ‘push-out’ feature* in July 2010. The service bulletin noted:

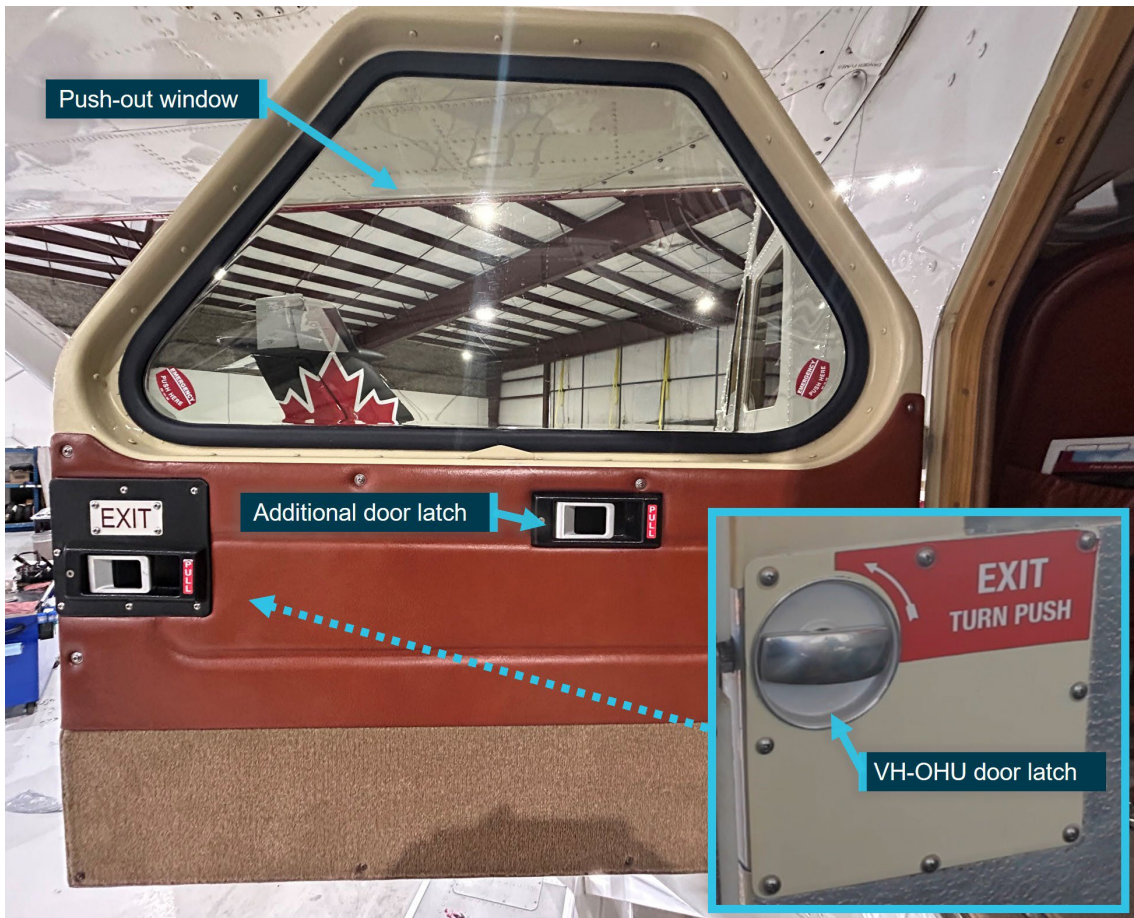
De Havilland Aircraft of Canada advised it had supplied 70 door latch kits to date. VH-OHU was not fitted with the modified door latch system, nor was it required by regulations.

**Figure 13: Representation of revised door latches, with VH-OHU door in inset**

Note: the rotational-style door latch, as was in VH-OHU, operates in one direction only.  
 Source: De Havilland Aircraft of Canada and the operator, annotated by the ATSB

Viking Air Limited published service bulletin V2/0004 *Installation of an automotive style cabin door latch system* in November 2010. The service bulletin cited the reason as ‘the dual automotive (pull) style cabin door latch system provides better egress from the cabin in the event of an emergency’ (Figure 13). The service bulletin also noted:
