Australian Transport Safety Bureau

Wheel brake failure involving Sling Aircraft Sling LSA, VH-PPY

Moorabbin Airport, Victoria, on 14 February 2025

AO-2025-006

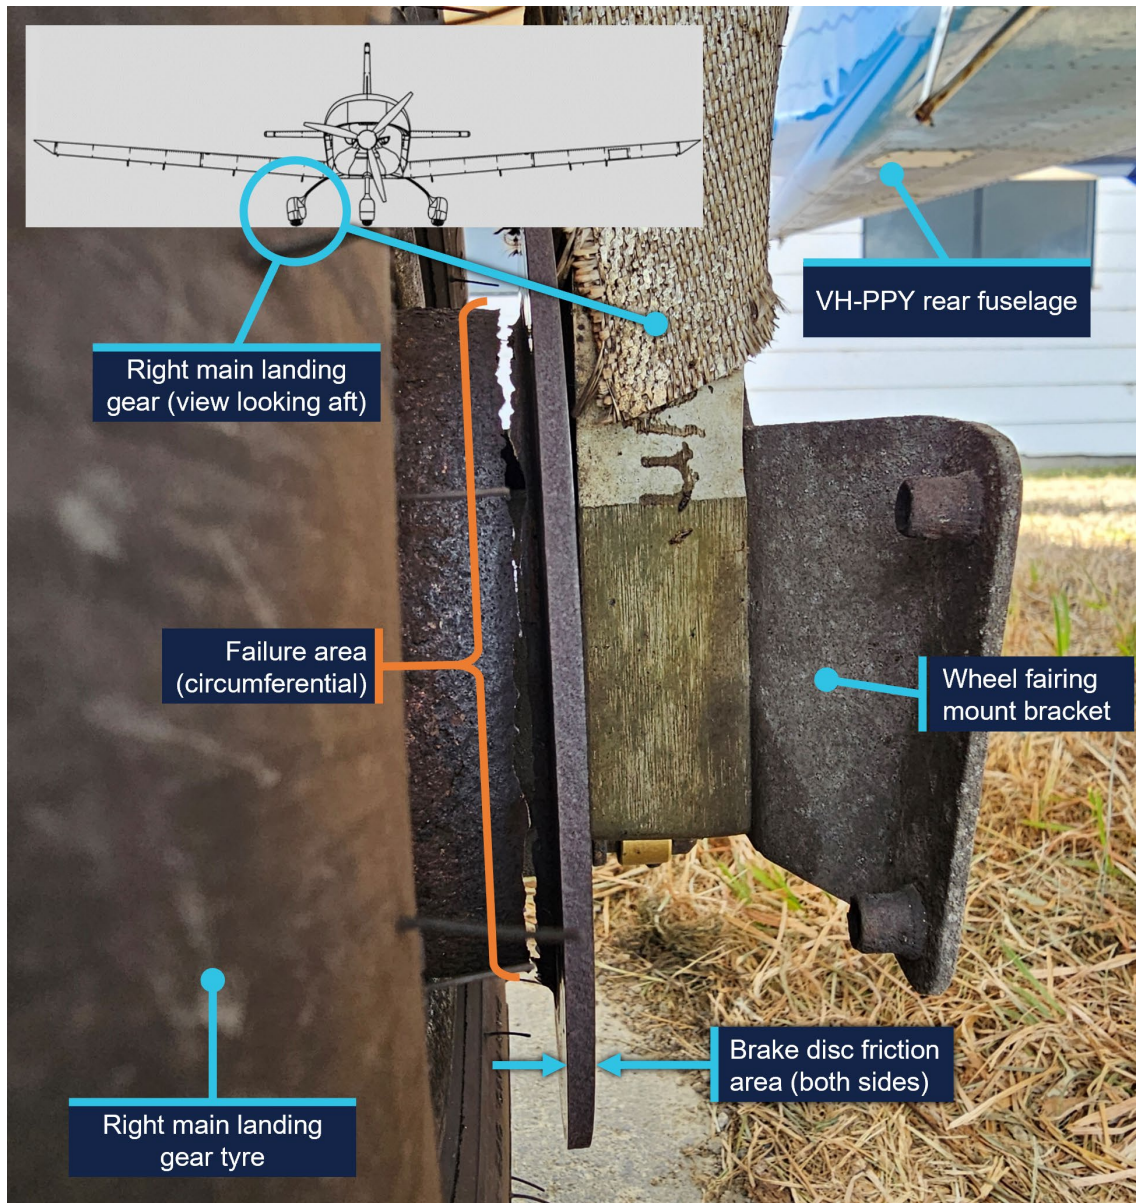
Figure 1: VH-PPY right brake disc post-flight

The instructor re-commenced taxiing to the operator's parking area, and after disembarkation saw that the right main landing gear brake disc had failed (Figure 1). The instructor noted the brake failure on the aircraft's maintenance release, grounding the aircraft.

The right brake disc of VH-PPY was severely corroded and its structural integrity had been compromised to the point where it failed during normal aircraft braking after landing. While there were no injuries or further aircraft damage from this occurrence, failure of the aircraft's braking system could result in a more serious outcome such as a runway excursion or surface movement collision.

The operator replaced all corroded brake discs fitted to its Sling LSA fleet with the correct Matco parts, and the aircraft are now moved onto the apron prior to boarding, allowing easier access to inspect the landing gear. Additionally, the operator discussed the occurrence in a safety presentation to instructor pilots which included a description of the event, photos of the corroded brake, possible reasons for the corrosion, and a direction to ensure inspection of the brakes is carried out prior to flight.

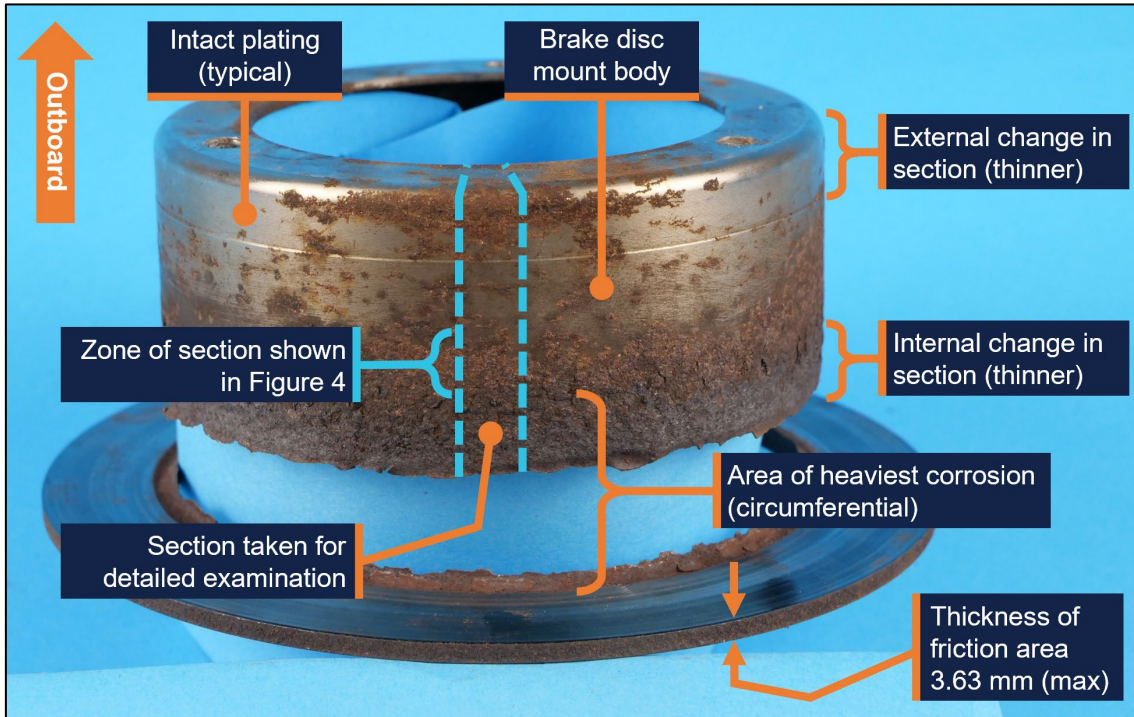
Figure 3: Brake disc as received at the ATSB’s technical facility

The brake disc fitted to VH-PPY at the time of the occurrence was manufactured by Rapco (Figure 3). Rapco brake discs are manufactured from forged carbon steel and electroless nickel plated for corrosion prevention. Rapco brake discs are identified with a laser-etched part number and have 2 areas where the section thickness has been reduced, which is not a feature of the approved Matco part.

The brake disc exhibited uniform corrosion⁹ with associated material loss and thinning of the base metal. The disc was most severely corroded around the region of failure, which was adjacent to the friction (braking) area and associated with a reduction in part thickness. The measured maximum thickness of the brake disc friction area was 3.63 mm (0.143 inches), making it about 0.612 mm (0.024 inches) less than the minimum thickness specified by Rapco.

The Rapco brake disc fitted to VH-PPY was not approved by the aircraft manufacturer for fitment to the Slingshot LSA, so assurance that it was a suitable replacement had not been established. However, the materials used in the construction were similar to those offered by the original equipment manufacturer (Matco) and found to be consistent with Rapco specifications.

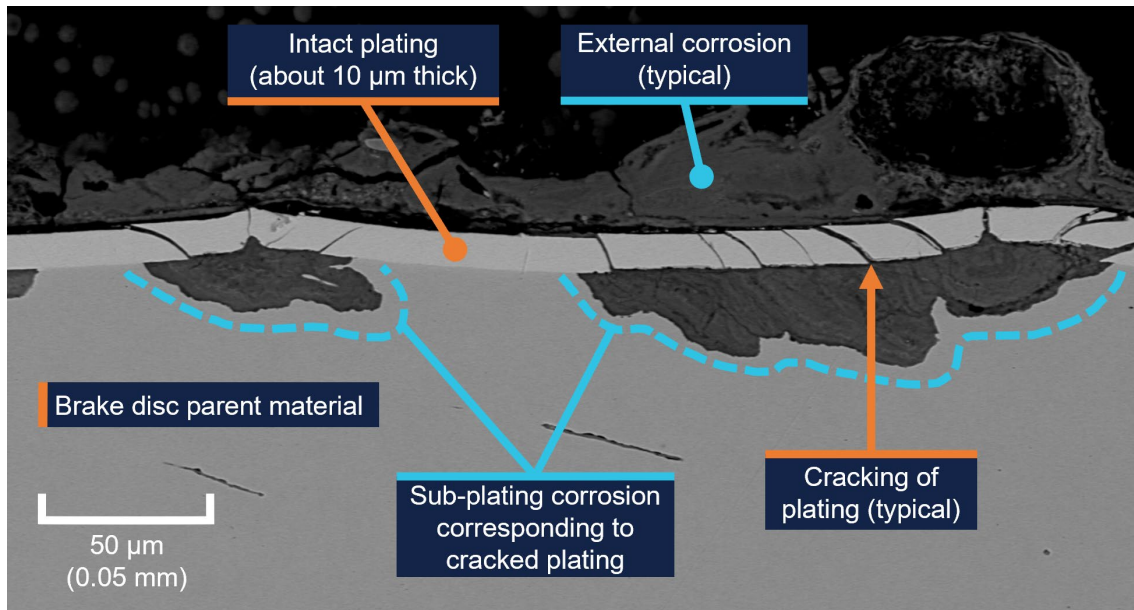
Figure 4: Sectioned view of damaged plating

To examine the remaining plating for continuity, a section was taken through the brake disc. The plating was measured to be about 10 µm (0.01 mm) thick and was broadly continuous around the hub but degraded closer to the region of failure. There were examples where cracking in the plating corresponded to sub-plating corrosion of the disc (Figure 4).

Rapco employed an electroless nickel barrier coating to prevent corrosion. This meant that corrosion can initiate at any point the plating becomes discontinuous, which was the most likely initiator for the corrosion in this case.

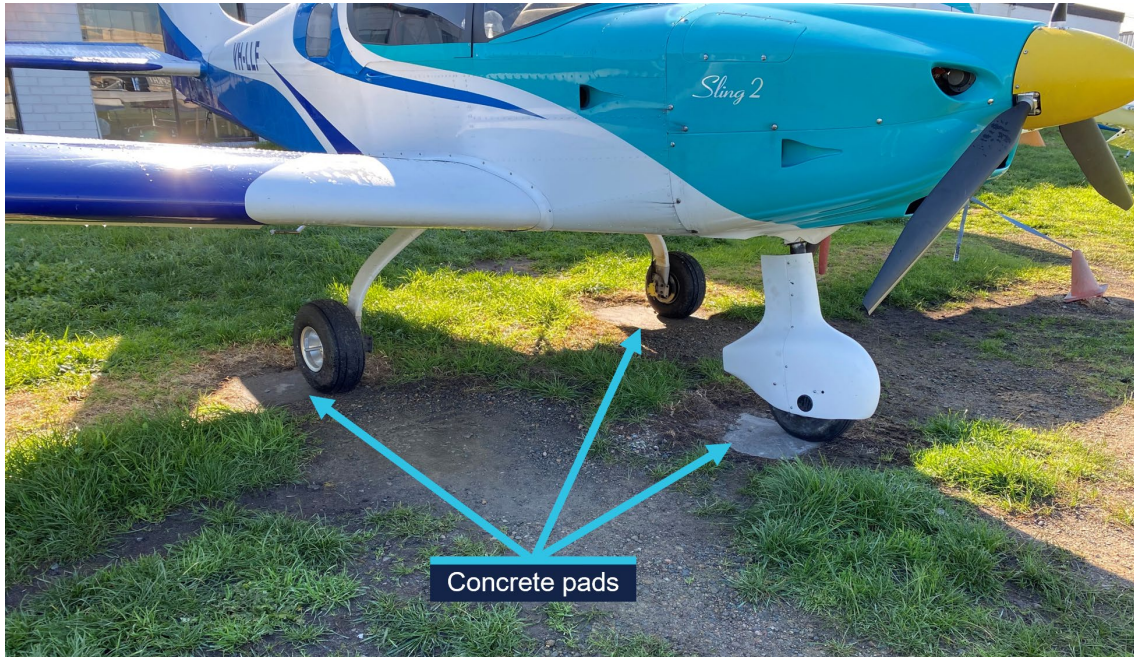
Figure 5: Parking area for the operator's aircraft

The operator's aircraft were parked outside on concrete pads, surrounded by gravel and grass (Figure 5). Rain reportedly pools on and around these pads.

It was not determined when the brake disc had been replaced and, therefore, the time taken for the corrosion to develop was not established. However, VH-PPY was being parked outside and operated in the vicinity of a saltwater environment, which would have contributed to the corrosion development. The effect of the environment was also demonstrated by the extent of corrosion observed on the brake disc assemblies of the other 6 aircraft in the operator's fleet.
