# **Collision with terrain involving Eurocopter EC120B, VH-JDZ**

Porepunkah aerodrome, Victoria, on 15 May 2025

**ATSB Transport Safety Report**

AO-2025-023

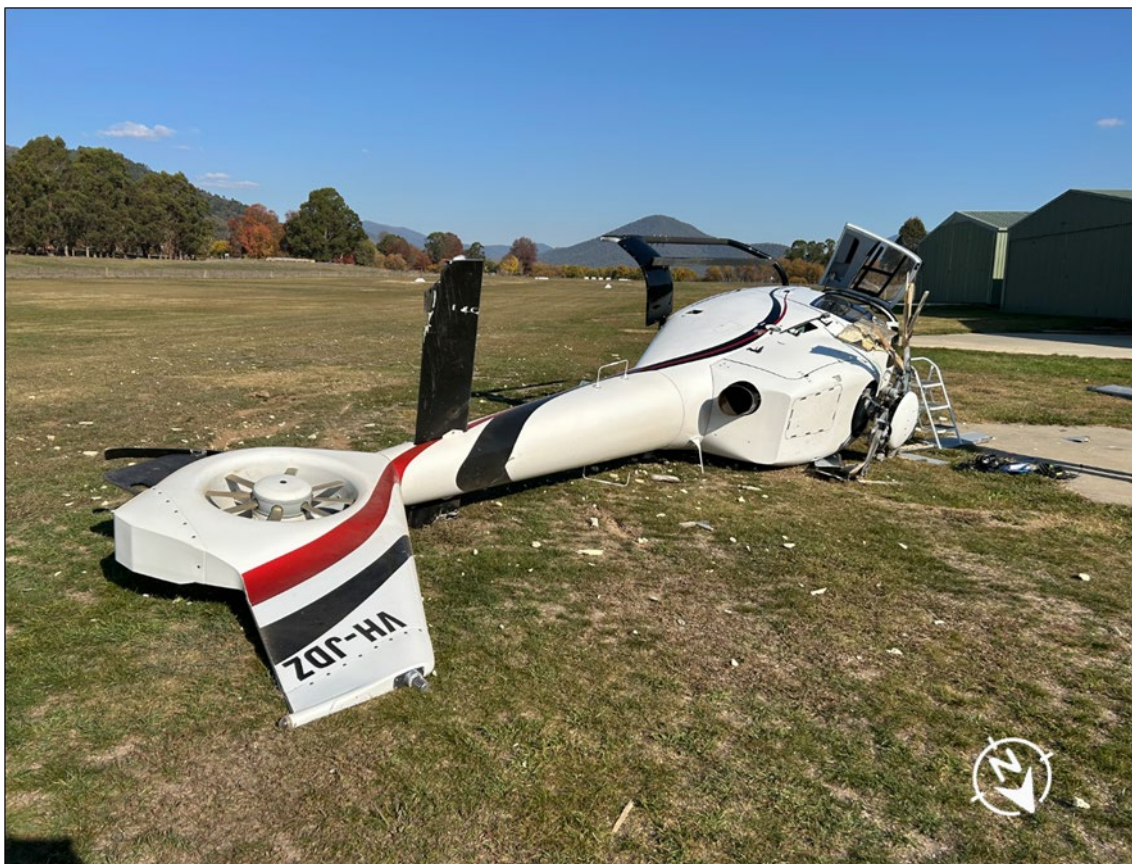
Figure 1: VH-JDZ photographed after the dynamic rollover

The pilot was unable to regain control and the helicopter completed about three quarters of a revolution before the right aft skid contacted the ground, leading to a further rotation on the ground and a dynamic rollover.<sup>3</sup>

The helicopter came to a rest on its right side and the pilot immediately checked on the welfare of the passenger and turned off the fuel. Noticing smoke and mindful of the potential fire risk, the pilot gave instructions to evacuate immediately.

As a result of the impact, the aircraft was substantially damaged (Figure 1).

With more power to the main rotor, less was available to the tail rotor and therefore the effectiveness of the right pedal input was reduced, allowing the continued helicopter rotation that resulted in ground contact and dynamic rollover.

When the pilot increased the collective on the accident flight, it is almost certain that the range of pedal movement required to arrest the unanticipated yaw outpaced the pilot's input.

- The pilot did not anticipate the performance of the design difference of the EC120B. Almost immediately after lifting off, the pilot was unable to counter the helicopter's left yaw resulting in ground contact and dynamic rollover.
- Limited recent flying experience on this helicopter type degraded the pilot's ability to manage the controls effectively. The pilot was unaware that this lack of currency had diminished their competence to safely operate the aircraft type.
