Tail rotor strike involving Robinson R22 Beta II, VH-HGE

58 km north-west of Anthony Lagoon, Northern Territory, on 1 July 2025

ATSB Transport Safety Report

AO-2025-035

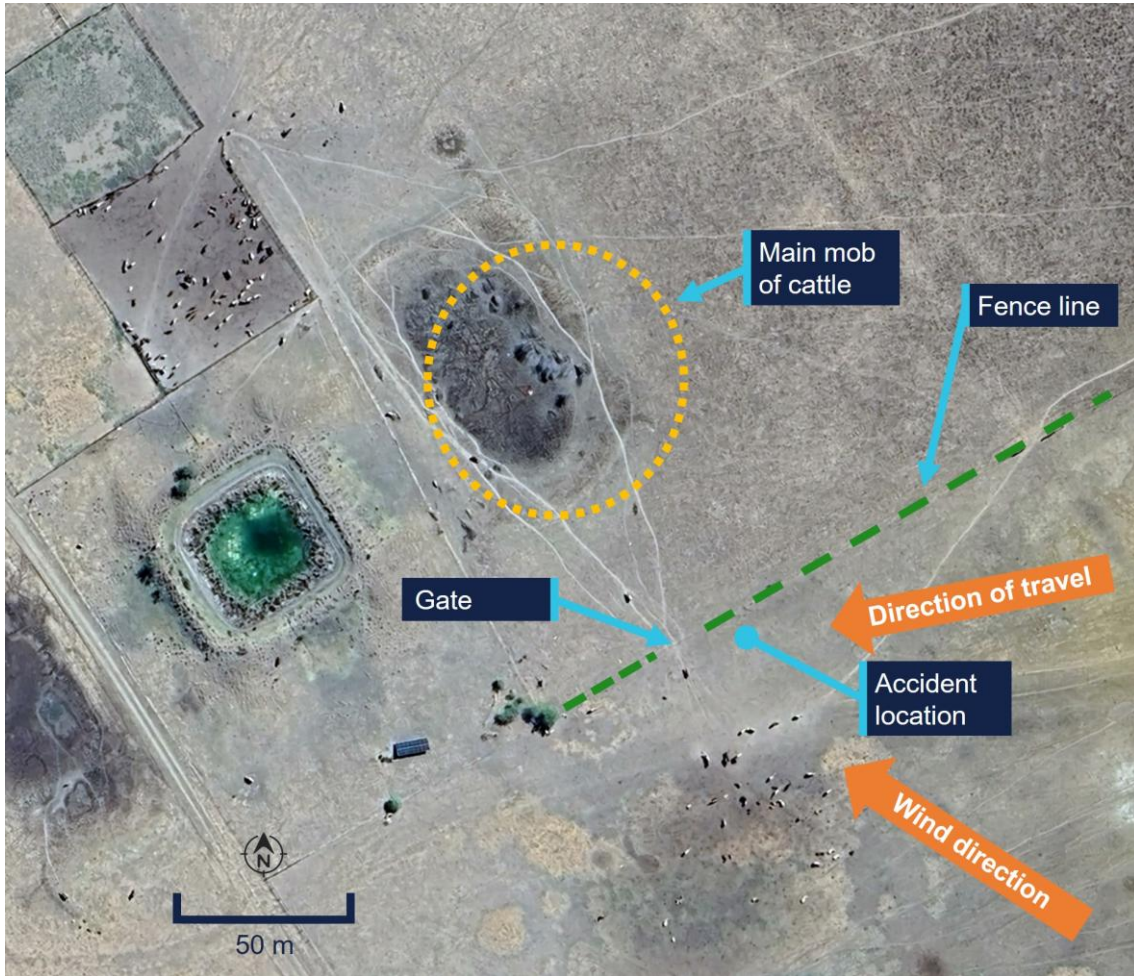
Figure 1: VH-HGE accident location and cattle yards

At about 1510, the pilot of VH-HGE was working the one remaining animal along a fence line (Figure 1) towards the gate of the holding paddock at about 6 ft above the ground. The pilot described that the animal baulked when approaching the gate about 4 m from the helicopter and attempted to run behind the helicopter. The pilot reported that they were highly motivated to complete the mustering operation and became increasingly focused on moving the animal.

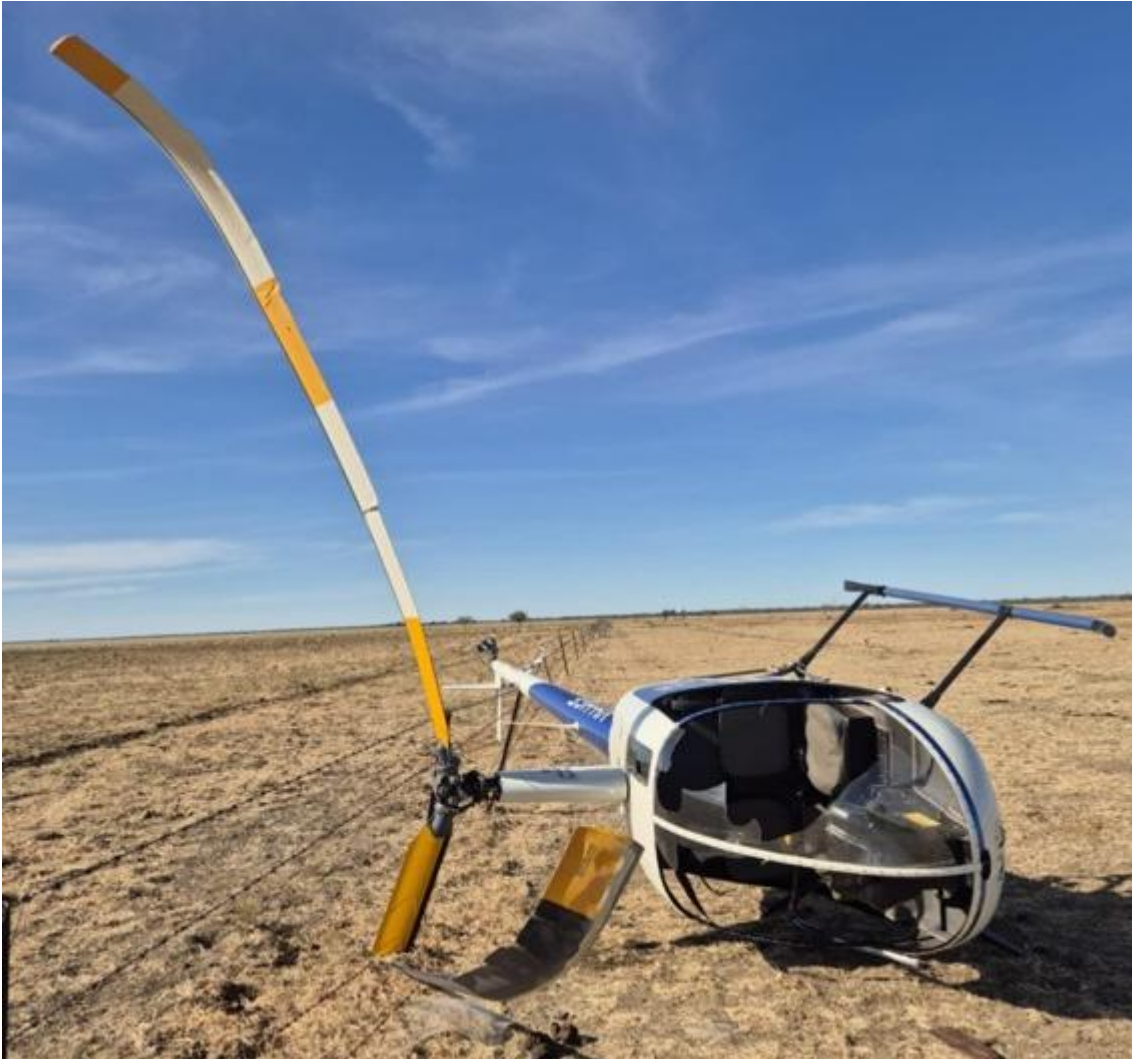
Figure 2: VH-HGE accident site

Reacting to the animal's movement, the pilot flared² the helicopter while travelling downwind in close proximity to the ground. During the flare, the pilot felt the helicopter sink more than expected and the tail rotor impacted the ground. This resulted in the tail rotor becoming ineffective. Without yaw³ control, the helicopter rotated quickly to the right and the pilot assessed there was a tail rotor failure. The pilot reduced the throttle to decrease the torque and raised the collective to cushion the aircraft onto the ground. The pilot estimated that the helicopter had completed 2 or 3 full rotations, and still had some rotation when the right skid made contact with the ground, causing the helicopter to roll over to the right. The main rotor blades then impacted the ground and the helicopter came to a stop on its right side, resulting in substantial damage (Figure 2).

This resulted in the pilot not anticipating the additional power required during the flare, leading to the helicopter descending. This, combined with the change in pitch attitude, lowered the tail rotor closer to the ground. With minimal clearance between the helicopter and the ground, there was likely insufficient opportunity for the pilot to apply additional power to climb or arrest the descent before the tail rotor impacted the ground.

Following the tail rotor impacting terrain the helicopter began to rapidly rotate to the right. The pilot assessed there was a tail rotor failure and reduced the throttle to decrease the torque and then increased the collective prior to impact to manage the rate of descent. This likely helped prevent a more serious accident and possible injury.

North Australian Helicopters also advised the safe work method statements had been updated for collision with obstacles adding that pilots were to prioritise flying the aircraft over the movement of stock and if an animal was unresponsive to the helicopter, pilots were advised to let the animal go.
