Loss of control and collision with terrain involving Pilatus PC-6, VH-XAA

2.5 km north of Moruya Airport, New South Wales, on 27 September 2025

ATSB Transport Safety Report
Aviation Occurrence Investigation
AO-2025-058
Preliminary – 12 November 2025

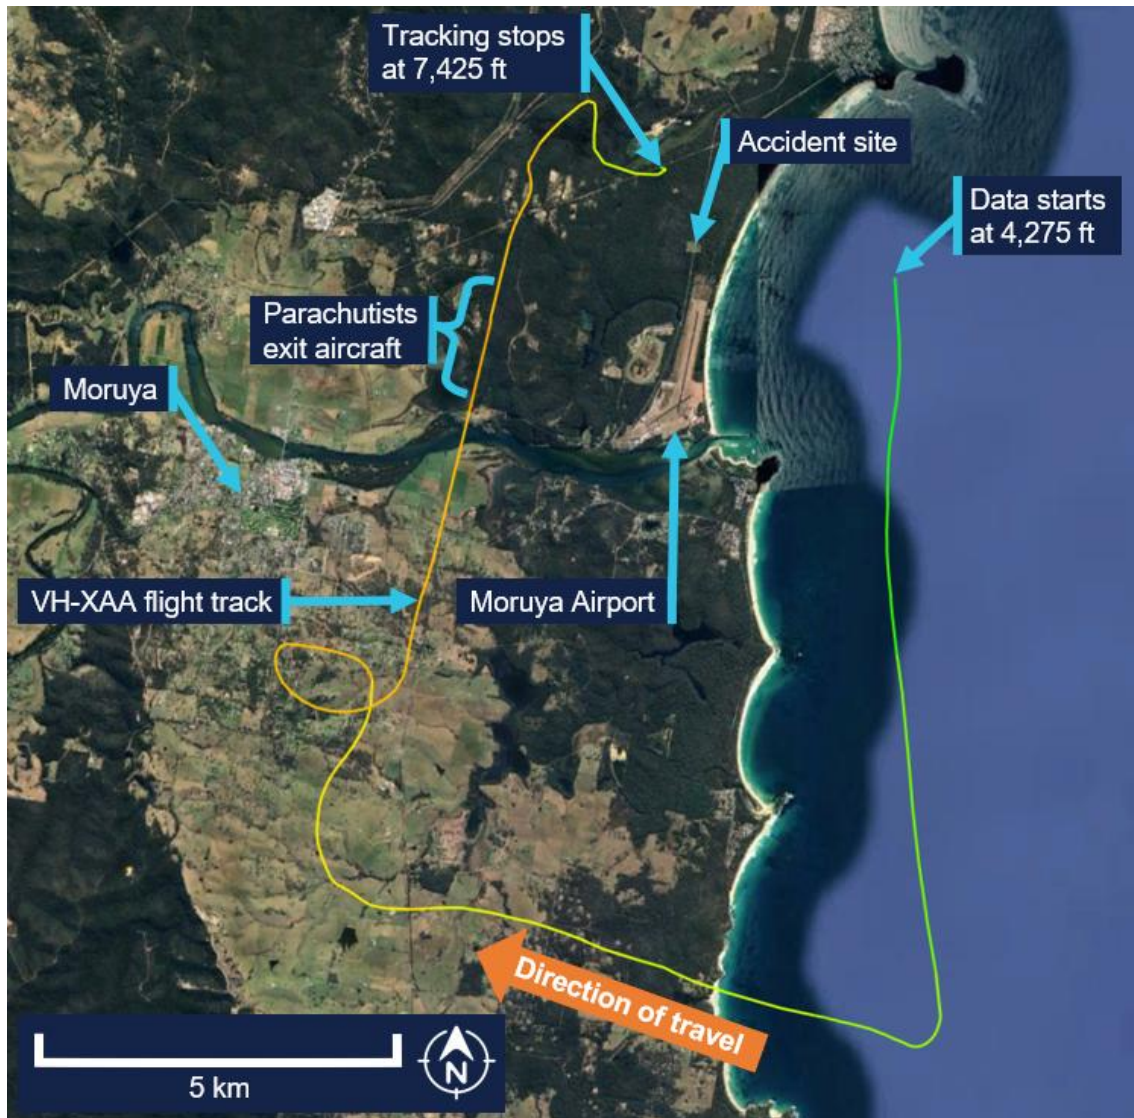
Figure 1: VH-XAA flight track and accident site

Several witnesses on the ground observed the aircraft enter a steep nose-down dive, rotating left before pitching⁵ up and rolling⁶ right. Recorded data showed the aircraft initially descended from FL 140 at about 5,000 fpm, but approaching FL 120, the descent rate increased significantly. The last recorded automatic dependent surveillance-broadcast (ADS-B) data position was at 1407:26 and 7,425 ft, descending at about 15,000 fpm (Figure 1). The aircraft subsequently impacted trees and terrain about 2 km north of Moruya Airport. The pilot sustained fatal injuries, and the aircraft was destroyed.

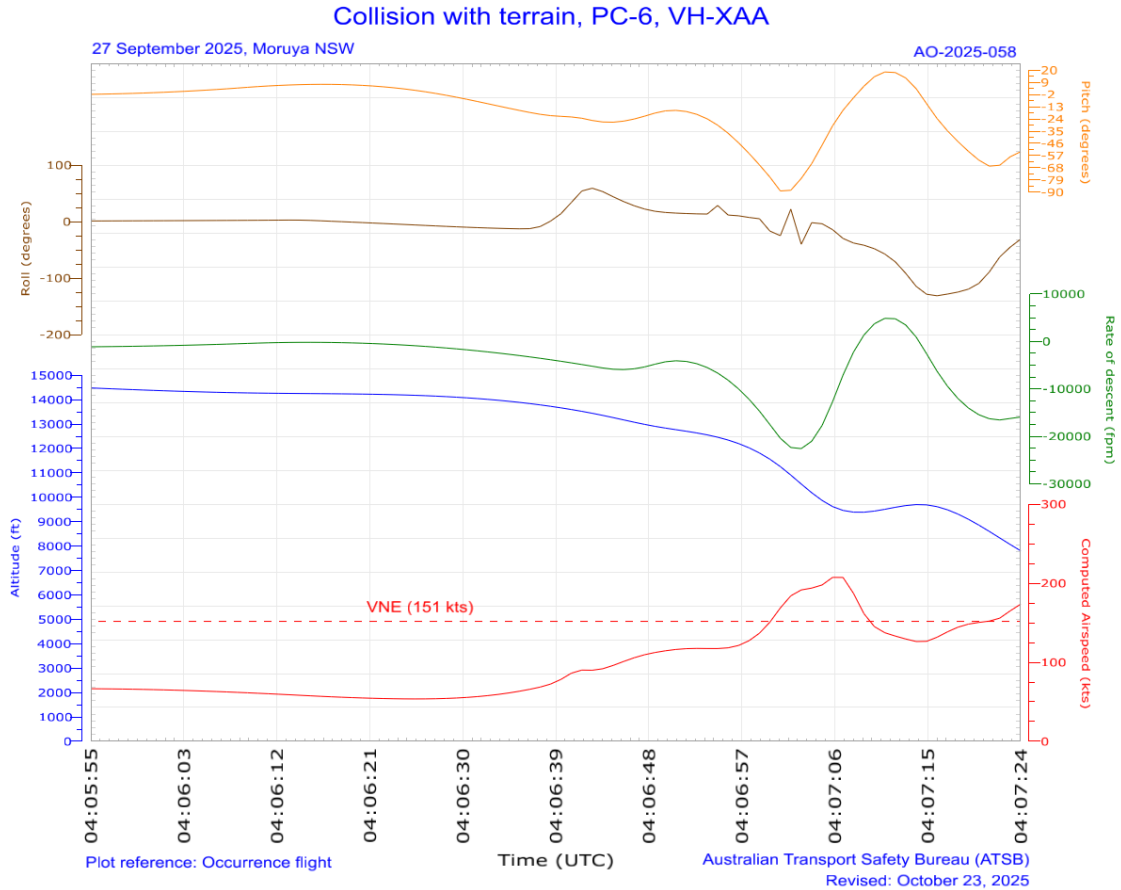
Figure 9: Preliminary plot of key parameters from the accident flight descent

The descent on the accident flight (flight 9) was initiated at about 53 KCAS from 14,200 ft to a nose-down pitch of about 25°, with a 60° right roll. The aircraft briefly reduced pitch slightly before nosing vertically down (about 90°) in a left roll, reaching a maximum descent rate of over 20,000 fpm. The aircraft then pitched up to a shallow climb and into a roll of more than 120°. From the data it could not be confirmed whether this manoeuvre was conducted upright or inverted. Passing about 9,600 ft, the airspeed reduced to

125–130 KCAS before increasing again. The last recorded position, passing about 8,000 ft indicated the aircraft had accelerated to 173 KCAS, with a final descent rate above 15,000 fpm (Figure 9).

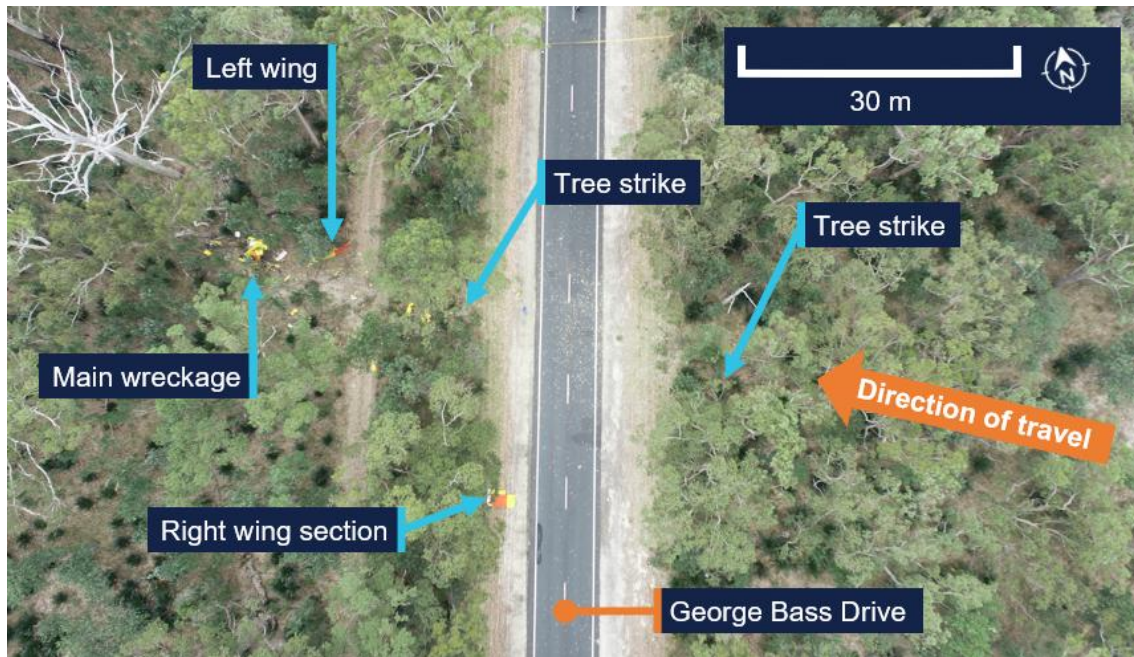
Figure 10: Overview of VH-XAA accident site

The wreckage site was about 2.5 km north (and slightly west) of the northern end of the Moruya Airport runway 36. ATSB examination showed that the right wing struck a tree on the eastern side of George Bass Drive and separated from the fuselage, before the aircraft collided with trees on the western side of the road and subsequently impacted terrain in a nose-down inverted attitude (Figure 10). The outer section of the right wing landed on the road but was moved clear by members of the public shortly after the accident.

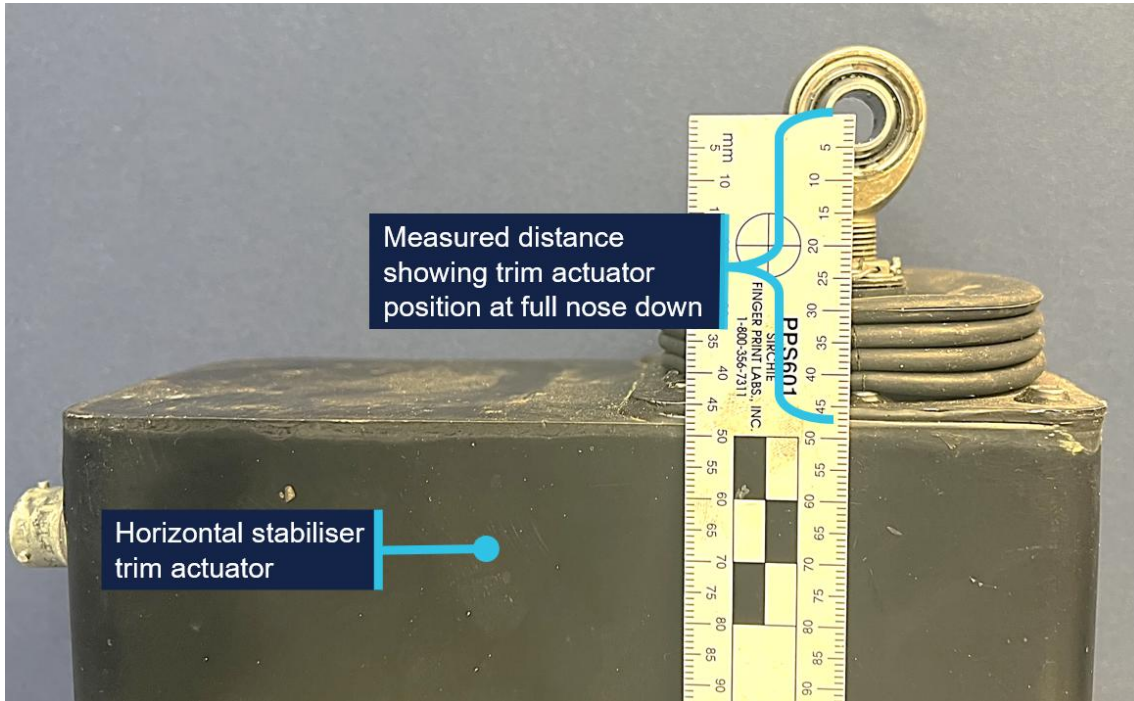
Figure 11: Horizontal stabiliser trim actuator showing trim position

- there was fuel remaining and no post-impact fire occurred
- all major components of the aircraft were at the site, indicating there was no in-flight breakup
- the propeller had indications that the engine was producing power at impact
- there were no indications of any pre-impact mechanical anomalies that would have precluded normal engine operation
- the pilot's 4-point restraint was undone, and the pilot was almost certainly not in the pilot seat at the time of impact
- the horizontal stabiliser trim actuator was found in the full nose-down position (Figure 11).
