Collision with terrain involving Piper PA-32R-300, VH-JVA

Shellharbour Airport, New South Wales, on 11 October 2025

ATSB Transport Safety Report
Aviation Occurrence Investigation
AO-2025-064
Preliminary – 14 November 2025

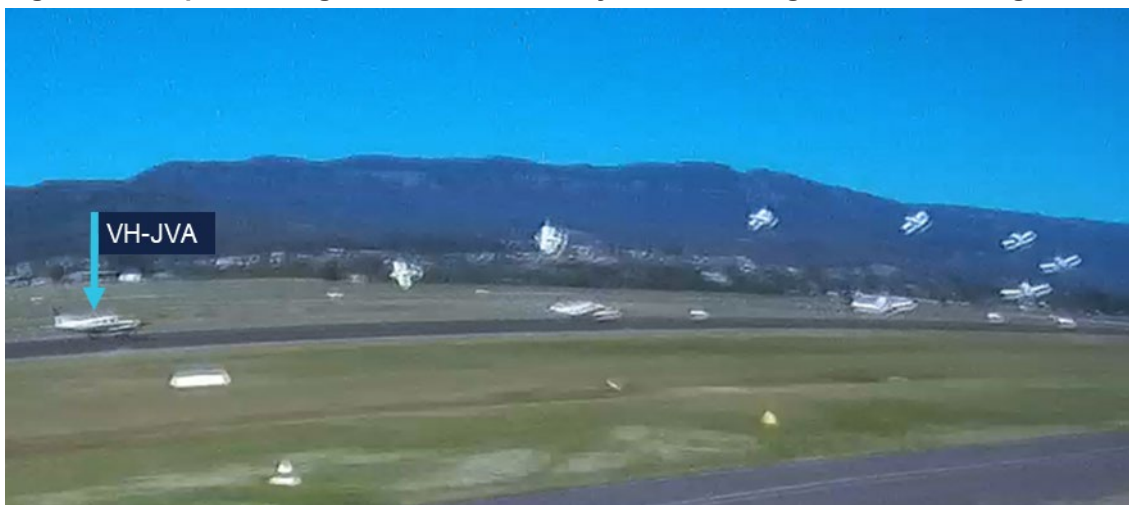
Figure 1: Composite image of recorded security camera footage of the whole flight

About a minute after the Cessna departed, VH-JVA began a take-off from runway 26. Following a ground roll of about 410 m, VH-JVA abruptly pitched up and yawed left as it became airborne. The aircraft then climbed away from the runway in a nose high attitude while skidding³ and rolling left (Figure 1 and Figure 2).

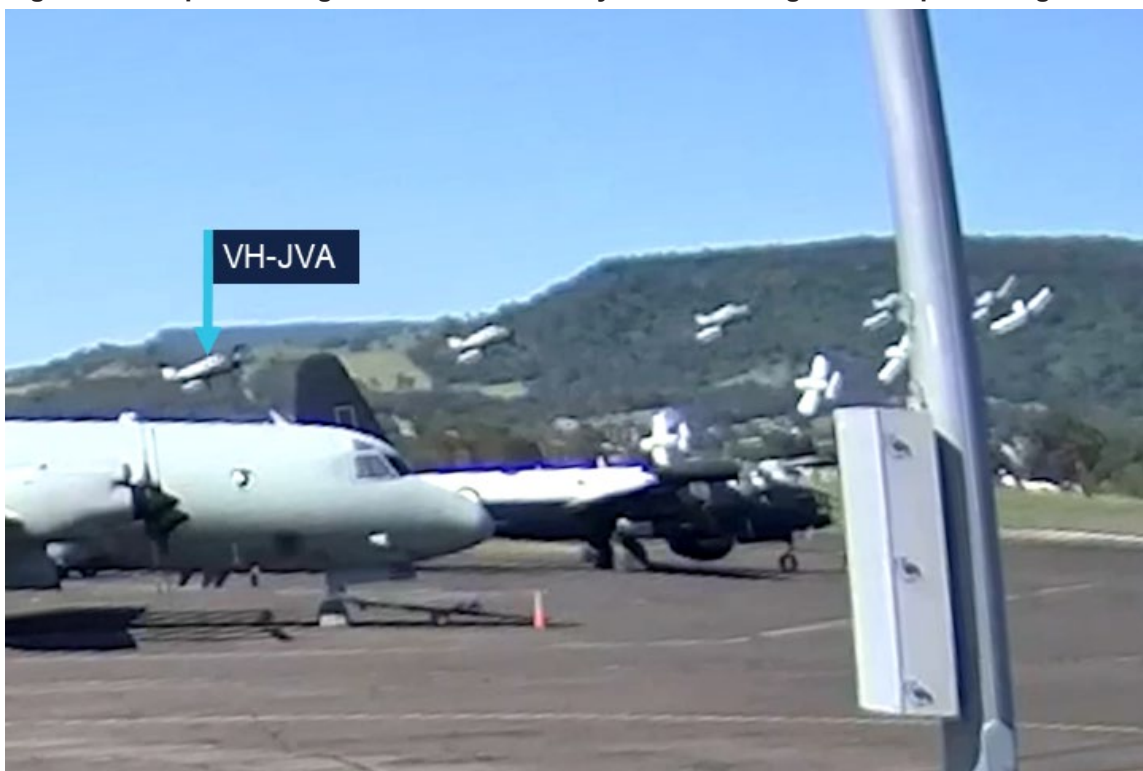
Figure 2: Composite image of recorded security camera footage of later part of flight

The angle of bank then appeared to stabilise briefly as the aircraft followed a left-turning flight path. As it turned to a heading of about 200° magnetic (M), it reached a maximum recorded altitude of about 50 ft above ground level (AGL) and then began descending. Three seconds after reaching 50 ft AGL, the angle of bank and descent rate began increasing rapidly before the aircraft collided with terrain, coming to rest at the threshold of the intersecting runway (runway 34). The pilot and passengers were fatally injured in the accident, and the aircraft was destroyed.

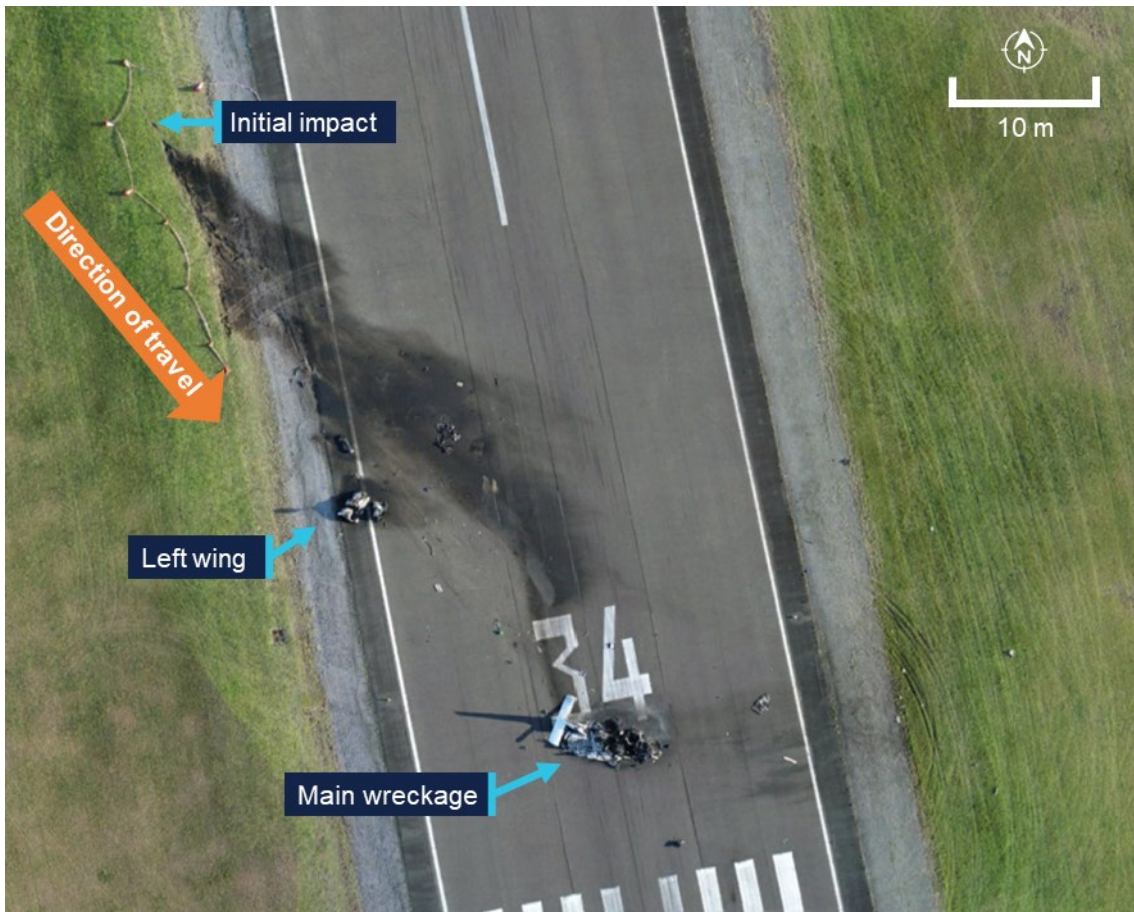
Figure 4: Accident site

The aircraft impacted the ground to the west of runway 34 while travelling in the 138° M direction (Figure 4). The left wing tip impacted the ground first with the aircraft at near 90° angle of bank and a slightly nose down attitude. The propeller and engine then impacted the ground 12 m from the wing tip and ground scars consistent with propeller strikes were indicative of engine rotation. The left wing separated from the aircraft and the main wreckage continued along the ground for a further 47 m before coming to rest on runway 34 near the runway threshold. The integral fuel tanks in both wings ruptured during the accident sequence, leading to a post-impact fire that destroyed most of the fuselage.

The ATSB conducted an initial examination of the wreckage at the accident site before moving the wreckage to an airport hangar for further examination. All major aircraft components were accounted for at the accident site. The damage to the propeller indicated that the engine was driving the propeller at the time of impact. The landing gear was extended and the flaps were extended to the 10-degree setting. The stabilator trim was set to slightly nose up and the rudder trim was neutral. Damage to the pilot's seat rails indicated that it was locked in an appropriate position. The left pin of the passenger's seat was found secured in the rearmost position while the right pin was found not secured into a position. There was no damage to the outboard passenger seat rail stop to indicate that this seat had slid rearward.⁵

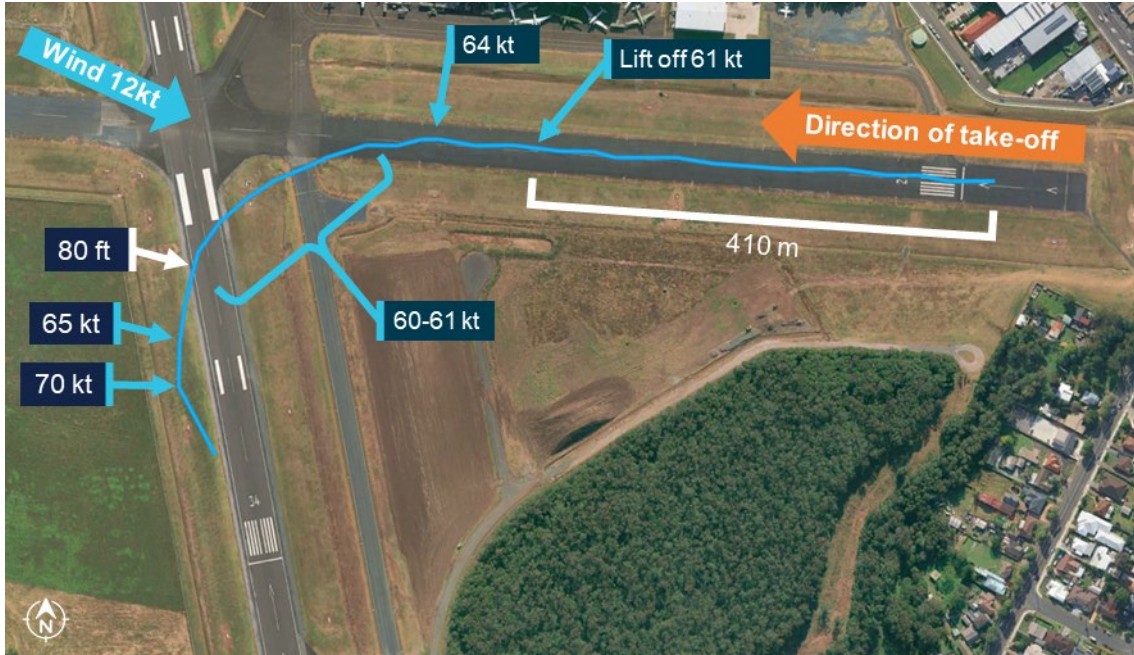
Figure 5: Flight path and recorded data from flight

Recorded automatic dependent surveillance broadcast (ADS-B) data and a number of security cameras captured the flight (Figure 5). A witness also captured 2 photographs of the aircraft while airborne (Figure 6). The data showed that:

- during the take-off ground roll, until the nose wheel lifted from the runway, the take-off appeared normal and the stabilator was in a neutral position
- the recorded groundspeed at the time the aircraft became airborne was 61 kt

- the groundspeed increased to 64 kt as the aircraft commenced turning left and then remained between 60–61 kt as the aircraft turned through 180° M. As the turn continued and with an increasing tailwind component, the groundspeed increased to the recorded maximum of 70 kt immediately before impact
- all doors appeared to be correctly secured.

All speeds are groundspeed, and the altitude is above mean sea level (equating to about 50 ft above ground level).
Source: Google Earth, Bureau of Meteorology, Avdata and publicly available ADSB data, annotated by the ATSB
