# **Collision between container ship *Maersk Shekou* and tall ship *STS Leeuwin II***

Fremantle, Western Australia, on 30 August 2024

**ATSB Transport Safety Report**

MO-2024-001

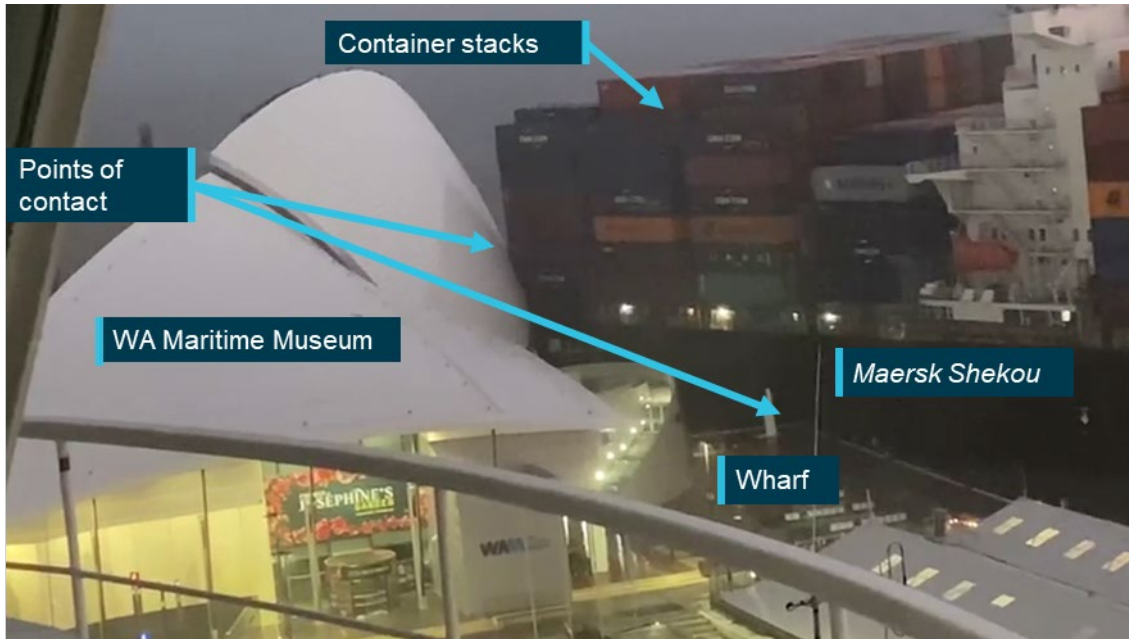
**Figure 5: Footage showing contact of *Maersk Shekou* with the shore**

At 0620:09, the helm was brought to midship. The ship’s rate of turn continued to decrease to nearly zero, but its stern continued to drift towards the wharf. At 0620:23, the pilot ordered the bow thrusters to be put full to starboard, however, the outermost stack of containers on the *Maersk Shekou*’s poop deck collided with the roof of the museum, and the ship’s starboard quarter contacted the wharf (Figure 5).

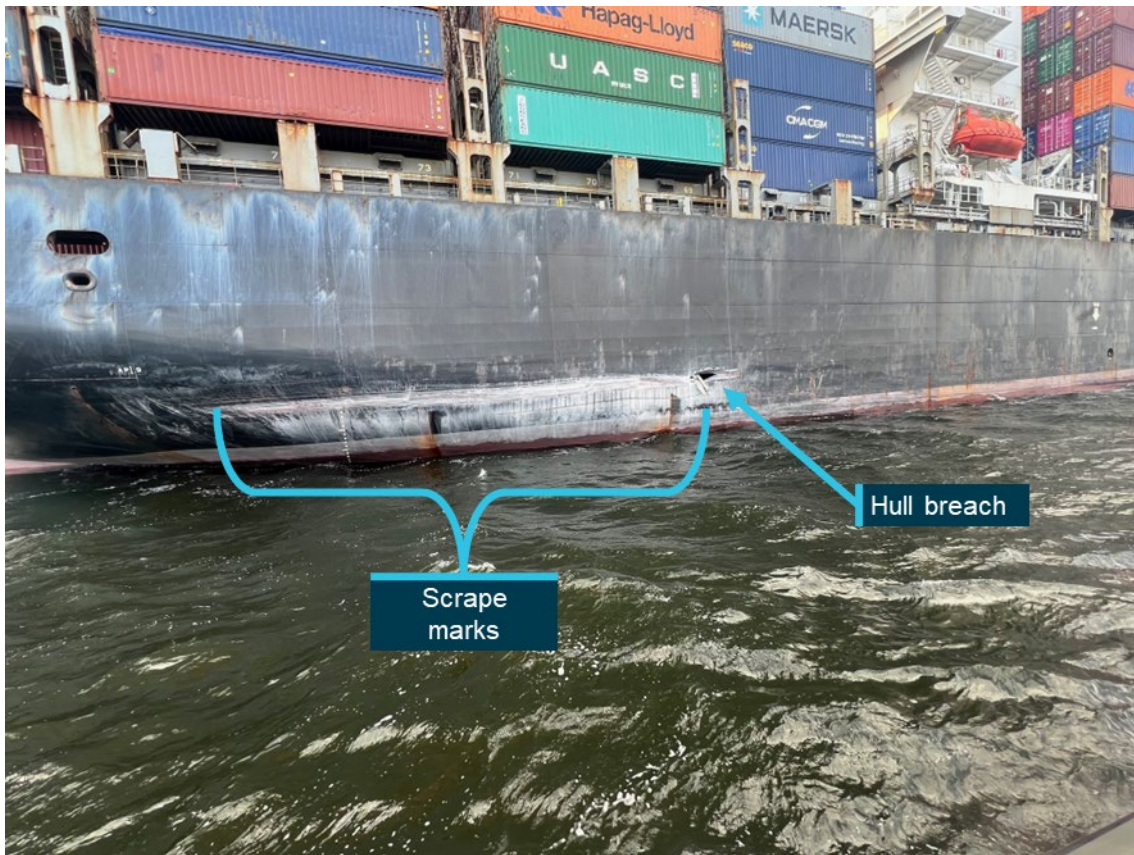
**Figure 6: Contact damage to *Maersk Shekou's* hull**

Thereafter, the ship developed a slight forward motion and starboard swing, resulting in the edge of the wharf scraping against and rupturing the ship’s hull by approximately 1.8 m x 0.5 m. The breach was situated above the waterline, and no ingress or egress resulted. Concrete and timber debris from the wharf lodged within the breached section of the hull as the ship pulled away from the wharf (Figure 6).

The *Maersk Shekou* sustained minor damage. The *STS Leeuwin II* sustained substantial damage and 2 of its crew members sustained minor physical injuries during the accident. At the time of writing, major repair works were underway on the *STS Leeuwin II*.

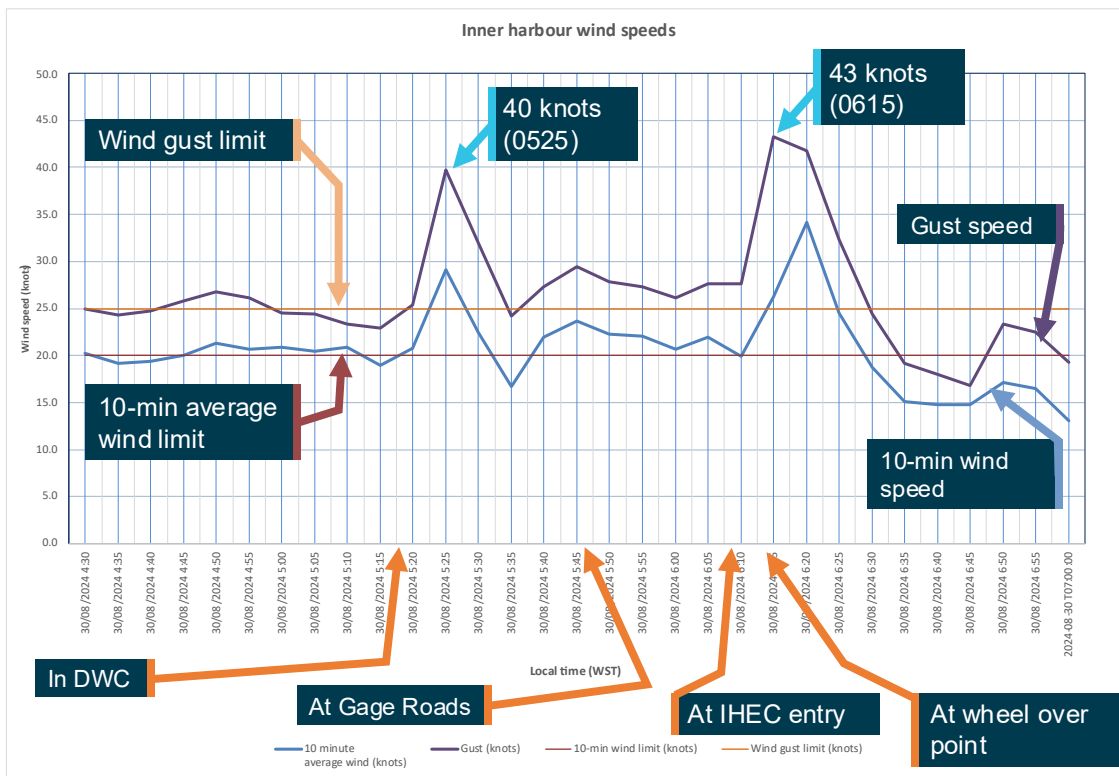
**Figure 11: Actual wind observations from Inner Harbour sensor**

A record of wind observations from 30 August 2024, from the ‘Inner Harbour’ sensor at the Fremantle Ports Building (close to the accident location) is depicted in Figure 11. Annotations along the bottom of the graph denote the representative position of the *Maersk Shekou* on its inbound voyage.
