# **Loss of propulsion of *Gaschem Homer***

Port of Brisbane, Queensland, on 15 March 2025

## **ATSB Transport Safety Report**

MO-2025-003

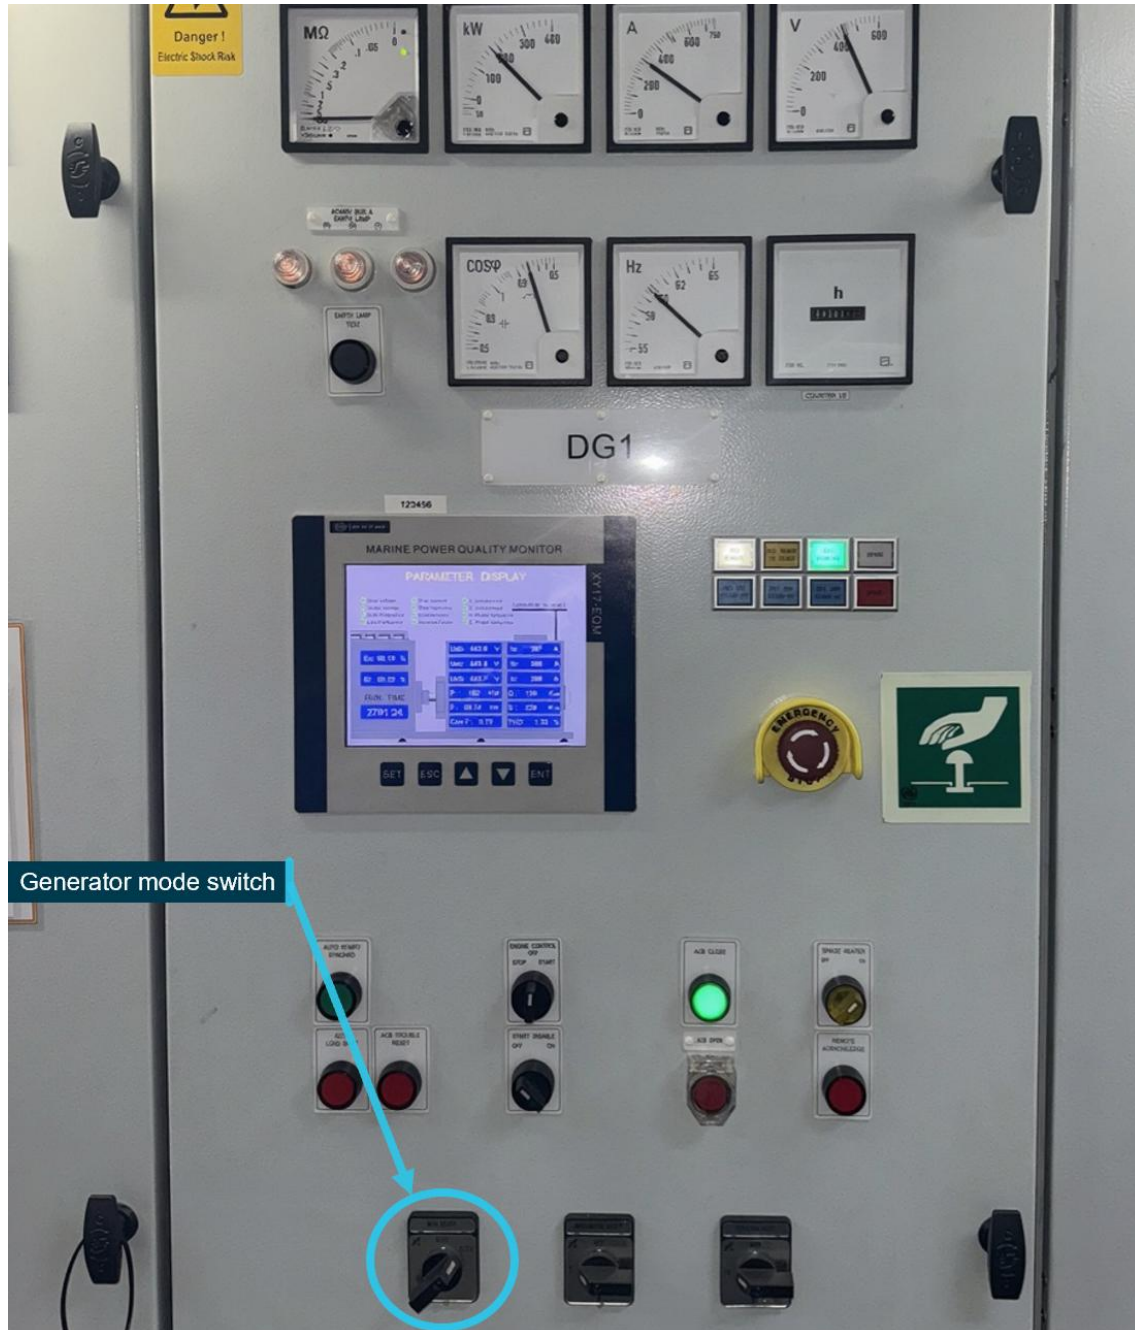
**Figure 2: Control panel for diesel generator 1 (DG1)**

ship's 3 auxiliary diesel generators in parallel. The ship was fitted with an automated power management system (PMS) designed to optimise and automate the generation and distribution of electrical power. The duty engineer set 2 generators to 'automatic' mode using the respective mode selector switches on each generator control panel (Figure 2), enabling the PMS to manage generator synchronisation and load sharing automatically between all three 3 auxiliary generators.

Cargo operations commenced at 1200 with all 3 generators operating and continued until 0424 the following morning. After their completion, the electrical demand was reduced and all generators except diesel generator 3 (DG3) were shut down. The machinery

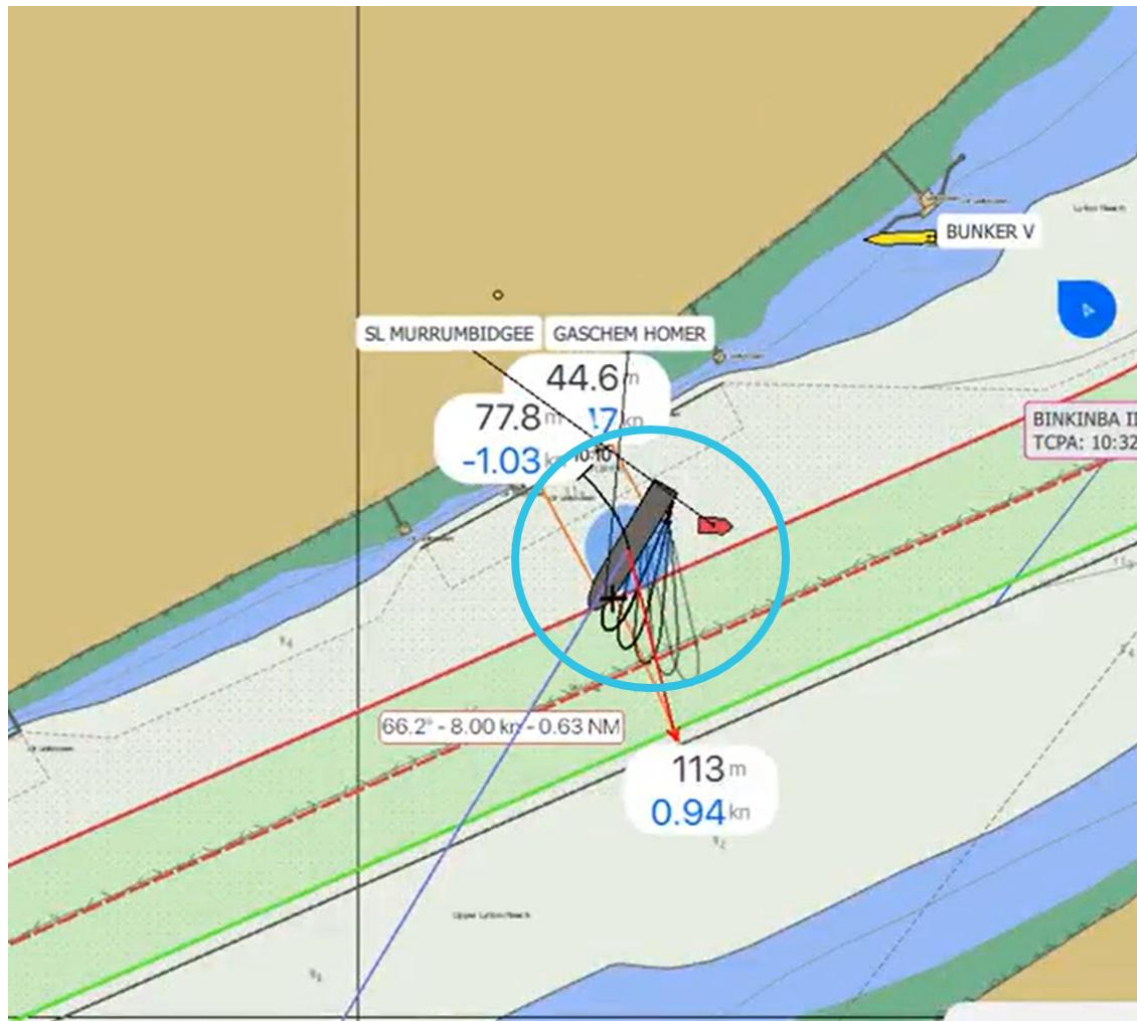
**Figure 3: Ship's position at the time of the power failure**

At 1104, while the ship was about one-third of the way through its swing (Figure 3), DG3 tripped on overload. This was immediately followed by a series of secondary power failure alarms for DG1 and DG2. Within 15 seconds, multiple alarms activated both on the bridge and in the ECR, indicating a blackout resulting in a total loss of electrical power, propulsion and steering.

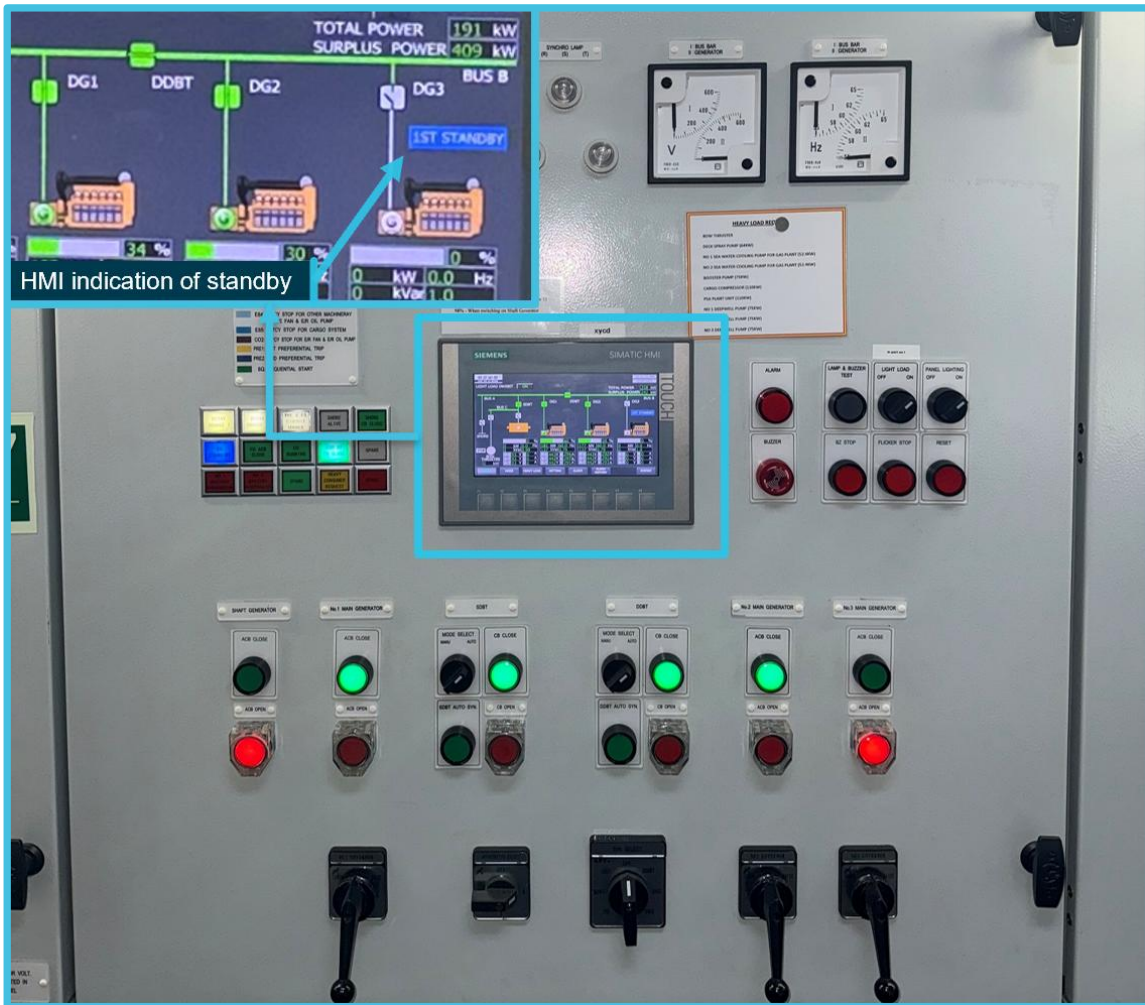
Figure 4: Synchronising panel

A principal component of the system was the synchronising panel (Figure 4), which was critical for ensuring the safe and effective connection of generators to the MSB. The synchronising panel supported both manual and automatic synchronisation, allowing for the alignment of generator voltage, frequency and phase angle with the busbar prior to circuit breaker closure.

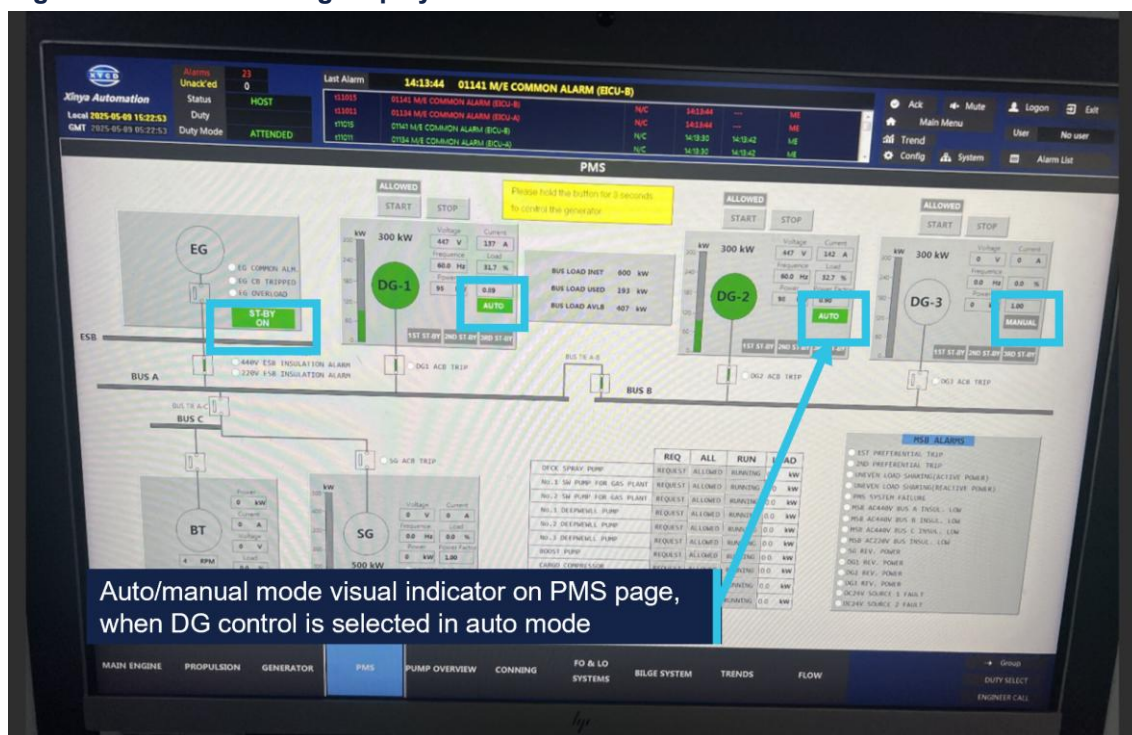
Figure 5: PMS monitoring display

A key feature of this integration was the colour-coded mode indication for each generator. When the generator control status was highlighted in green and read 'AUTO', the generator was in automatic mode with the PMS autonomously managing generator start/stop, synchronisation, load sharing, and fault recovery. When the status was grey

and read 'MANUAL', the generator was in manual mode, requiring direct operator control. This visual differentiation enabled the crew to easily determine the operational mode of each generator and respond appropriately during normal or fault conditions. Because the HMI provided monitoring capability for multiple onboard systems, operators were required to manually select the PMS display to view generator status.

The status of each generator's operating mode could be readily observed by the engine room team via the generator control panels or the PMS interface on the ship's machinery and alarm monitoring system. However, the team was mainly focused on monitoring the seawater cooling systems due to concerns about potential blockage by debris. In the absence of automated alarms or system warnings for incorrect generator mode selection, their incorrect configuration went undetected.
