Midair collision involving Robinson R22 Beta II, VH-HQH, and Robinson R22 Beta II, VH-HYQ

51 km south-south-east of Curtin Airport, Western Australia, on 25 July 2024

ATSB Transport Safety Report

AO-2024-044

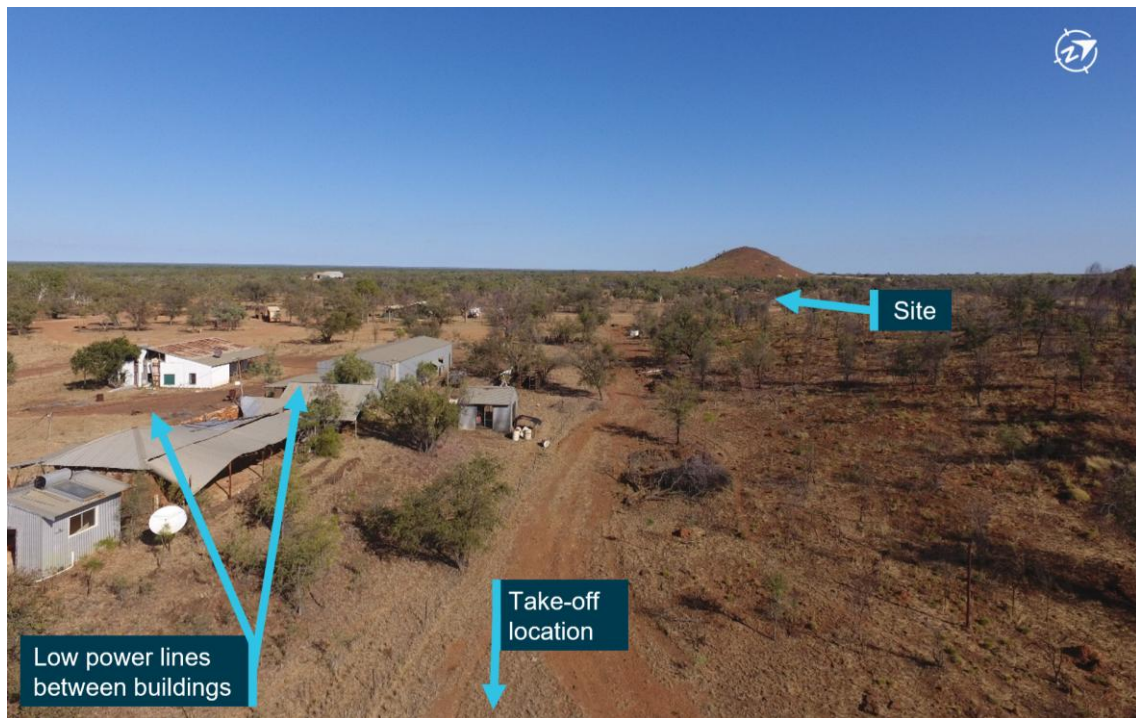
Figure 8: View from departure point towards the accident site

The accident site was located about 400 m west-north-west of the Mount Anderson homestead at an elevation of about 42 m above mean sea level (AMSL). The small hill beyond the site had an elevation of about 80 m. Power to the property was produced via generator. There were some low powerlines immediately above the buildings, but the powerlines did not extend along or across the flight path (Figure 8).

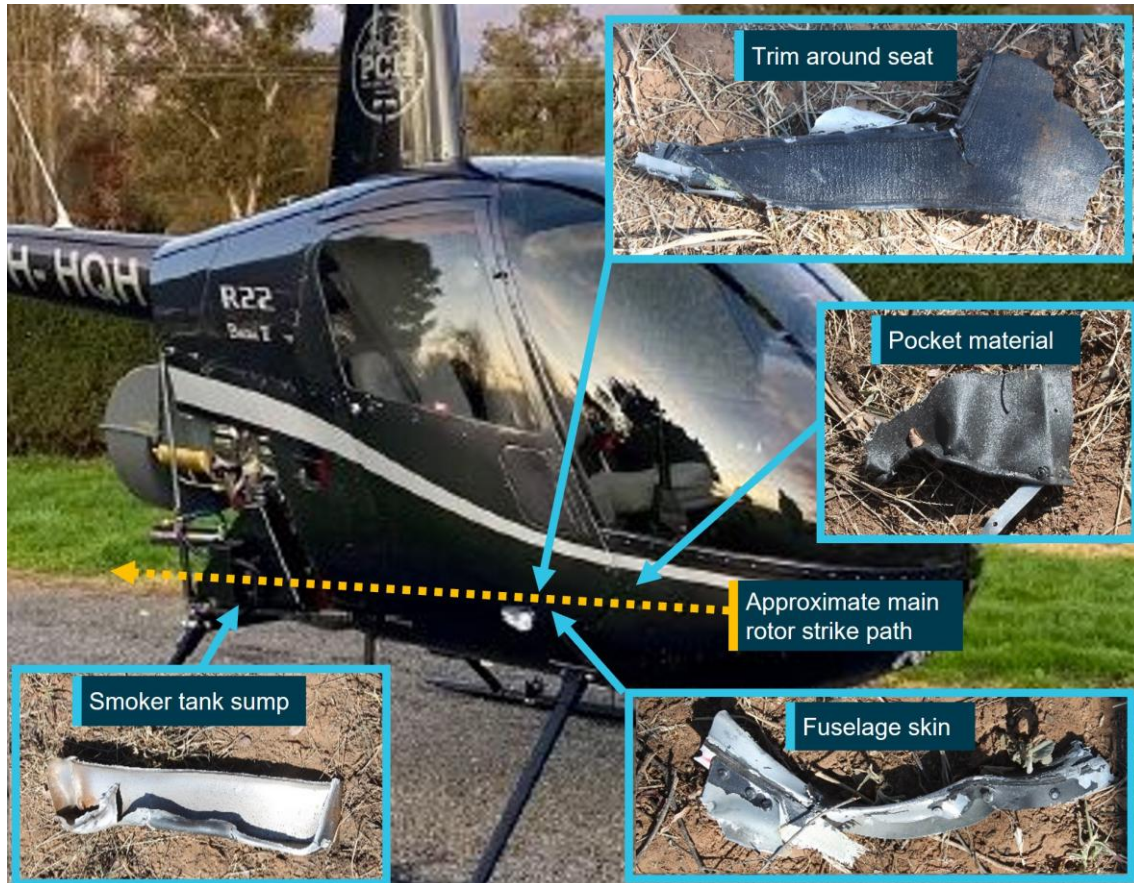
Figure 9: VH-HQH (pre-accident) showing approximate location of rotor strike and first items in debris field

- fuselage skin from just forward of right position light
- right seat 'pocket' material section (located on forward panel of the pilot seat structure)
- trim from around the forward and right edges of pilot seat.

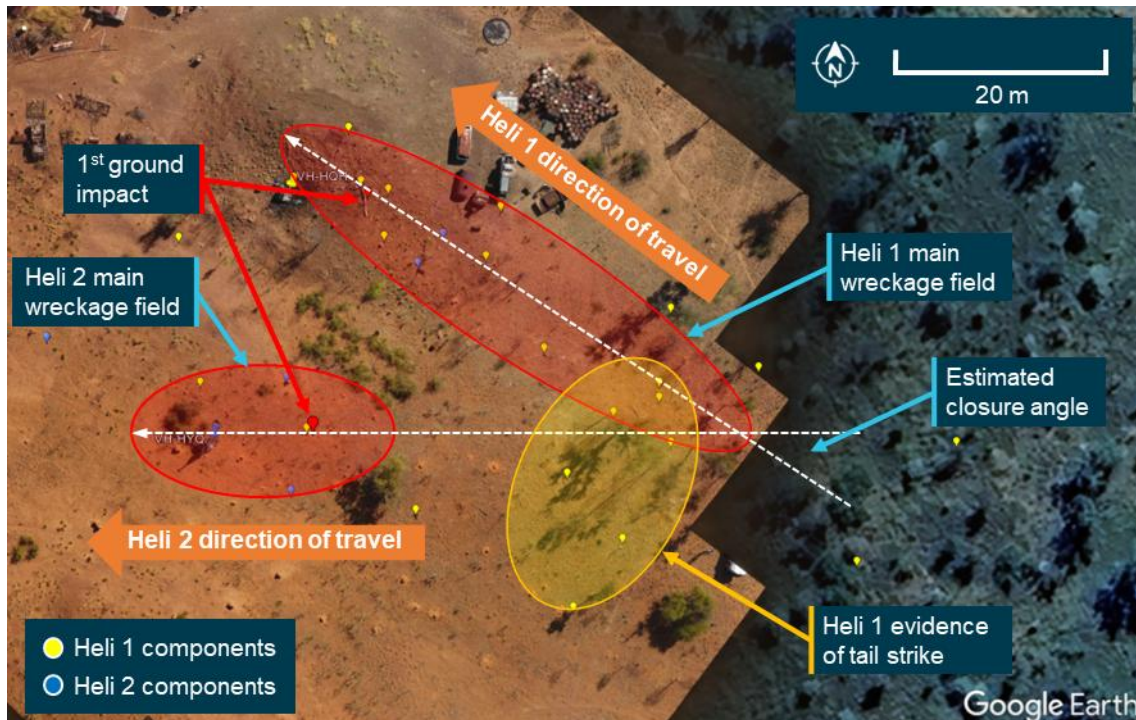
Figure 10: Debris field showing main areas of wreckage for each helicopter

The main debris trail was arranged in 2 key areas (Figure 10), in a north-westerly direction ending with the wreckage of Heli 1, and in a west-north-westerly direction, ending with the wreckage of Heli 2. The heaviest items of wreckage were found to have followed these general directions.

Keperť's research must be considered in the context of a helicopter midair collision. While helicopters and their components can be subject to changes of trajectory when damage occurs while airborne, when considering heavier items of wreckage, the research provides a likely scenario for establishing flight path information. The flight path estimates for the accident are depicted as white dotted lines in Figure 10.

Following the midair collision, witnesses observed the helicopters descend on different trajectories. The main debris trail was arranged in 2 key areas. Each consisted of the heaviest components for each helicopter (except the main rotor of Heli 2 which detached at the point of collision or immediately thereafter). Based on the wreckage trajectories from the estimated point of collision, the helicopters were likely maintaining different tracks at the point of collision.

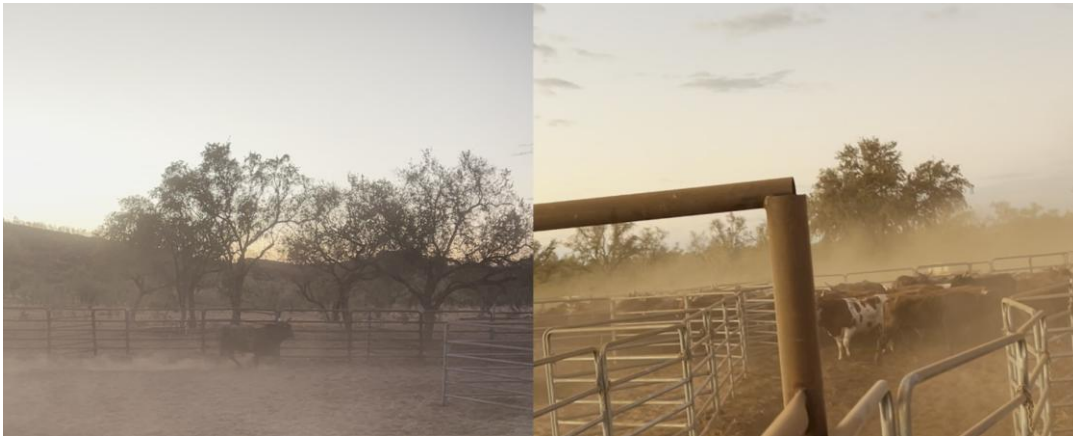
Figure 13: Witness video showing ambient lighting conditions

see, however when looking east, objects were silhouetted against the light background and depth perception was diminished (Figure 13).

The image on the left is the view looking to the east in the direction of the rising sun. The image on the right is facing towards the south and shows the increased detail visible when not looking directly towards the east.
 Source: Witness video provided by Western Australia Police Force

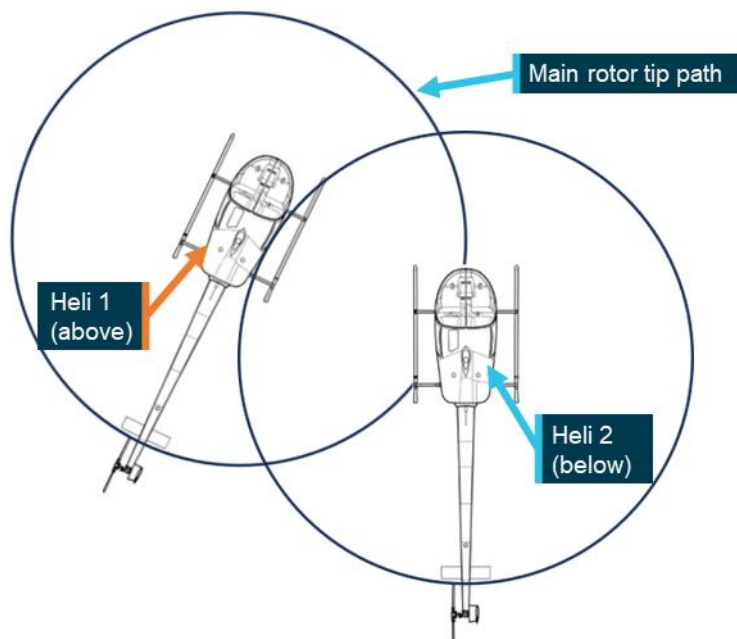
Figure 14: Approximate relative positions of Heli 1 and Heli 2 at the point of collision

Based on the wreckage examination and the location of the Heli 2 main rotor strike to Heli 1, the approximate relative lateral position of each helicopter was calculated (Figure 14).

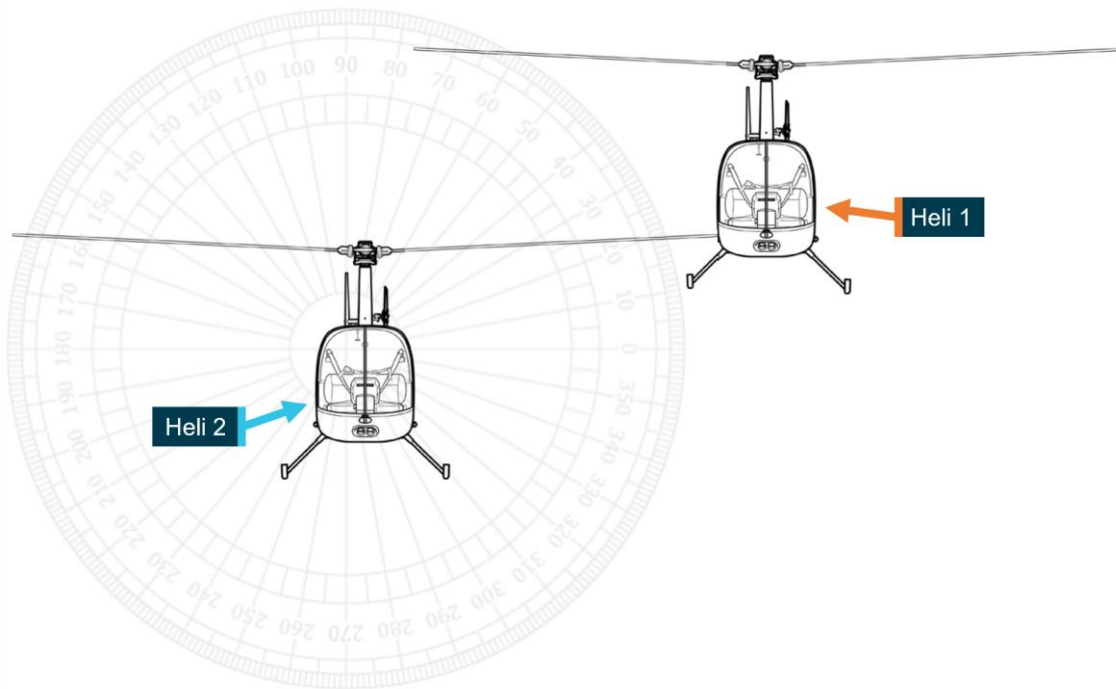
Figure 15: Approximate vertical orientation of Heli 1 and Heli 2 at the point of collision

Similarly, based on the main rotor strike location on Heli 1, the vertical orientation of the aircraft was estimated in Figure 15.

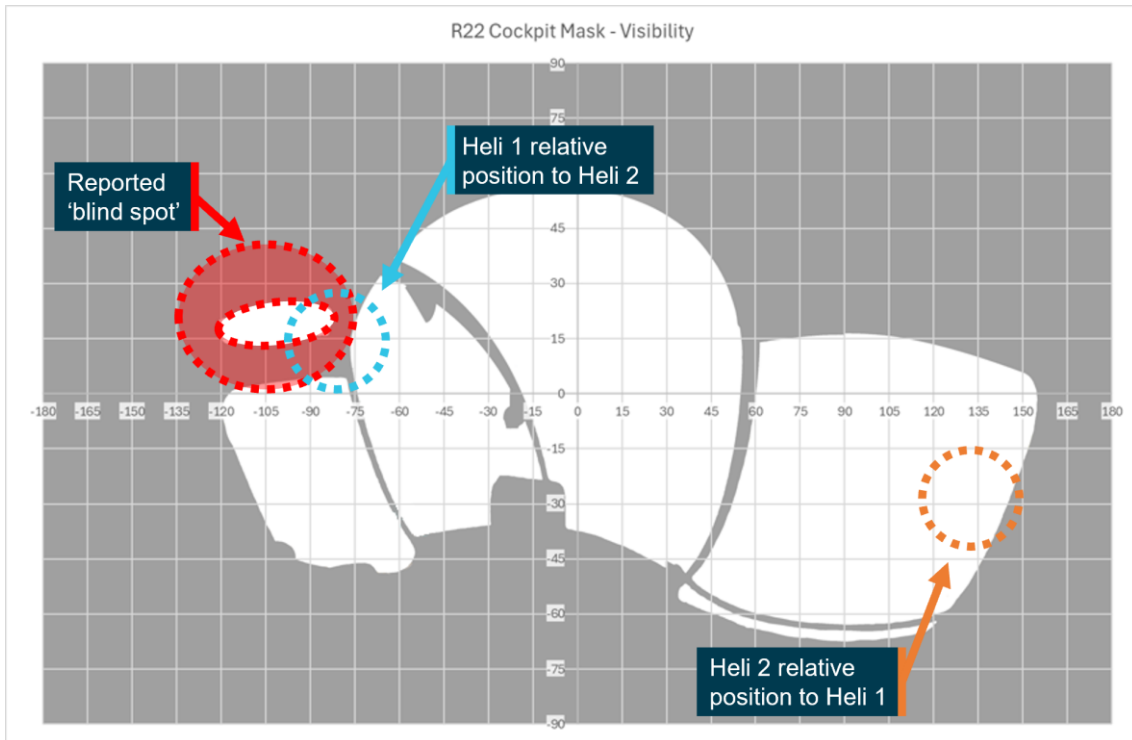
Figure 17: R22 generic cockpit mask

The image was overlaid with a grid to indicate the viewer's eye position as azimuth and elevation angles from the centre of the view. As the eyes were moved upwards and to the left, so too would these boxes (Figure 17). The cockpit mask shows that although

visibility is generally very good out the front of the cockpit, obstructions to line of sight exist above and to the left of the helicopter.

The blue and orange circles represent the approximate location of the other helicopter at the time of collision.
Source: ATSB
