Midair collision involving Jabiru UL 450, 19-4079, and Cessna 182, VH-APN

2.7 km west of The Oaks, New South Wales, on 26 October 2024

ATSB Transport Safety Report
Aviation Occurrence Investigation
AO-2024-054
Interim – 4 December 2025

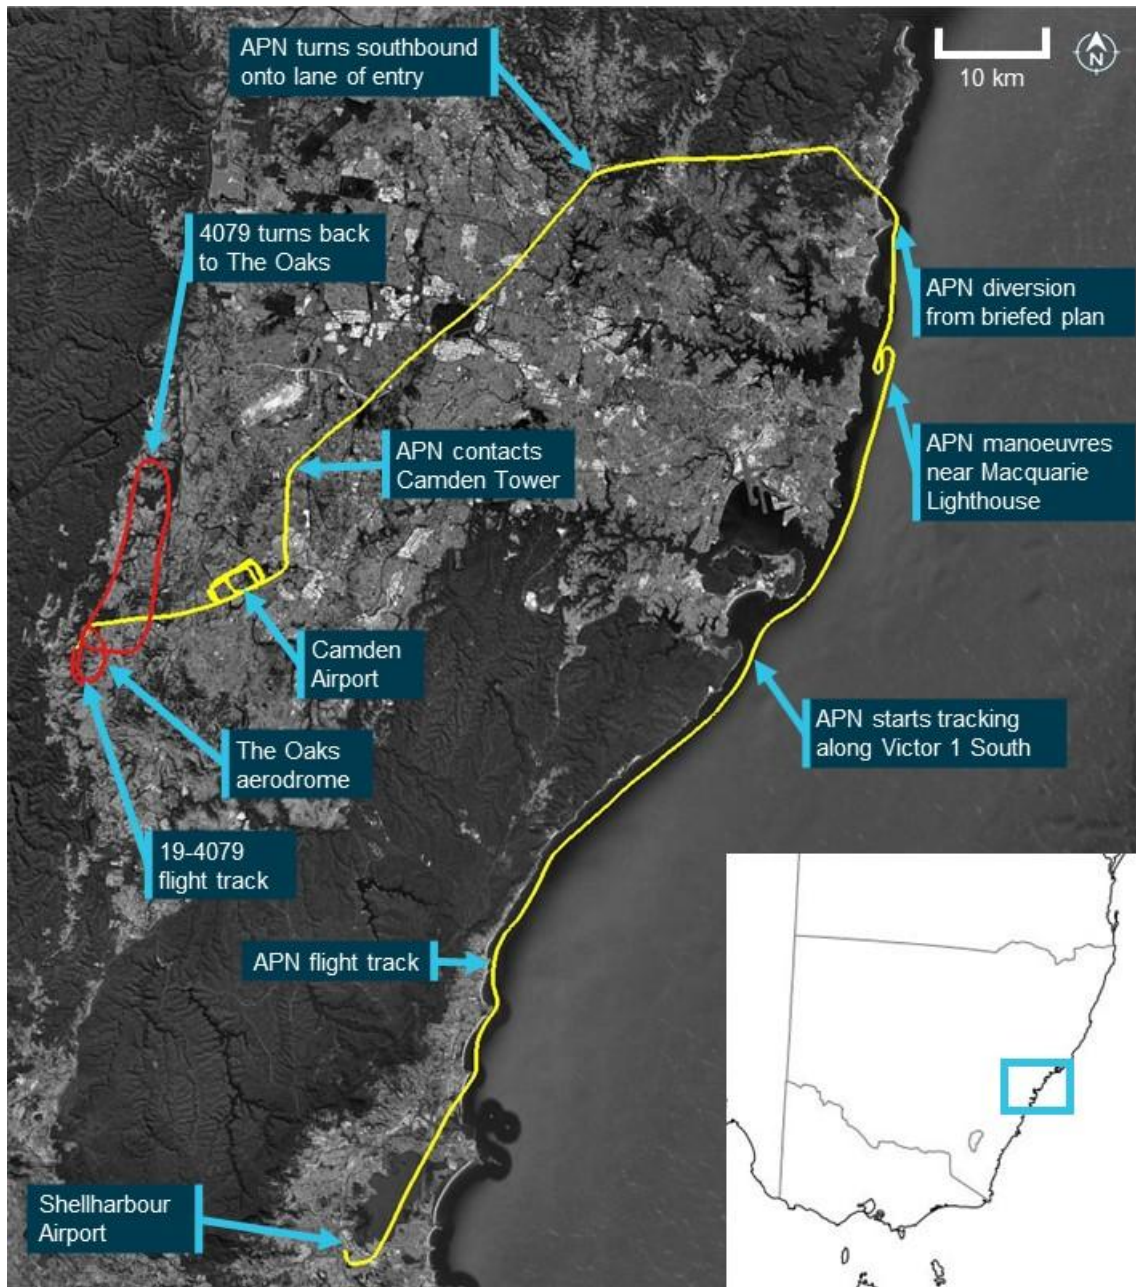
Figure 1: Flight paths of VH-APN, 19-4079 and accident location

Flight data transmitted by the CPL candidate’s electronic flight bag (EFB)³ device (APN flight data) indicated that at 1035, APN departed Shellharbour Airport, climbing to 1,500 ft above mean sea level.⁴ At 1036, a radio call recorded on the CTAF stated that APN was departing crosswind and tracking north-east toward the sea cliff bridge, with the flight proceeding in this direction (Figure 1).

APN continued tracking in a south-westerly direction toward Bringelly township, an inbound reporting point for Camden Airport (Figure 1). At 1124, APN contacted Camden Tower air traffic control (ATC), requesting clearance for a touch-and-go and to conduct some circuits. ATC gave instructions to maintain 1,800 ft, join final for runway 24 and report when APN was 3 NM (5.6 km) from the runway threshold, with the aircraft starting to track toward this position. At 1128, APN reported being 2 NM (3.7 km) from runway 24, with Camden Tower ATC clearing APN for a visual approach. Shortly after, APN called ATC again requesting to remain at 1,800 ft for a practice glide approach to runway 24, which was approved.

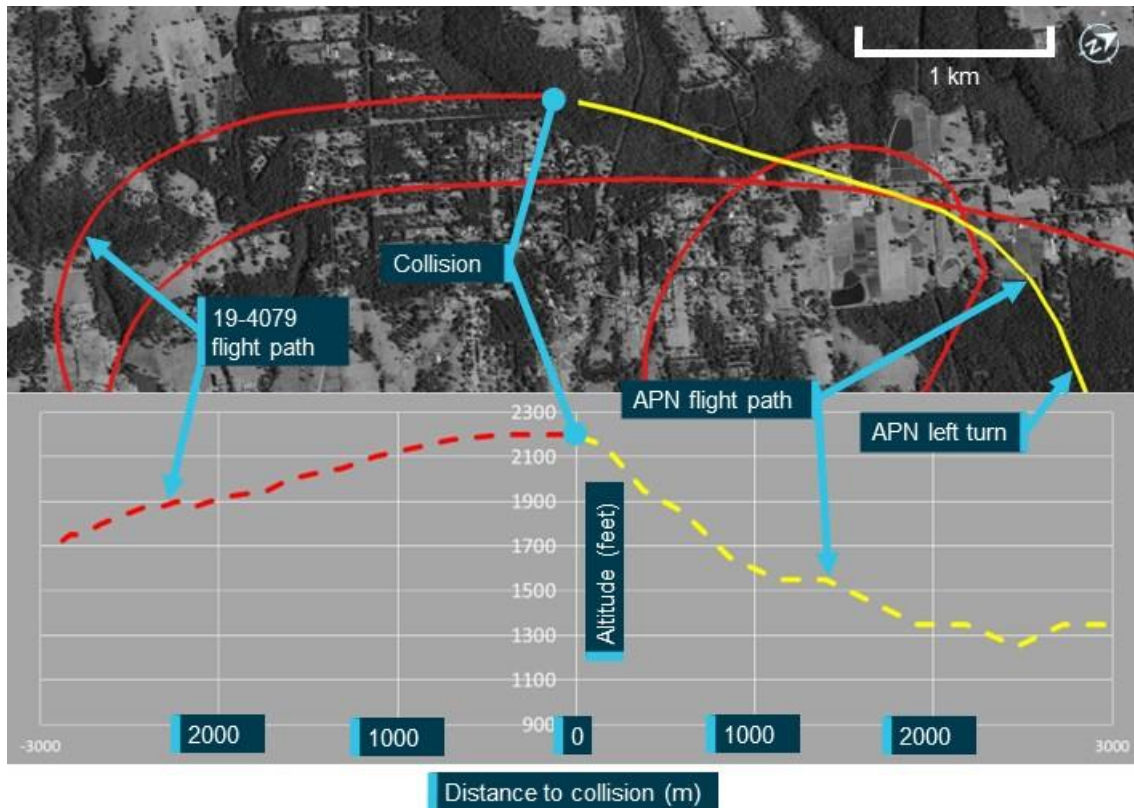
Figure 2: Flight paths and vertical profiles of VH-APN and 19-4079 prior to the accident

At 1144:47, the tracking data for the other Jabiru showed this aircraft had turned right base, with a spacing of about 1.1 NM (2.0 km) north of the runway 18R threshold. Neither the Sonex or other Jabiru pilot reported hearing any radio transmissions from APN that morning. At 1145:16, the 4079 flight data showed this aircraft in a right climbing turn at about 1,700 ft, and mid-way through an ovalised crosswind leg of the circuit for runway 18L or 18R. Around this time, tracking data for APN indicated that this aircraft was about 1.1 NM (2.0 km) from the runway 18R threshold, continuing to track at 263° at 1,250 ft. At 1145:34, as 4079 continued the right climbing turn, APN tracking data showed that a level left turn was conducted onto a heading of 209°. Shortly after this turn was completed, at 1145:54, APN started a straight, steady climb from 1,350 ft (Figure 2).

At 1146:00, 4079 completed the right turn onto a northerly heading. At 1146:26, the onboard video and tracking data showed 4079 leveling out at 2,200 ft, about 1.5 NM (2.8 km) from runway 18R. After this time, APN and 4079 were on relatively constant flight path trajectories for about 8 seconds, with APN captured by the onboard video of 4079 in the lower right quadrant of the windscreen.

The onboard video and tracking data showed that the aircraft collided at 1146:34 on near reciprocal headings. Following the midair collision, the left wings of both aircraft separated, with closed-circuit television footage from a nearby residence showing both aircraft descending steeply. Both aircraft were destroyed in the subsequent collisions with terrain. All 3 pilots were fatally injured.

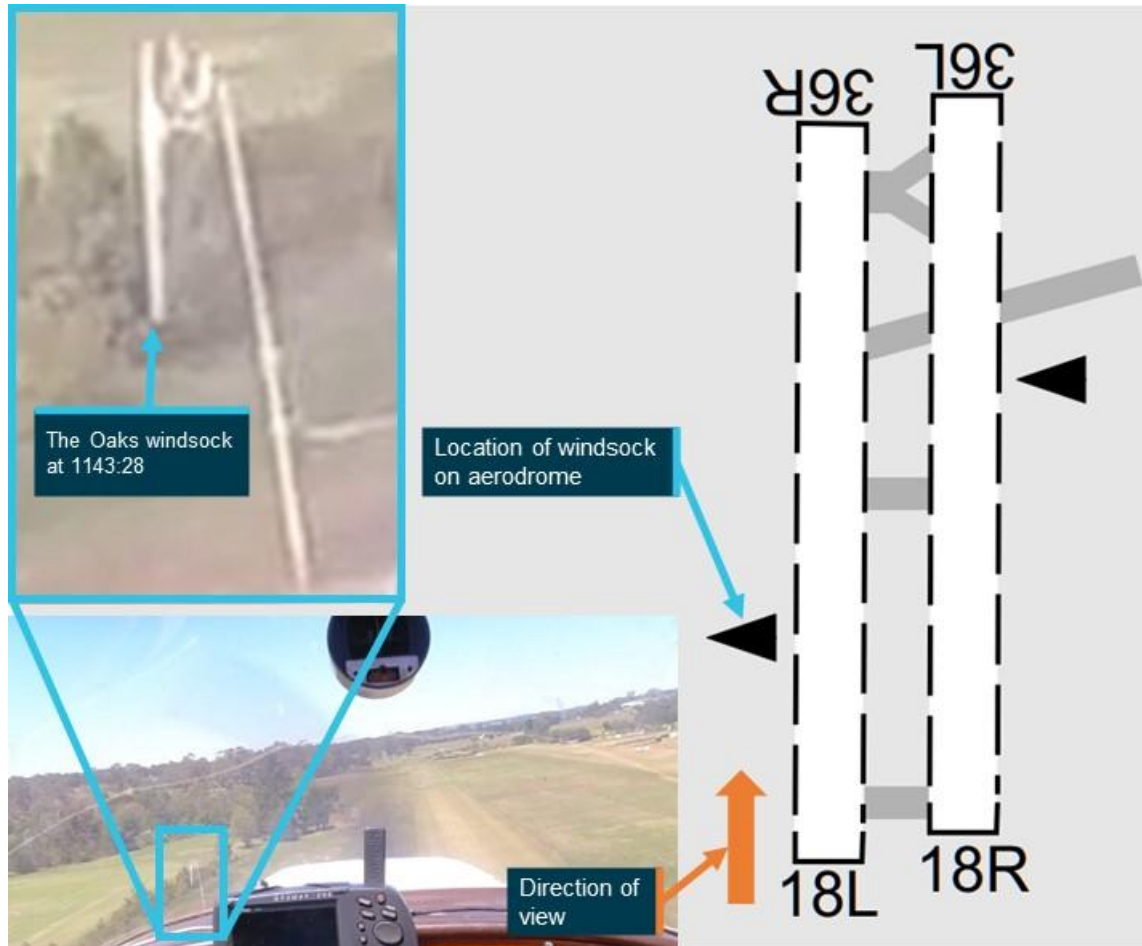
Figure 5: The Oaks windsock at 1143:28

The onboard video from 4079 also showed that, during the go-around on runway 18R at about 1143, the northern airport windsock was facing east indicating that there was minimal wind (Figure 5).

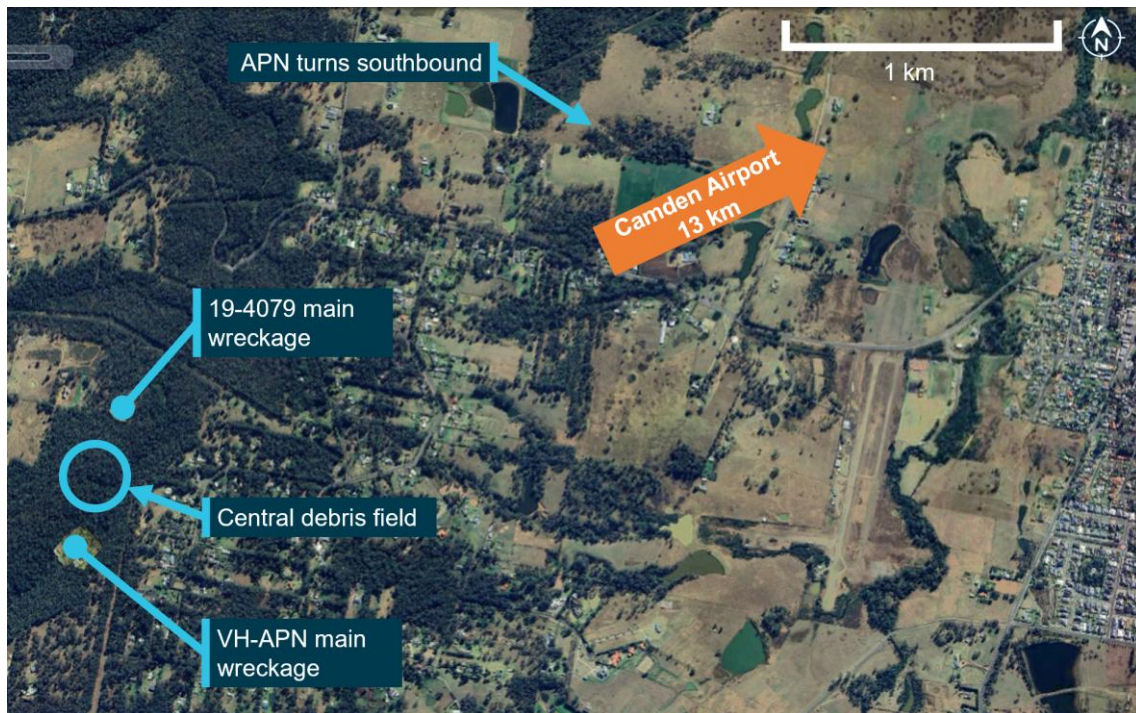
Figure 7: Accident site location in relation to The Oaks

The accident site was located about 2.7 km west of The Oaks aerodrome in heavily treed terrain. The 2 primary wreckage locations were approximately 520 m apart, with 4079 north of APN (018° true) (Figure 7). A debris field was located about halfway between the 2 main wreckage locations. Most wreckage items found in the central area were from the left wing of 4079, with a small number of components from APN. Most of the central wreckage was found within a radius of about 50 m.

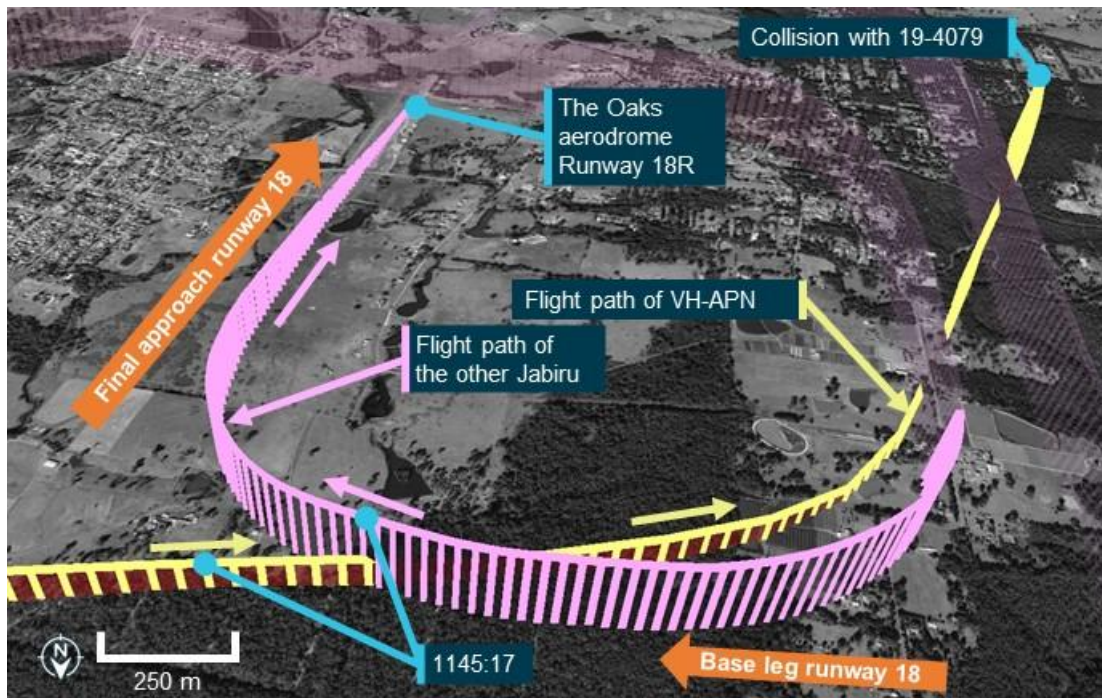
Figure 9: Flight tracks of VH-APN and the other Jabiru (55-1837)

The pilot of the other Jabiru stated they did not see APN nor were they aware APN was in the area until after the collision with 4079.

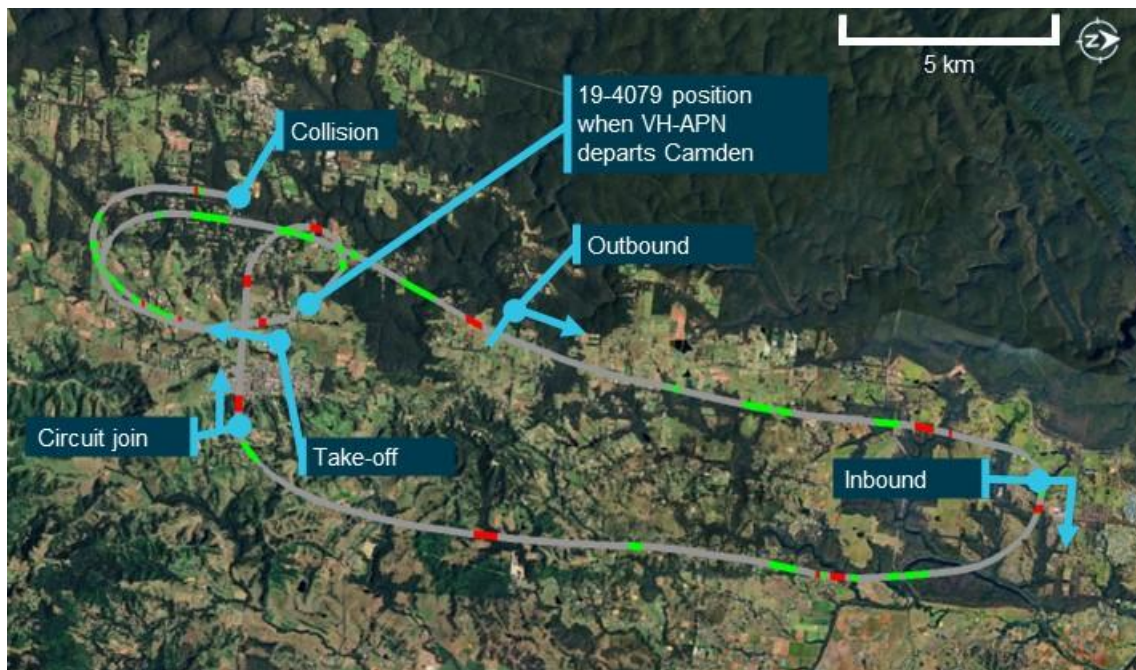
Figure 10: Flight track showing the position of 19-4079 when no transmission was detected (grey lines), and when radio calls were transmitted (red lines) and received (green lines) by 19-4079 during the accident flight

The flight track of 4079 was synchronised with the radio transmission data from the onboard video, and this is shown in (Figure 10). The red coloured parts of the track show the position of 4079 when the pilot was transmitting and the green shows the locations of 4079 when receiving radio calls. The grey parts of the track show the locations when no radio transmissions were made or received by 4079. For context, Figure 10 also contains labels for key parts of the flight for 4079 that are cross-referenced in figures for orientation and discussed in the text below.
