Passenger loading event involving Boeing 737-838, VH-XZK

Canberra Airport, Australian Capital Territory, on 1 December 2024

ATSB Transport Safety Report

AO-2024-064

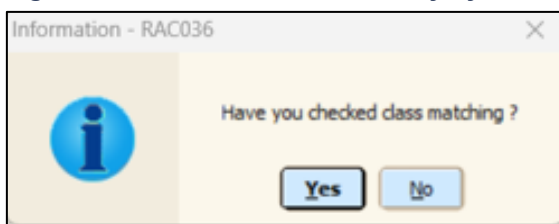
Figure 2: Amadeus Altea Inventory system class change dialogue box

Prior to committing the flight, the system would have presented the CJL with a dialogue box, caused by the Boeing 717 not having business seating, that required them to check and acknowledge the change (Figure 2). While the CJL recalled that the inventory system would present a number of automated pop-ups that needed to be accepted, they did not specifically recount sighting or accepting the class matching dialogue box.

The CJL committed the flight in the Altéa Inventory system prior to identifying the error. When doing so, the CJL would have been presented with a pop-up that highlighted the business class seating issues. However, they did not specifically recount sighting or acknowledging the pop-up. This was probably due to 'expectation bias' which involves an individual observing what they expected to occur, rather than what actually occurred (Flight Safety Foundation 2014). It is therefore likely that the CJL acknowledged the pop-up, without considering the contents of the message, due to their expectation that the flight information was correct.
