Loss of control and collision with water involving Cessna 208 Caravan amphibian, VH-WTY

Rottneest Island, Western Australia, on 7 January 2025

ATSB Transport Safety Report
Aviation Occurrence Investigation
AO-2025-001
Interim – 19 December 2025

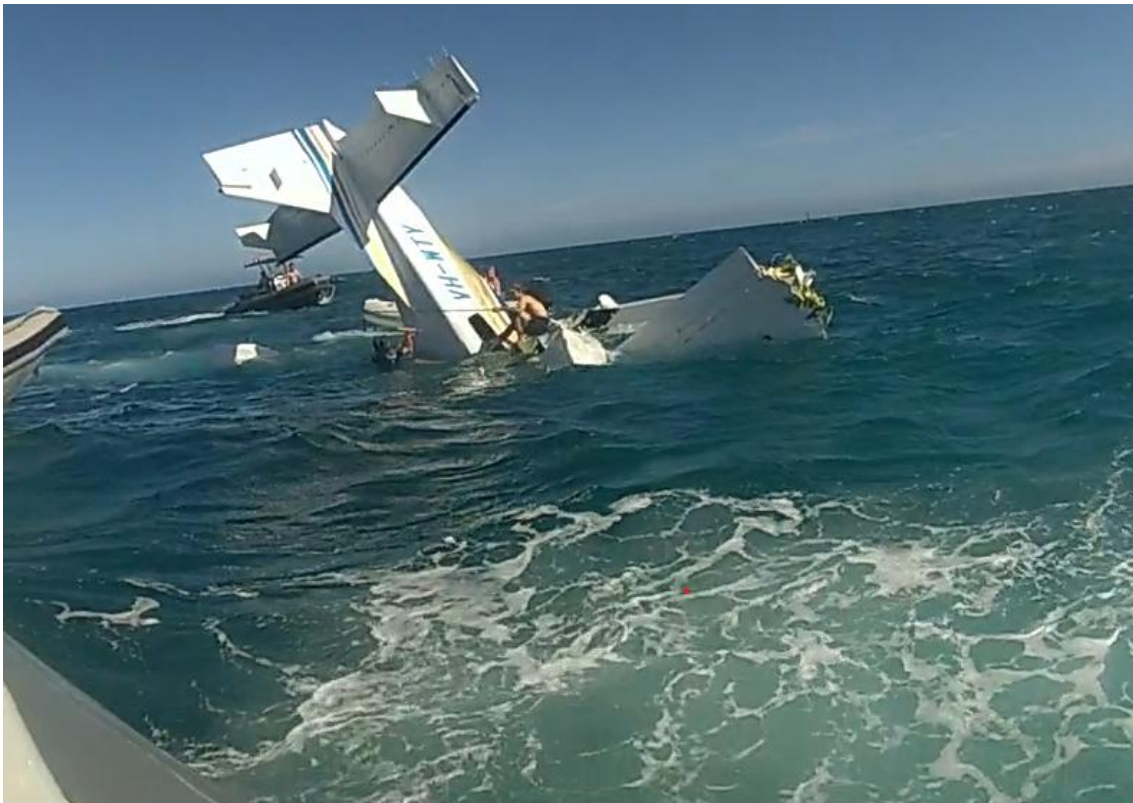
Figure 4: VH-WTY inverted in the water shortly after the collision

Police officers stationed at Rottnest Island responded to the accident, arriving at the aircraft at about 1610. Police body-worn camera footage showed the aircraft was partially submerged in a vertical orientation, with the rear left window above the water surface (Figure 4). Under conditions of uncertainty and potential danger, police and members of the public entered the water and attempted to rescue the occupants. Despite these efforts, none of the remaining occupants were able to be freed from the aircraft. Police who entered the water were not able to open the forward aircraft doors.

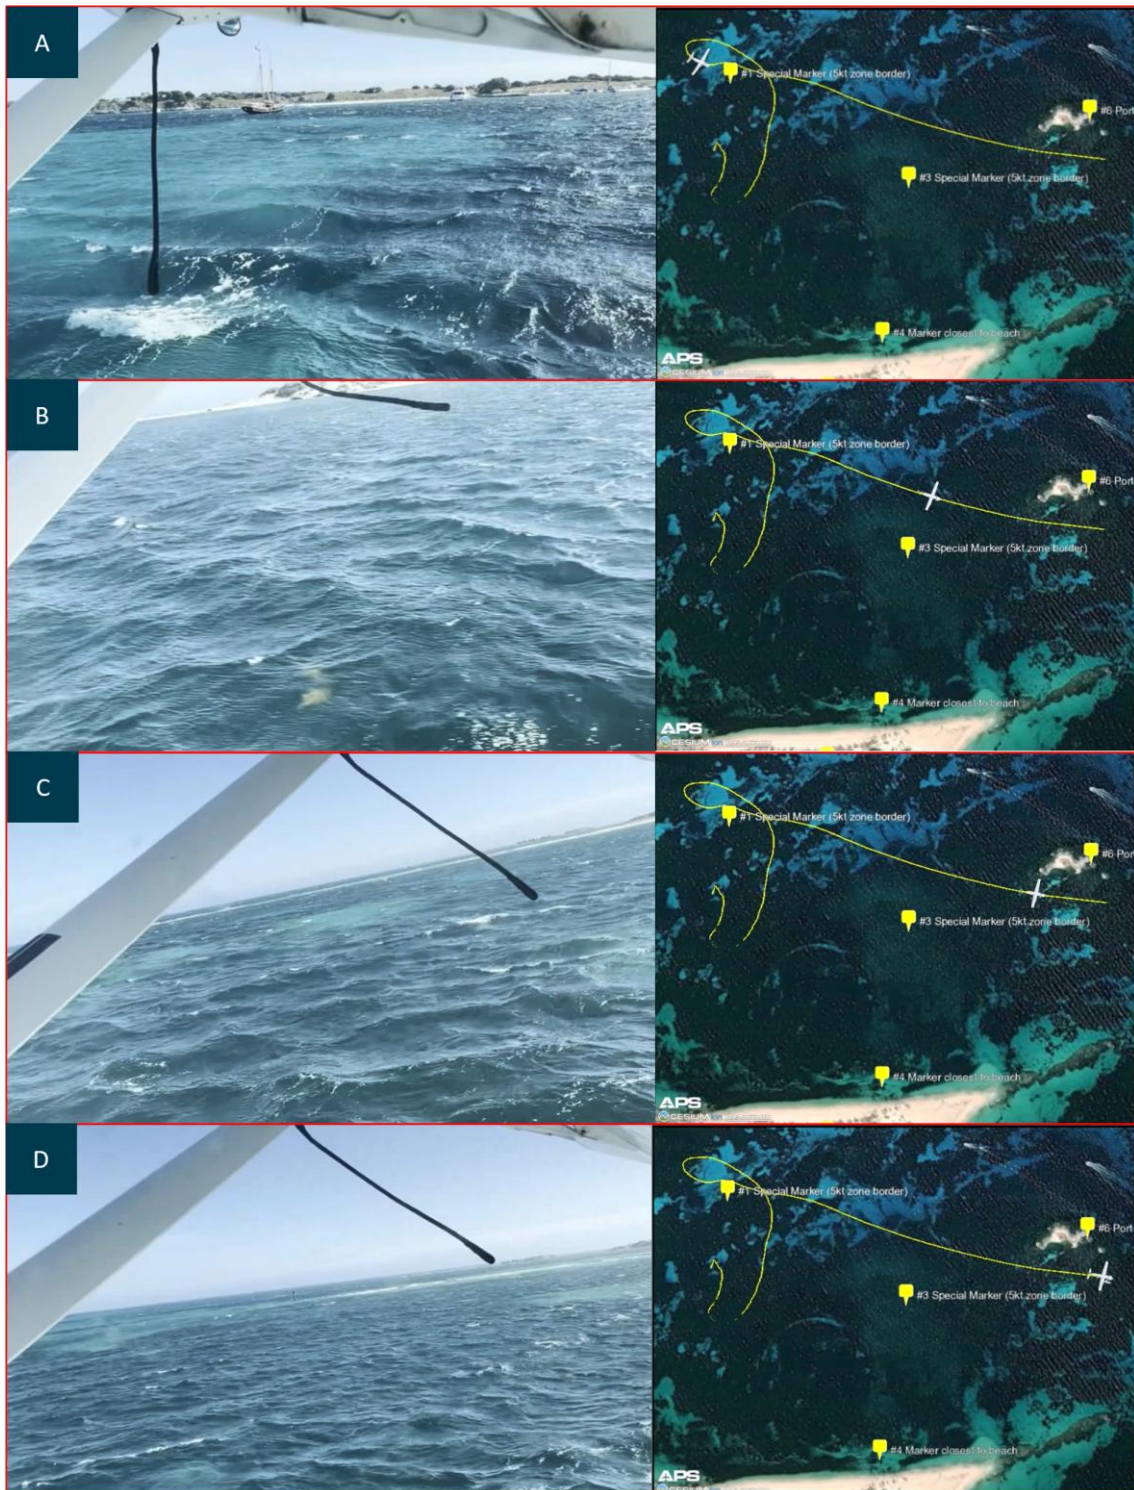
Figure 9: Sea conditions encountered by VH-WTY during take-off

- The aircraft encountered rougher sea conditions later in the step phase, causing it to bounce. Figure 9 (image C) shows the sea conditions at the time the aircraft separated from the water. The video showed that the waves encountered by the aircraft had changed in direction, and were now more reciprocal to the take-off track.
- Sea conditions developed east of Philip Rock, with larger waves observed. Figure 9 (image D) shows the sea conditions almost directly beneath the nose of the aircraft when it was about 25 ft above the water surface.

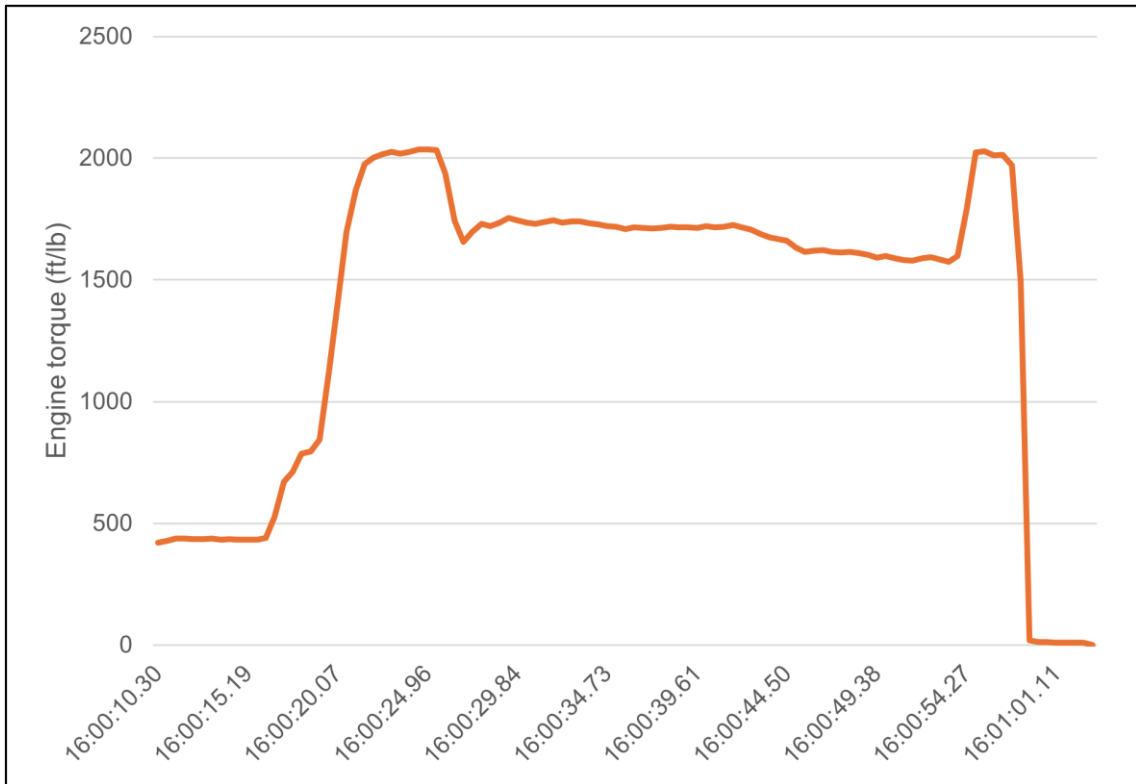
Figure 10: Engine torque recorded by ADASD unit on board VH-WTY

- The propeller speed was relatively constant, just below the maximum take-off limit of 1,900 RPM. Fuel flow and temperature values were consistent with the recorded engine torque.
- At the beginning of the take-off, between 1600:21 and 1600:26, the engine torque was above the maximum take-off limit of 1,865 ft lb. This was below the maximum transient limit of 2,400 ft lb.
- Between 1600:29 and 1600:42, the engine torque was relatively stable between about 1,750 ft lb and 1,710 ft lb.
- Between 1600:43 and 1600:52, the engine torque reduced from about 1,720 ft lb to about 1,580 ft lb.
- At 1600:53, the engine torque increased, exceeding the maximum take-off limit until the aircraft impacted the water. The engine torque did not exceed the maximum transient limit.

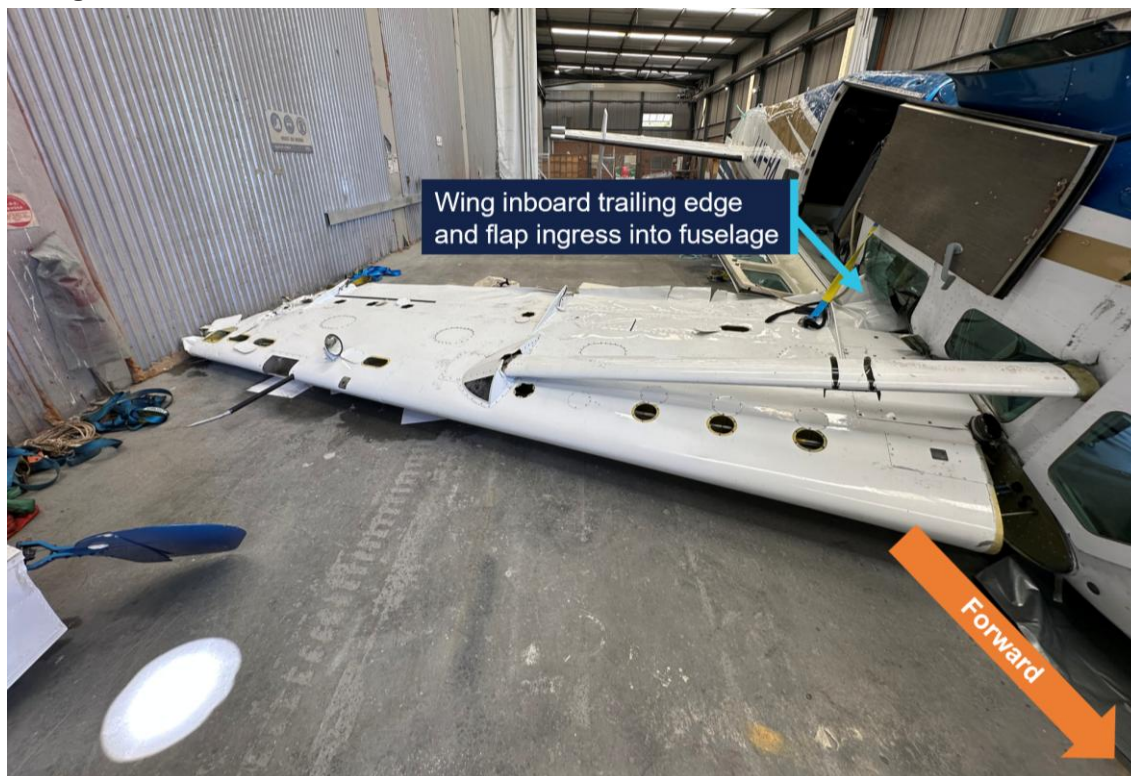
Figure 12: Ingress of left wing into VH-WTY fuselage. Image depicts inverted aircraft facing aft

The trailing edge and inboard flap sections of both wings had been forced into the cabin area at the wing rear attachment points. The fuselage was deformed and the passenger windows broken around the wing structure (Figure 12 and Figure 13).

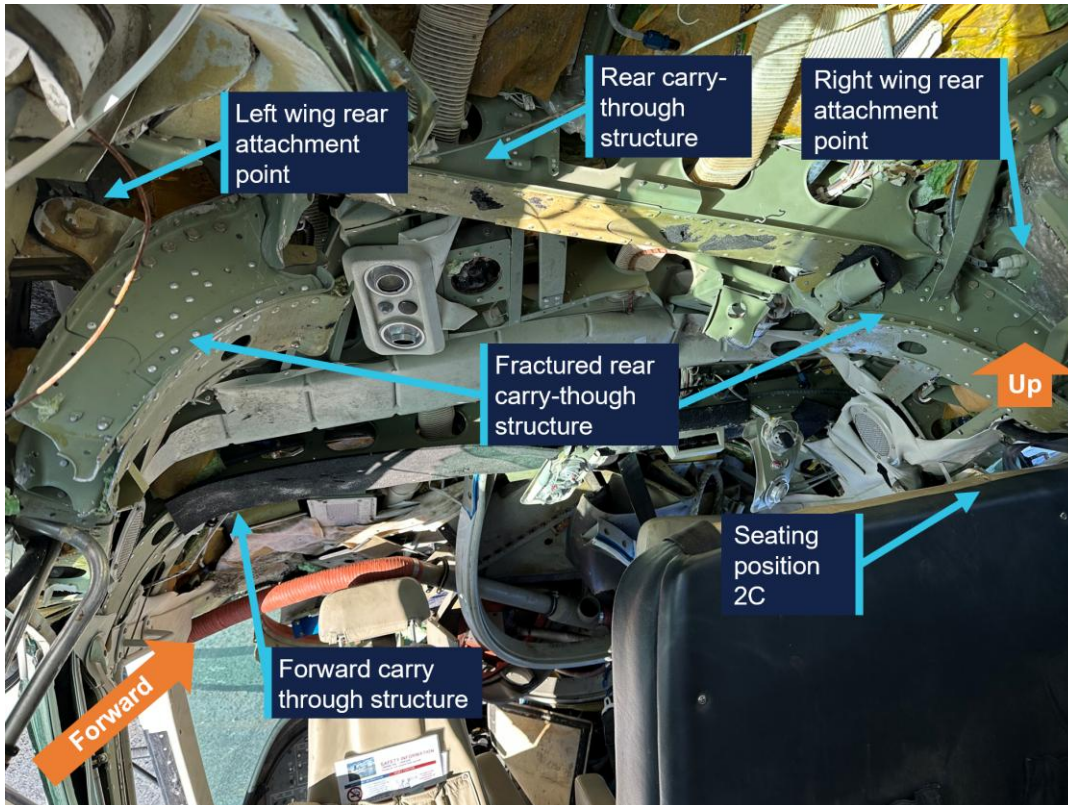
Figure 14: Internal cabin showing fuselage and wing support structural damage. The image is taken from the rear of the cabin looking towards the cockpit.

Examination of the wing support structure showed the left and right carry-through structure¹⁷ had fractured at the wing rear attachment points (Figure 14). The fractured sections of the carry-through structure were forced inwards and downwards into the space normally occupied by passengers seated in row 2 of the cabin.

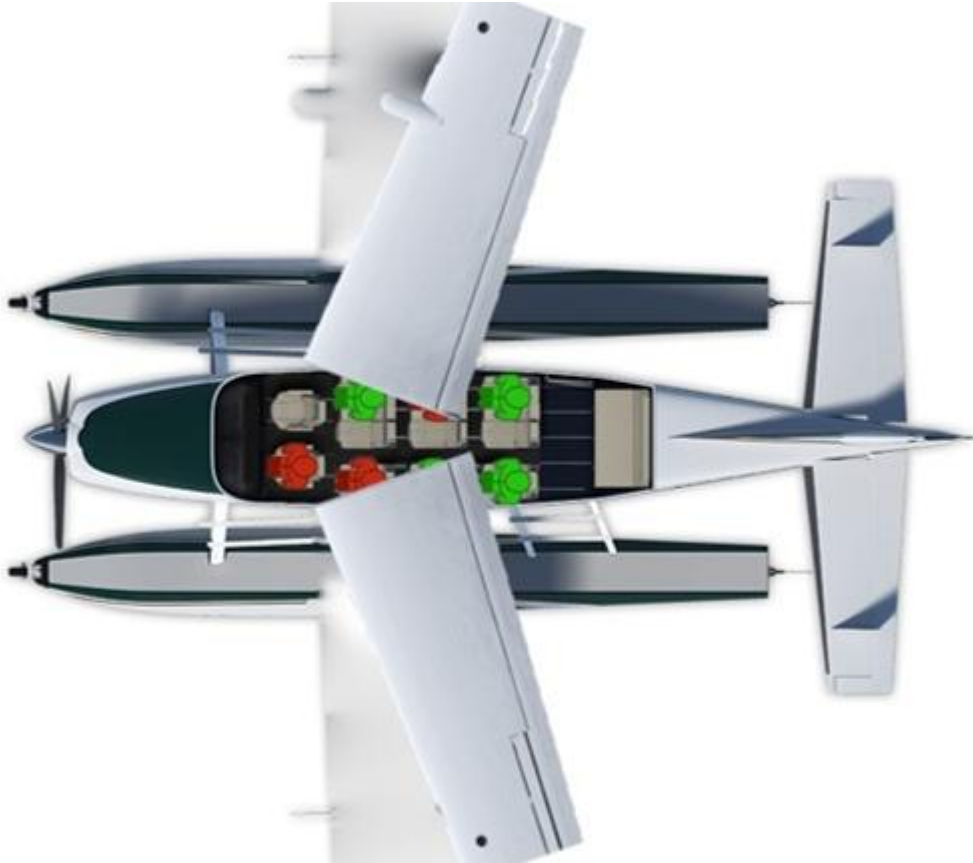
Figure 16: Projected movement of wings inboard into cabin space

Figure 16 is an illustration showing the ingress of the wing trailing edges into the cabin area and encroaching seats 2A and 2C. It also illustrates how the wings were hinged and rotated on the forward attachment points and wing struts. Figure 17 shows the ingress of the wing structure relative to the position of seats 2A and 2C.

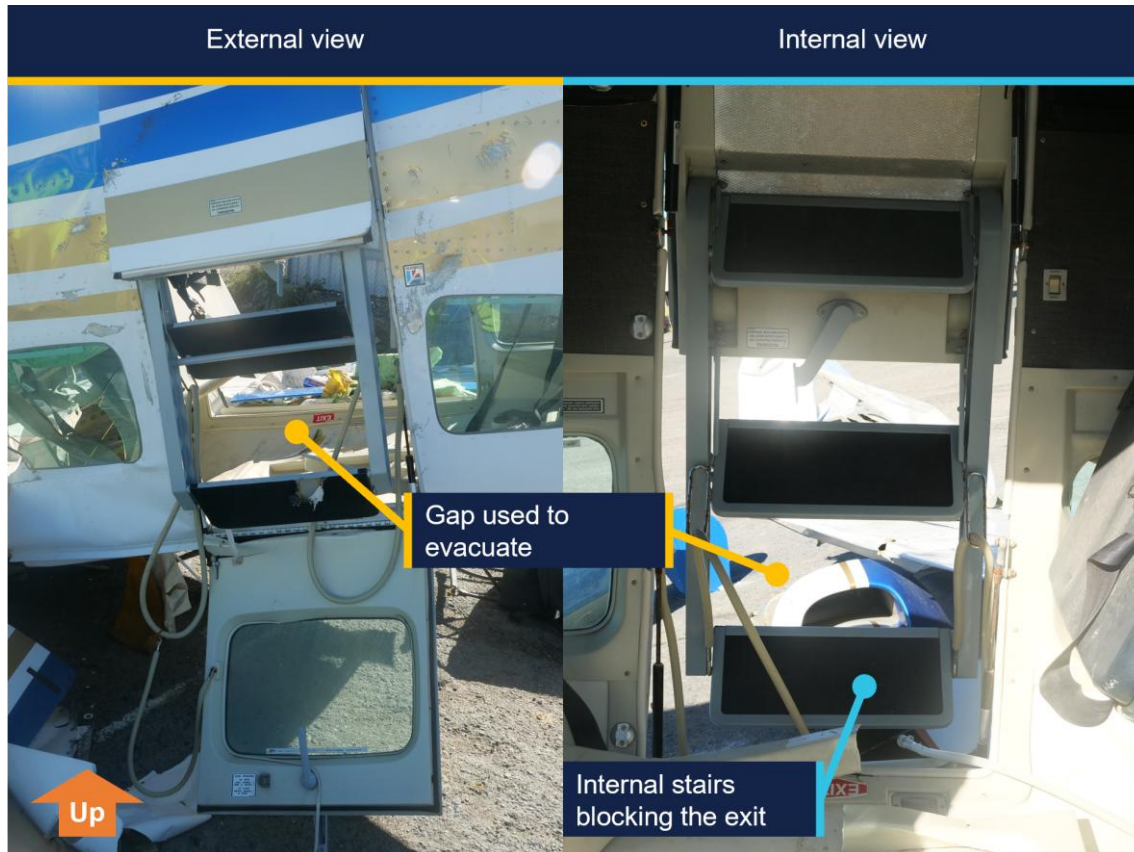
Figure 20: VH-WTY right rear door

The passenger in seat 2A recalled unsuccessfully attempting to open a door in the rear of the aircraft.
