VFR into IMC and collision with trees involving Cessna 182T, VH-TSS

57 km south-east of Mount Surprise, Queensland, on 16 June 2025

AO-2025-028

Final – 28 October 2025

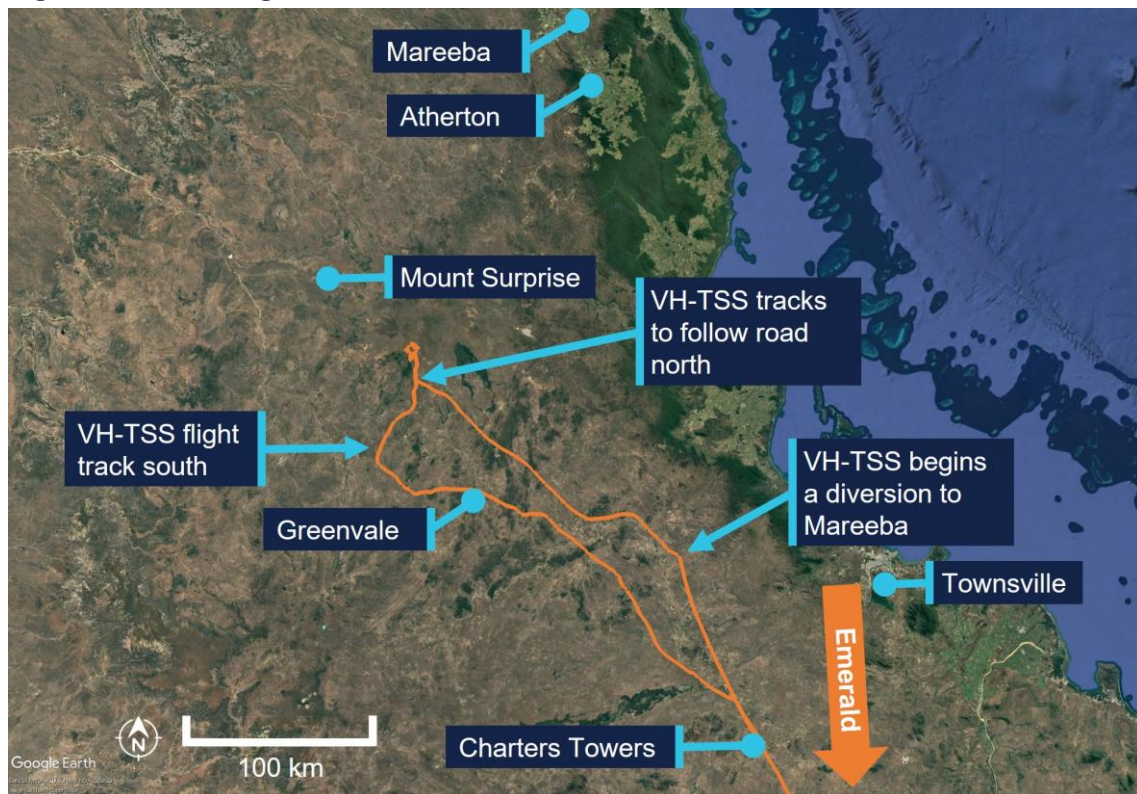
Figure 1: VH-TSS flight track between 0828 and 1115

Electronic flight data showed the aircraft departed and climbed to 4,500 ft above mean sea level (AMSL) where it initially held a steady track towards Atherton (Figure 1).

At 0848, the aircraft descended to 3,000 ft AMSL, about 35 NM north of Charters Towers. The pilot then assessed that cloud and reduced visibility would affect continued visual flight direct to Atherton. The pilot stated they elected to continue, however diverted around weather to Mareeba Airport which they had planned as an alternative destination due to the lower elevation. They stated that they were familiar with the area, having flown a similar route 7 or 8 times previously and reported that they assessed the weather for

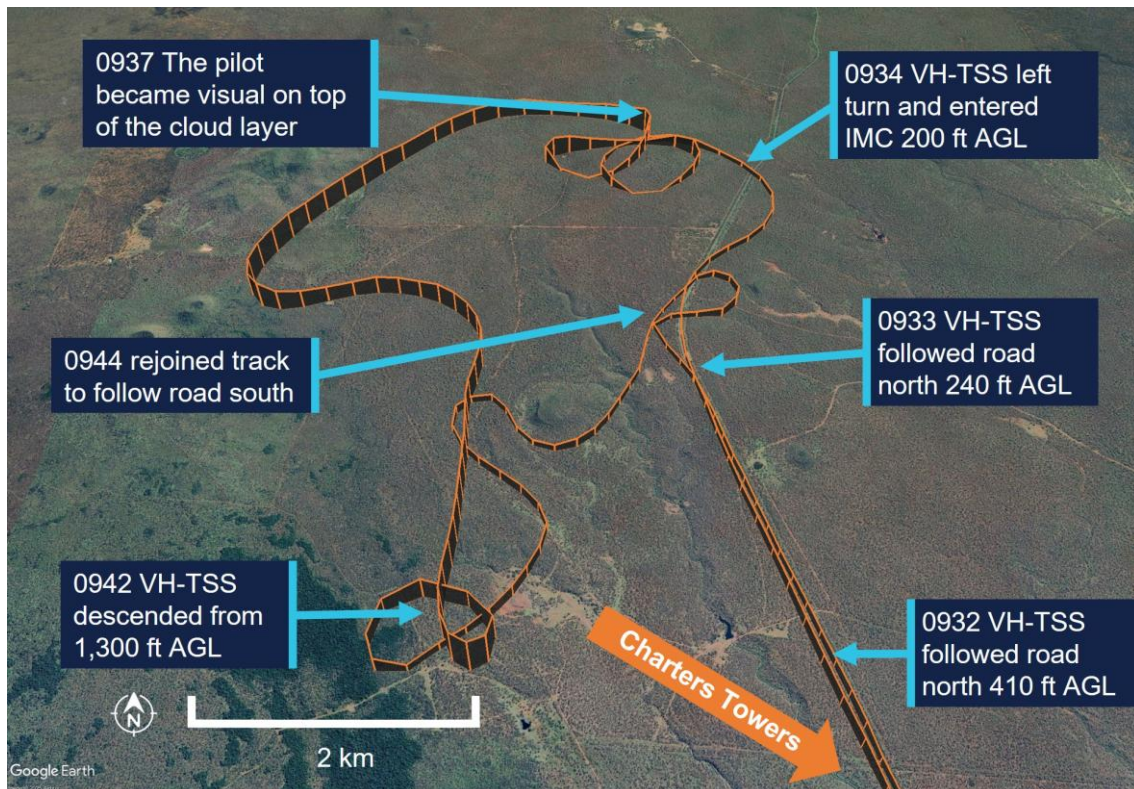
Figure 2: VH-TSS flight track between 0932 and 0946

About a minute later at about 200 ft AGL and 140 kt airspeed (Figure 2), the pilot recalled commencing a left turn and reduced the aircraft's engine power to try to avoid flying into 'white-out' conditions ahead. However, during the turn, the pilot recalled that they entered cloud.

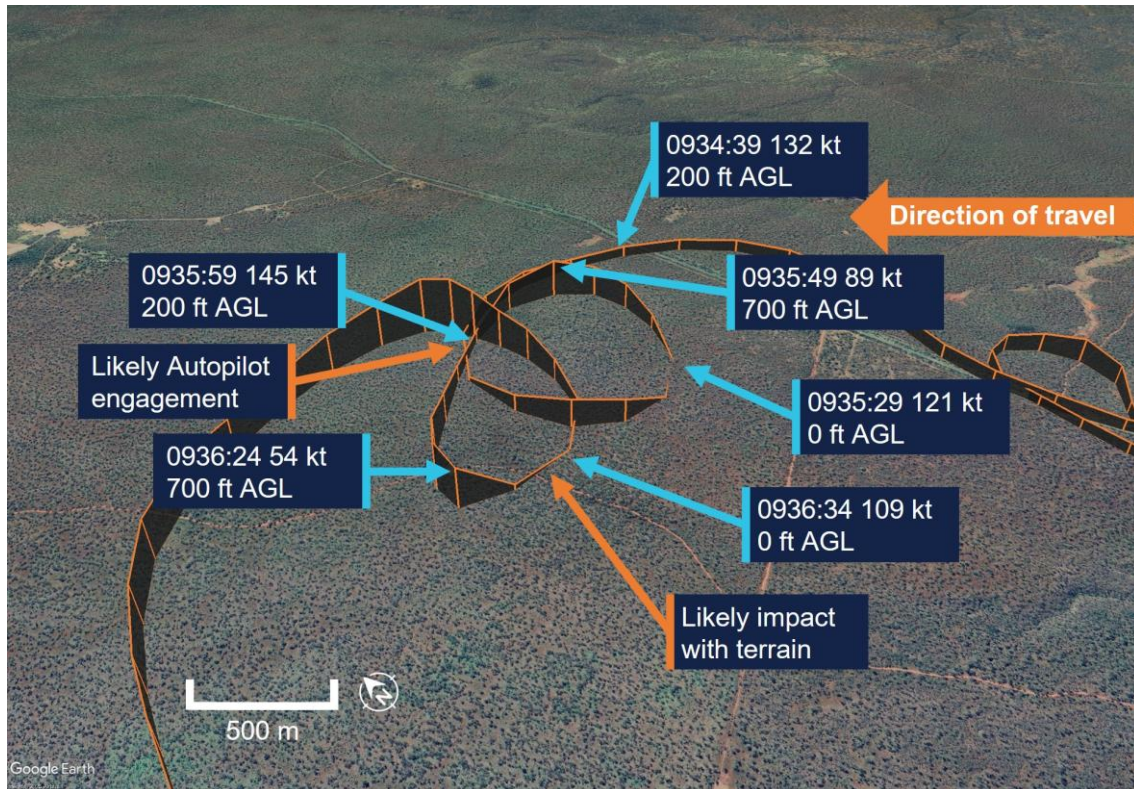
Figure 3: VH-TSS flight track between 0934 and 0938

At 0936, having descended a third time to about 200 ft, the aircraft began to maintain a constant heading for about 20 seconds during which time it had a high rate of climb consistent with the engagement of the autopilot (see *Autopilot*). The aircraft climbed from about 200 ft to 700 ft AGL and reduced groundspeed to 54 kt. The pilot recalled they engaged the autopilot after entering cloud (this was likely after about 1–2 minutes after entering cloud) and then commanded a 180° left turn, in an attempt to reverse their track and navigate out of the instrument meteorological conditions (IMC) (Figure 3). During the next 10 seconds, the aircraft turned sharply left and descended rapidly. The pilot recalled the aircraft instrument panel went red and displayed a terrain warning and immediately applied right rudder and attempted to level the aircraft during the recovery, as it descended almost to ground level.

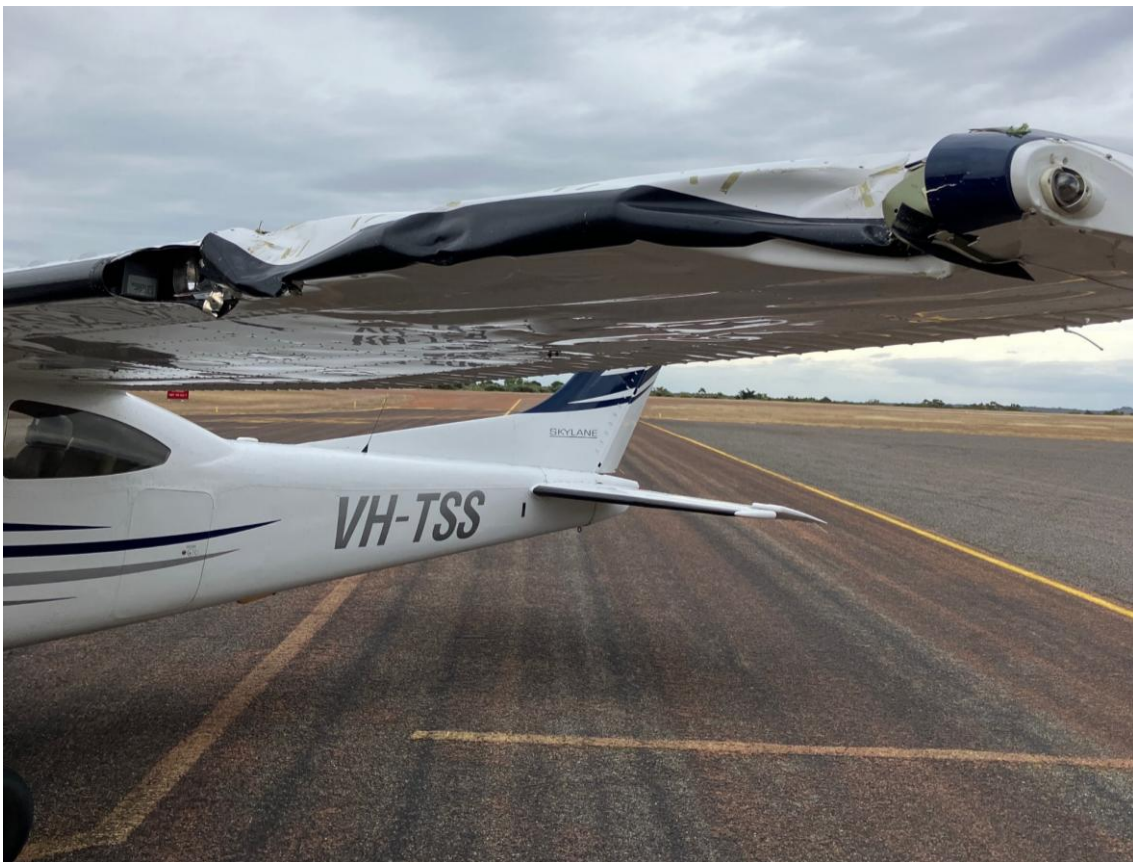
Figure 4: Left wing damage

As a result of the impact with the tree, the aircraft sustained substantial damage to the left wing (Figure 4), with minor damage to the left wing strut and both landing gear struts. No injuries were reported by either occupant.

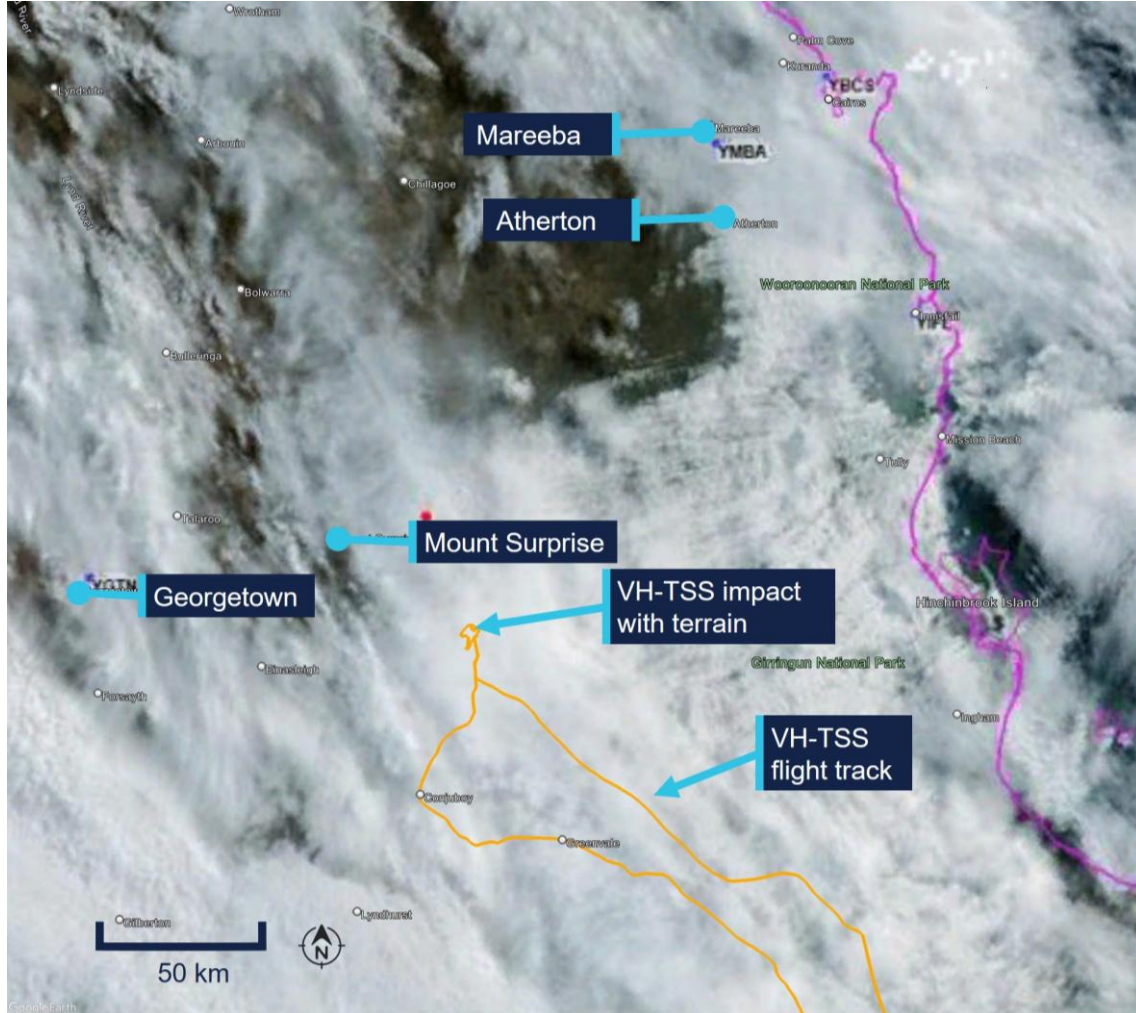
Figure 7: Satellite image 0930 local time

Satellite image taken at 0930 provided by the Bureau of Meteorology indicated cloud cover in the flight planned area and the area the pilot intended to use as a diversion (Figure 7).

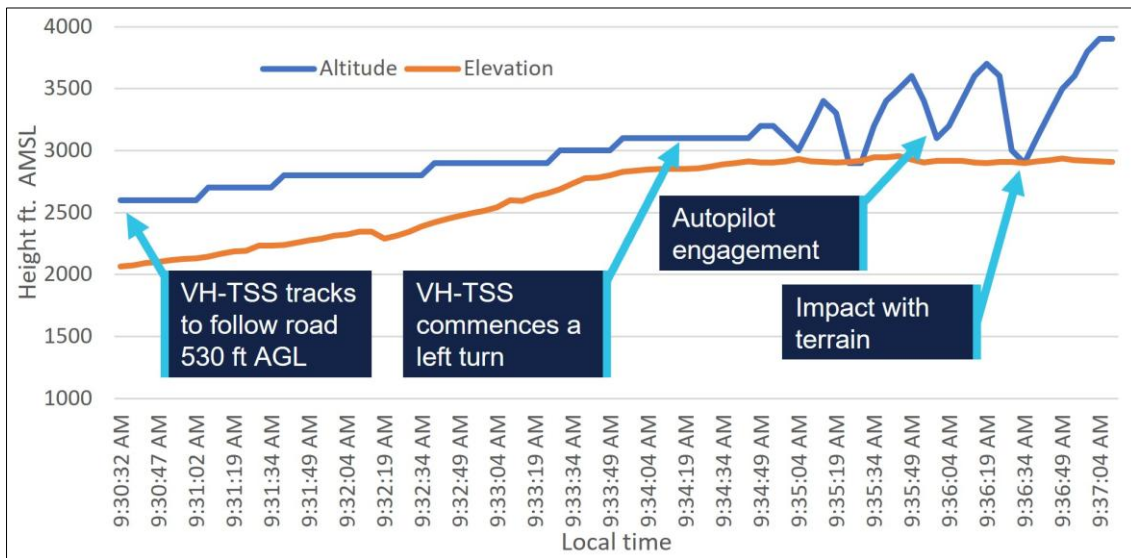
Figure 8: VH-TSS height above terrain

The aircraft height was about 560 ft AGL when the aircraft began to track north along Kennedy Developmental Road which the pilot followed for about 3.5 minutes. At 0934 the aircraft began to deviate away from the road after an increase in altitude of about 500 ft, however due to the rising terrain was about 250 ft AGL (Figure 8).
