Separation occurrence involving Piper PA-44, VH-KZJ, and Cessna 172, VH-ZER

Near Jandakot Airport, Western Australia, on 12 June 2025

ATSB Transport Safety Report

AO-2025-033

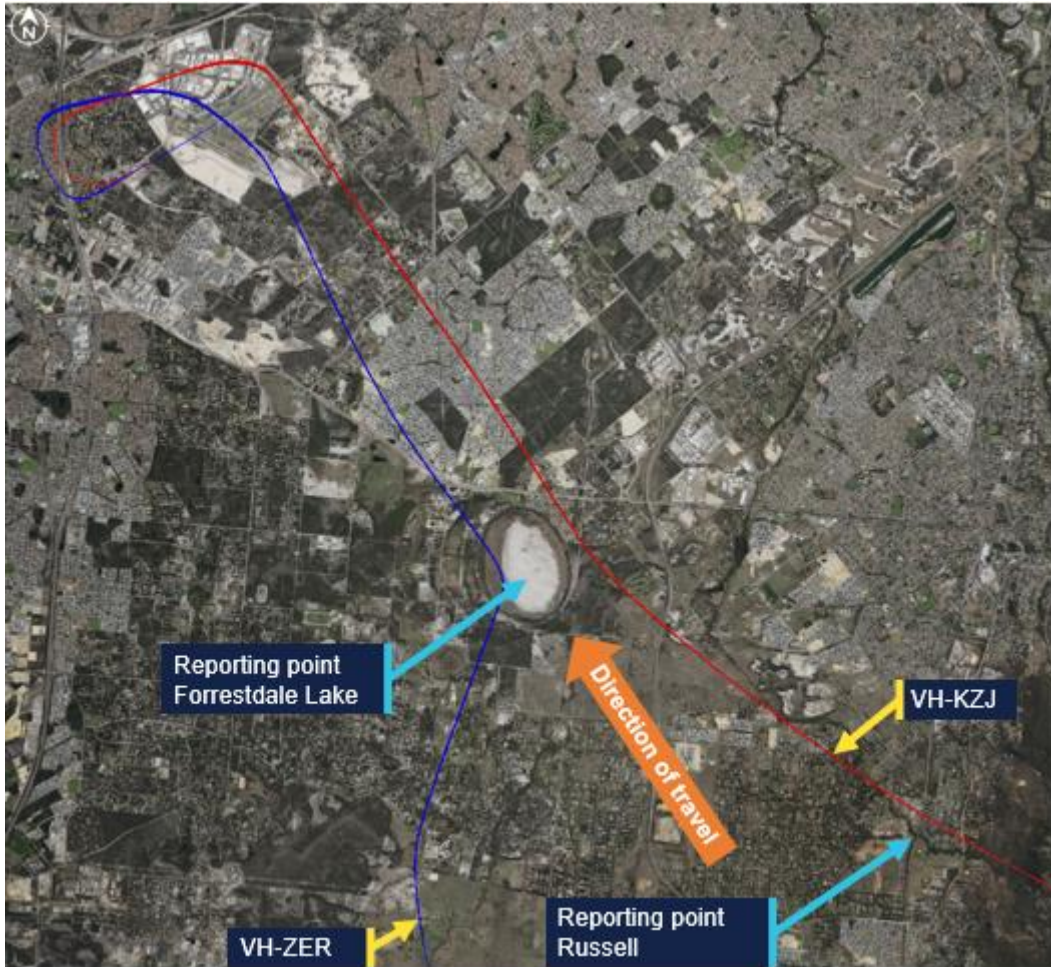
Figure 1: Aircraft inbound tracks

The runway in use at Jandakot was 06L¹ and local procedures required aircraft to contact air traffic control (ATC) at specified approach points (in this instance Oakford and Russell) then track to Forrestdale Lake. From there, aircraft were to fly overhead the airport at 1,500 ft above mean seal level (AMSL) towards the north and join the circuit as directed by Jandakot Tower (Figure 1).

As the PA-44 was passing the inbound reporting point Russell, ATC passed traffic information on the C172 inbound to the circuit area via the Forrestdale Lake inbound reporting point (Figure 1). With the PA-44 being the faster aircraft, ATC instructed the PA-44 pilot to overtake the C172 on the right which was acknowledged by the PA-44 pilot by a callsign response. The pilot then reported at Forrestdale Lake with the C172 in sight. Both aircraft were at 1,500 ft.

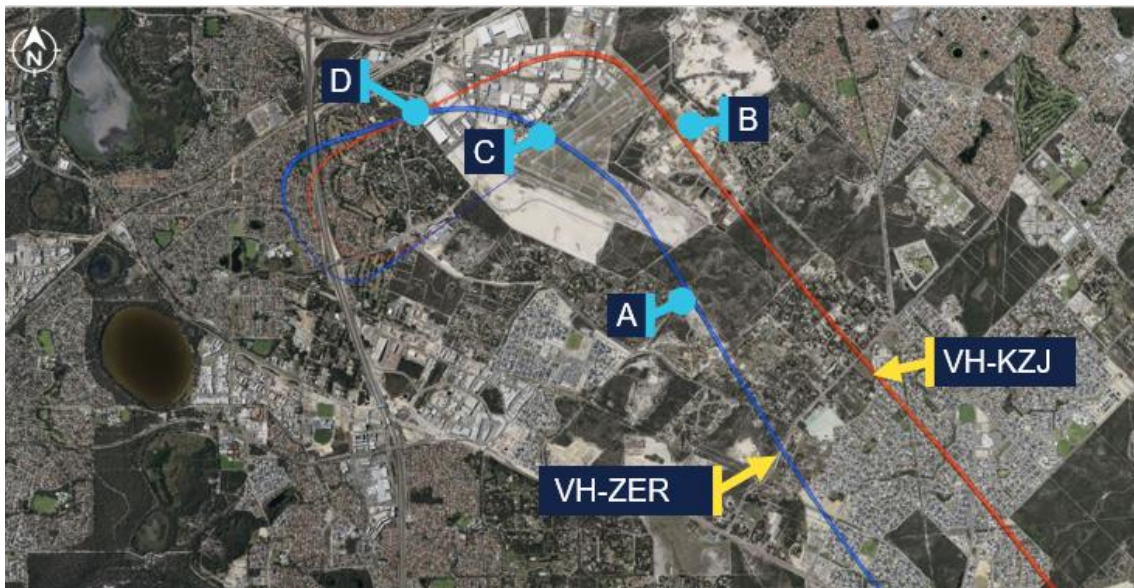
Figure 2: Aircraft track with ATC clearances

Observing that the PA-44 had not overtaken the C172 as they had anticipated, the controller changed their sequencing plan to have the C172 land first. The table below details the exchange between the pilots and controller and Figure 2 shows where these calls were in relation to the flight paths.

The PA-44 continued to overtake the C172 on downwind by descending and accelerating, and then turning inside the C172. The pilot recalled that they thought the sight picture of the close overtake 'did look a bit odd', but did not consider questioning the controller.

The PA-44 pilot did not identify the final part of the amended instruction to 'follow the Cessna'. Consequently, the PA-44 pilot passed the C172 as per the original clearance, resulting in reduced separation between the 2 aircraft.

Airservices Australia advised that the Air Traffic Management Standards and Senior Air Traffic Services Specialists conducted a review, and will investigate a change to Manual of Air Traffic Services (MATS) 9.2.2.13.2 and the respective Aeronautical Information Publication (AIP) reference (GEN 3.4 – 37) to include the instruction ‘follow’ in the list of items requiring readback.
