# Propeller strike of a taxiway edge light involving Beechcraft King Air B200C, VH-RFD

Hobart Airport, Tasmania, on 1 July 2025

**ATSB Transport Safety Report**  
Aviation Occurrence Investigation (Short)  
AO-2025-034  
Final – 5 December 2025

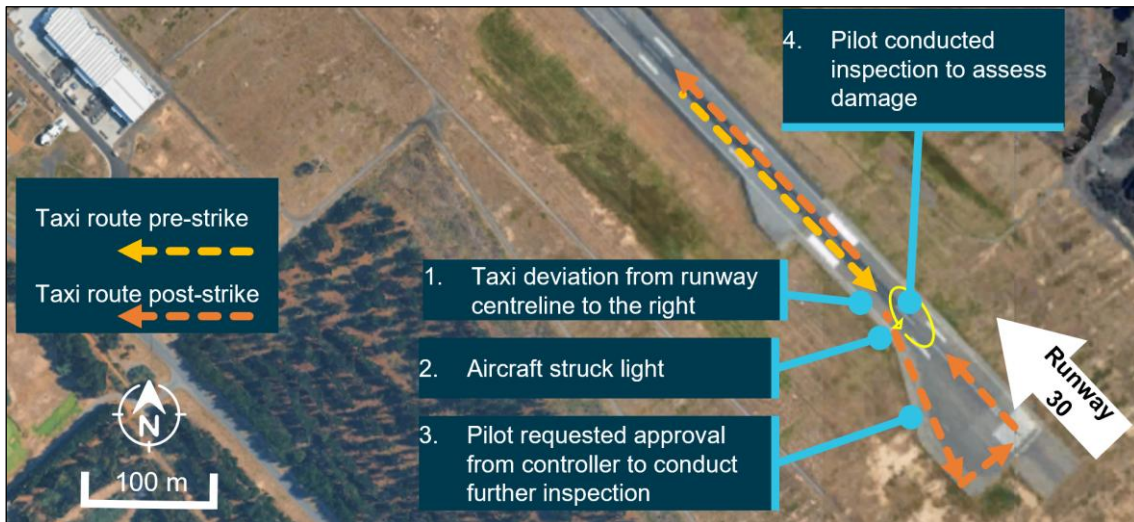
**Figure 1: Taxi route**

During taxi, the PF steered the aircraft away from the centreline taxiway ground markings, toward the right runway edge, approximately 100 m prior to the runway threshold (Figure 1, label 1). This manoeuvre was to position the aircraft for a 180° turn via the runway turnaround pad (a wide, paved area that allows room for aircraft to reverse taxi direction).

The wide turn taken by the PF was consistent with what was expected by the SP. As the aircraft approached the right side of the turnaround pad, the SP recalled that they were waiting for the PF to turn the aircraft as it came into the proximity of a taxiway edge light. Once the SP identified that the aircraft was close to the edge light, the SP advised the PF. However, before the PF could steer away from the light, the right propeller struck it (Figure 1, label 2).

Suspecting the aircraft had struck the light, the PF requested from air traffic control (ATC) clearance to conduct a further ground inspection to assess for damage (Figure 1, label 3 and label 4).

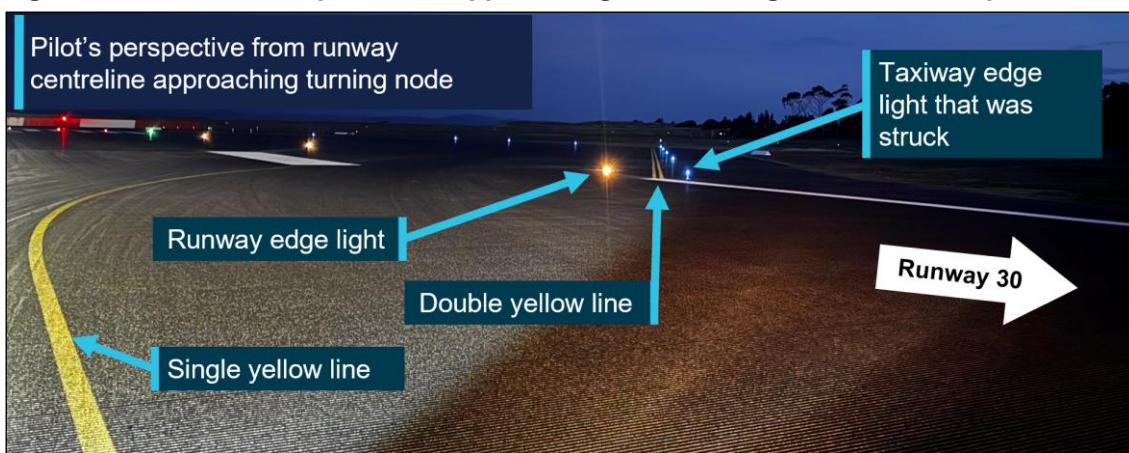
**Figure 2: Reconstructed pilot view, approaching and entering the turnaround pad**

The pilot reported that they subconsciously mistook the blue taxiway edge lights and double yellow line on the edge of the turning pad as taxi centreline guidance. This subsequently resulted in positioning the aircraft to the far right of the turning pad, aligning the aircraft with the double yellow line runway edge light rather than the single yellow line. A reconstructed visual perspective, replicating what the pilot may have seen is shown in Figure 2.

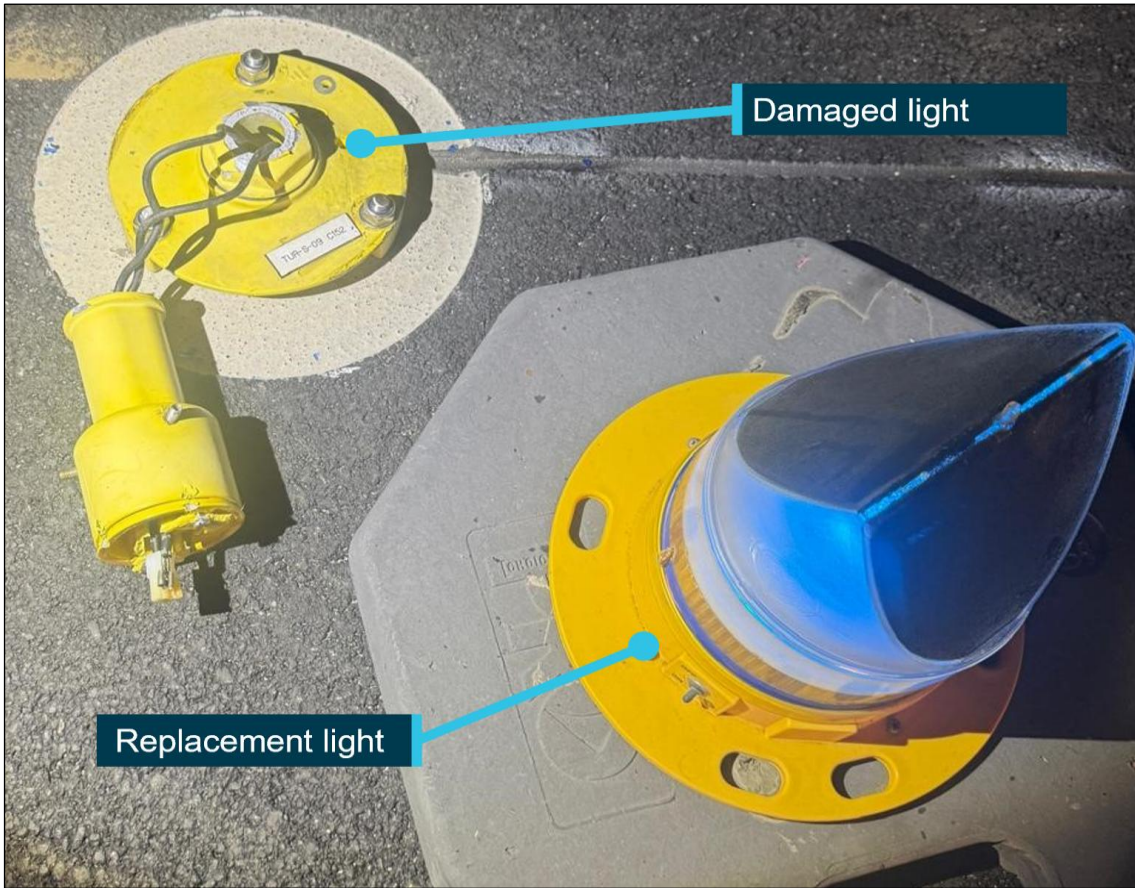
**Figure 3: Blue pad edge light damage**

The pilot then confirmed with ATC that the aircraft had struck the light (Figure 3) and advised that they would need to return to the apron.

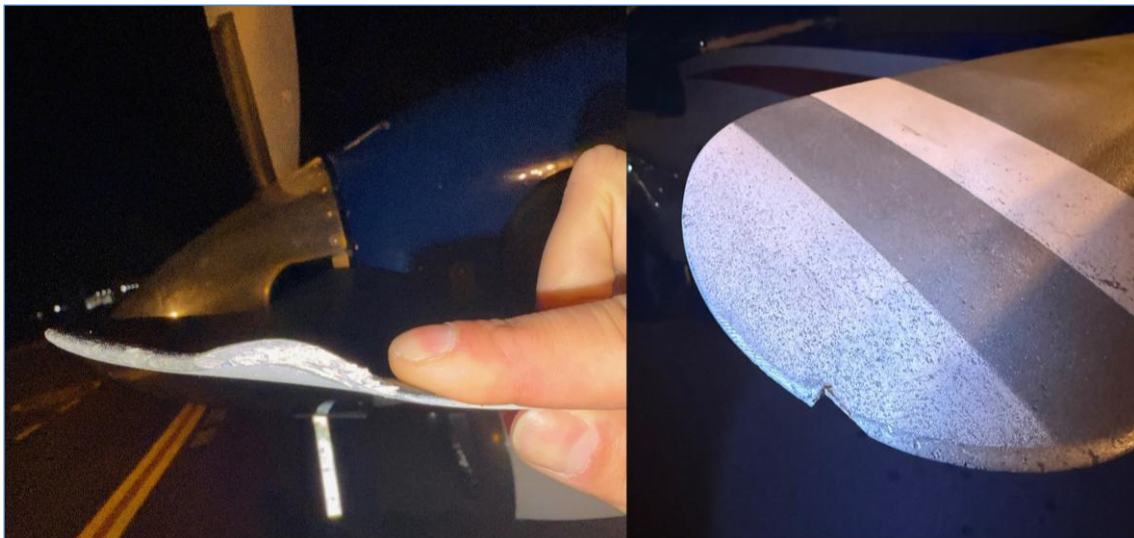
**Figure 4: Propeller damage**

After shutting down the aircraft, the pilots inspected the aircraft and identified damage to the right-hand side propeller (Figure 4).

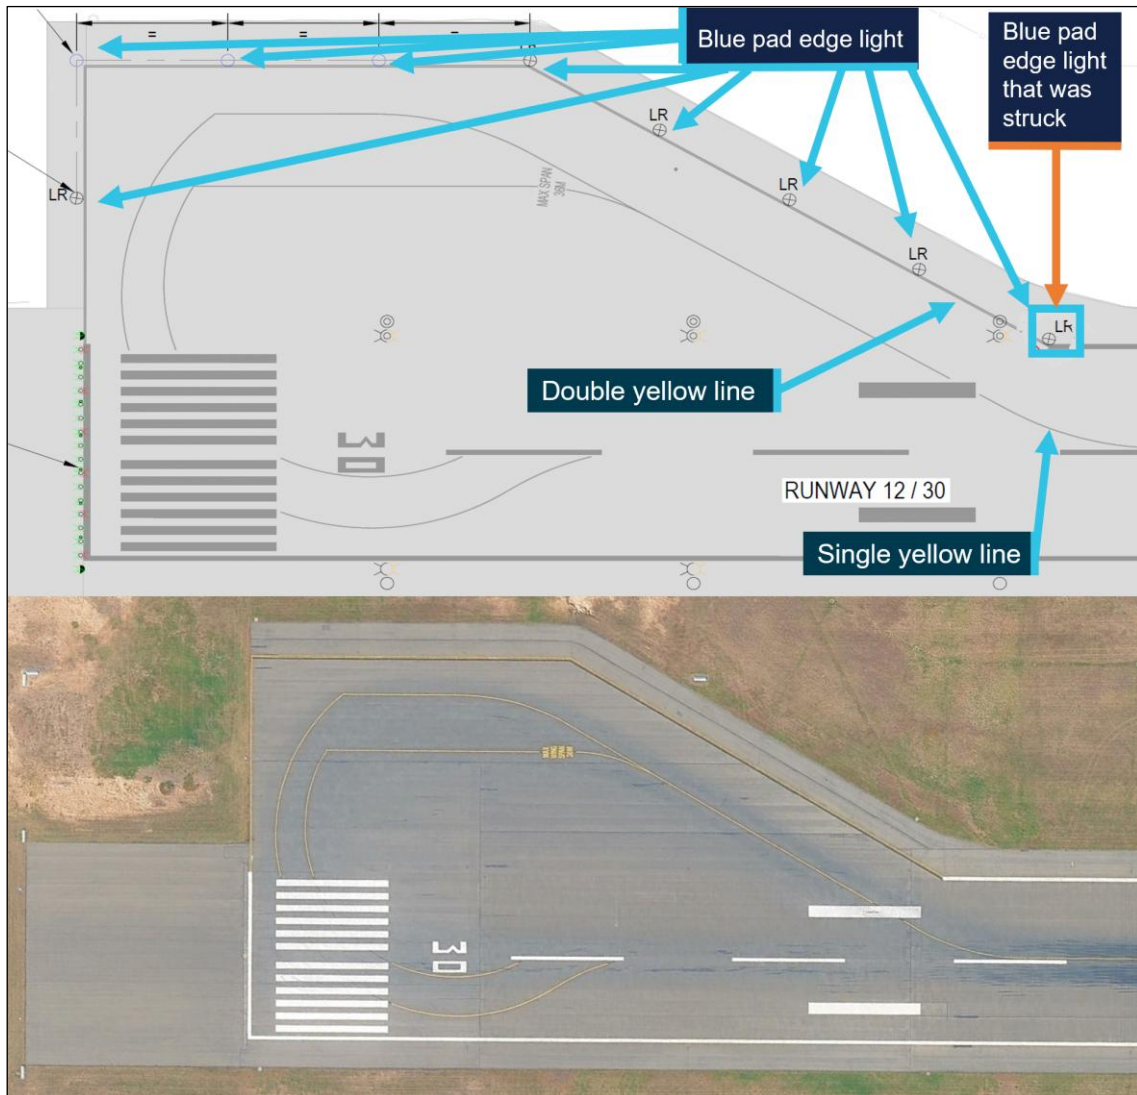
**Figure 5: Illustrations (top) and photograph (bottom) of lights and line guidance at the turnaround pad**

There were line markings and lights on the runway and turnaround pad to guide pilots in turning and lining up their aircraft for departure (Figure 5). The markings and design appeared to be consistent with the requirements of the Civil Aviation Safety Authority Part 139 *Manual of Standards*.

While backtracking, the pilot flying (PF) deviated to the right of track in preparation to conduct a wide left turn using the turnaround pad. Making a wide arc turn was a common technique used by pilots for taxiing and turning the King Air B200. As they turned into the turnaround pad, the PF mistakenly manoeuvred the aircraft to align with the blue taxiway edge lights and 2 yellow (edge line) markings. A pilot would normally rely on taxiing guidance of a single yellow line (and green lights), on a taxiway.
