VFR into IMC and collision with terrain involving Beechcraft 35-C33 Debonair, VH-KZK

12 km east of Khancoban Airport, New South Wales, on 15 July 2025

ATSB Transport Safety Report

AO-2025-040

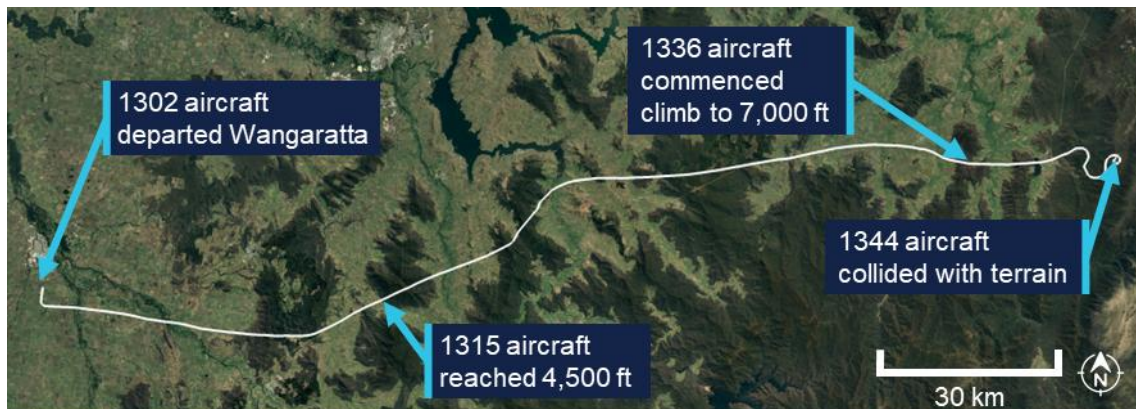
Figure 1: Flight path of VH-KZK on 15 July 2025

A flight path recreated from automatic dependant surveillance broadcast (ADS-B) transmissions is shown in Figure 1. The pilot departed Wangaratta at 1302 and flew approximately east towards Moruya, 189 NM away, making occasional changes in heading. By 1315 the aircraft had climbed to an altitude of 4,500 ft above mean sea level (AMSL), where it remained until it approached the rising terrain of the Snowy Mountains, where the aircraft began climbing to 7,000 ft. The mountainous area along the aircraft’s flight path had varying terrain heights, with a maximum of approximately 6,000 ft AMSL.

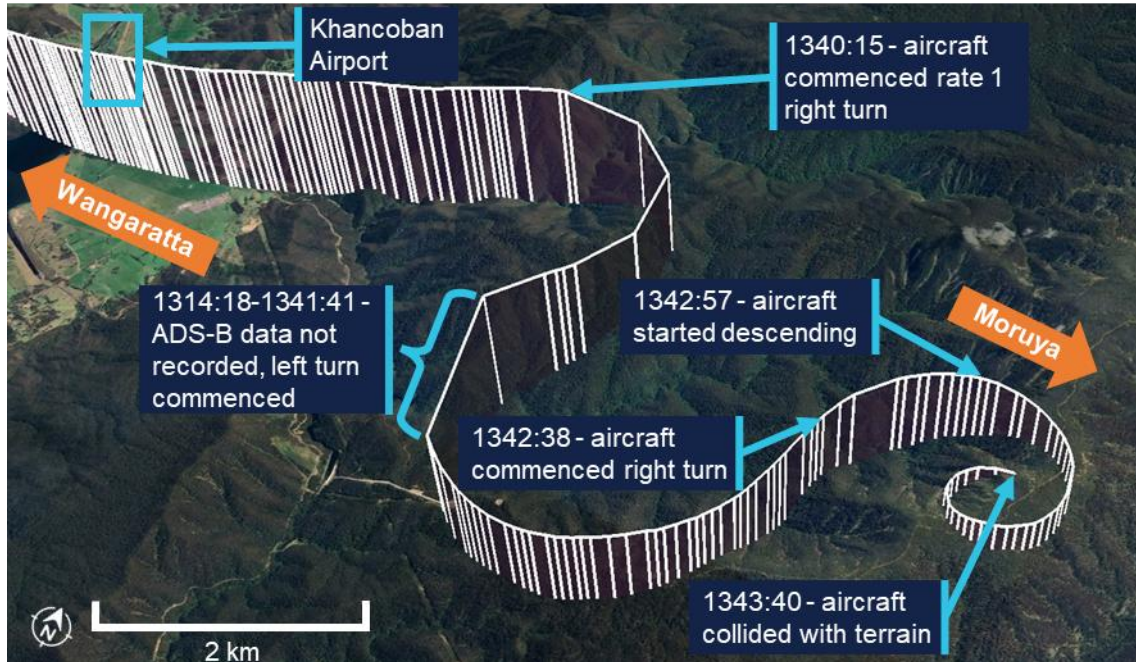
Figure 2: Flight path prior to colliding with terrain

1 turn³ to the right with minimal change in altitude. At 1341:18, after turning through 150°, there was a 20-second period where ADS-B transmissions were not received. The aircraft was subsequently detected in a left turn through 206°, also approximately rate 1. An airspeed of approximately 150 kt was maintained through these turns.

At approximately 1342:38, the aircraft entered another right turn and shortly after, began descending from 6,725 ft AMSL. From this point, the aircraft's rate of turn, descent rate and groundspeed all steadily increased into a spiralling descent. The last ADS-B transmission was recorded 55 ft above ground level, with an estimated airspeed of 210 kt and a rate of descent above 4,000 ft/min. At 1343:40, the aircraft collided with terrain at an elevation of 4,830 ft AMSL. The pilot was fatally injured and the aircraft was destroyed.

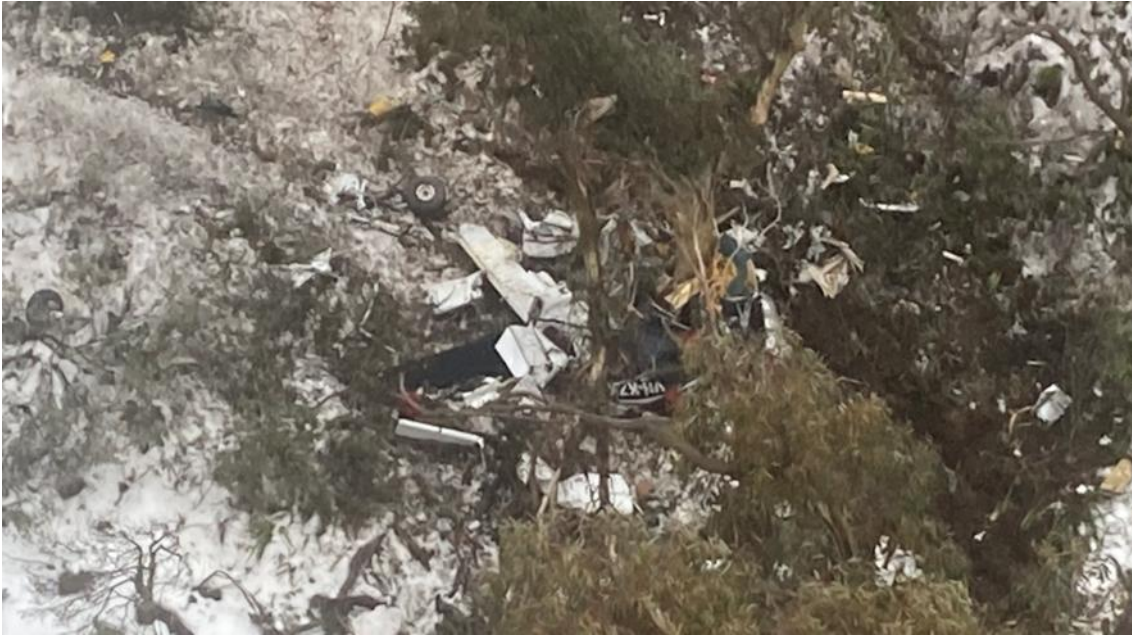
Figure 4: Wreckage of VH-KZK

The aircraft was significantly disrupted (Figure 4), consistent with the estimated final aircraft speed of 210 kt and a vertical rate of descent of over 4,000 ft/min. The impact was not survivable. Accident site photographs indicated that the wreckage was relatively contained, rather than spread over a long wreckage trail. This was consistent with the steep descent indicated by the flight data. The engine had separated from the aircraft wreckage and was located 10–15 m away. From the photographs, it was not possible to determine conditions such as aircraft configuration, control cable continuity or the state of control surfaces. It also could not be determined whether all components remained attached up to the point of impact.

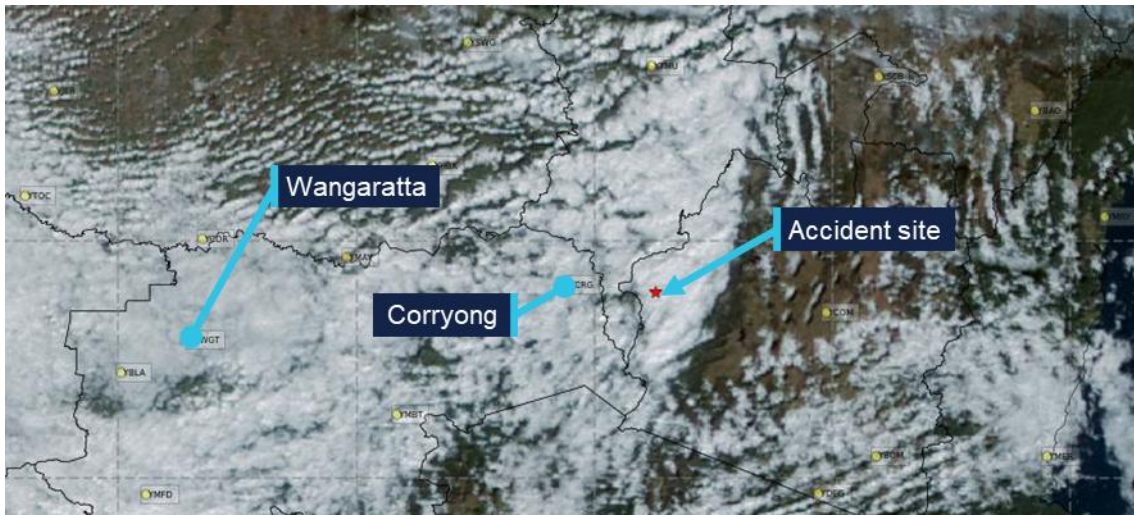
Figure 5: Satellite image from 1340 on 15 July

A satellite photograph taken at 1340, less than 4 minutes before the aircraft collided with terrain, showed cloud cover in the vicinity of the accident site (Figure 5). However, the image provided no information on cloud height or density.
