# **Collision with terrain involving Reims Aviation F406, VH-EYQ**

3 km from Oakey Airport, Queensland, on 20 July 2025

**ATSB Transport Safety Report**  
Aviation Occurrence Investigation  
AO-2025-042  
Preliminary – 10 December 2025

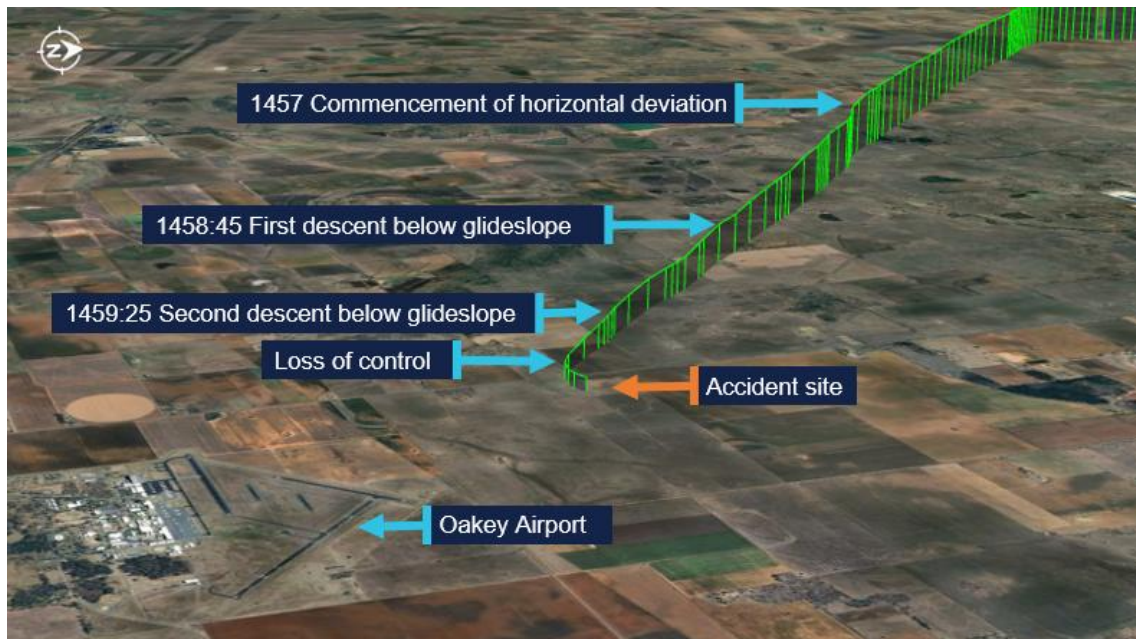
**Figure 3: Final approach track**

At 1457, the aircraft began to deviate from the horizontal profile for the approach. The aircraft initially deviated right of the extended centreline and then to the left (Figure 3). Fluctuations in vertical speed also occurred during this period. The aircraft continued the approach slightly left of the extended centreline, but the vertical profile of the approach remained on the glideslope.<sup>5</sup> The wind conditions recorded at Oakey Airport at the time were a light breeze of 6 kt, with a mean direction of 190°M (see *Meteorological information*).

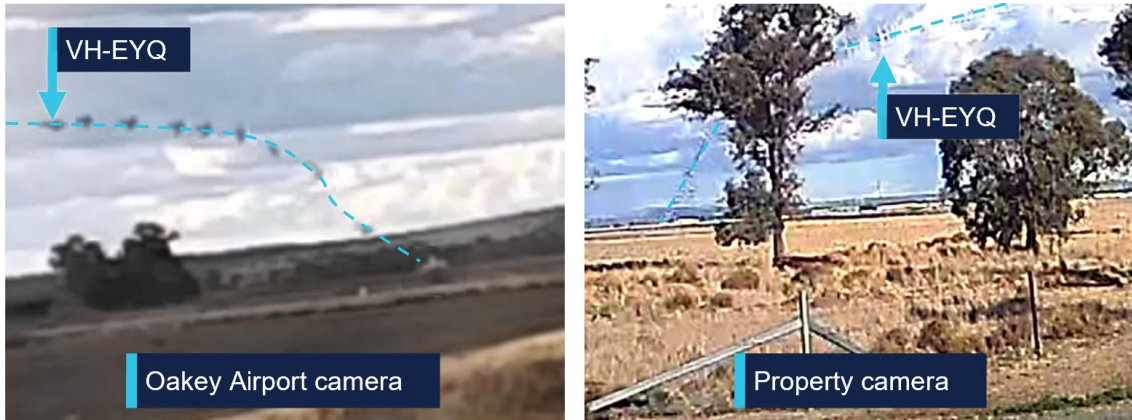
Figure 5: Composite images of recorded CCTV camera footage

Closed-circuit television (CCTV) cameras located at a nearby property and Oakey Airport captured the aircraft commence a steep descent before colliding with terrain (Figure 5).

The aircraft was destroyed in a post-impact fire, and both occupants were fatally injured.

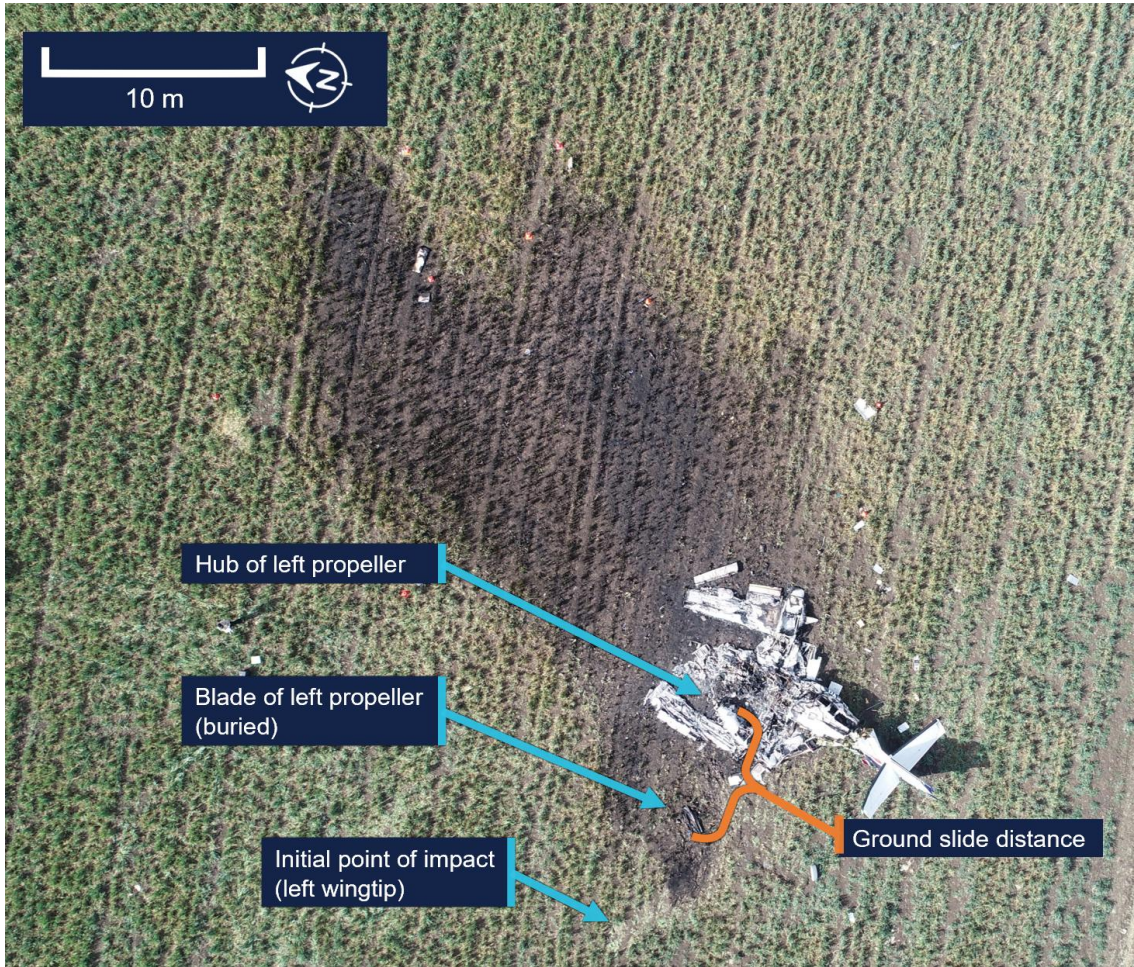
Figure 9: VH-EYQ accident site

The wreckage was confined to a 30 m radius of the accident site. The impact marks and wreckage position indicated the aircraft impacted terrain left wing low with little forward momentum. Ground scars indicated the aircraft moved about 6 m after the initial impact. All components were upright.

The tail and aft cabin section showed signs of vertical compression. There was no fore or aft compression damage to the nose or wings. The left wing had separated from the aircraft just outboard of the left engine, and the right wing had separated just inboard of the right engine. Both wings had swung forward to lay parallel to the fuselage (Figure 9).

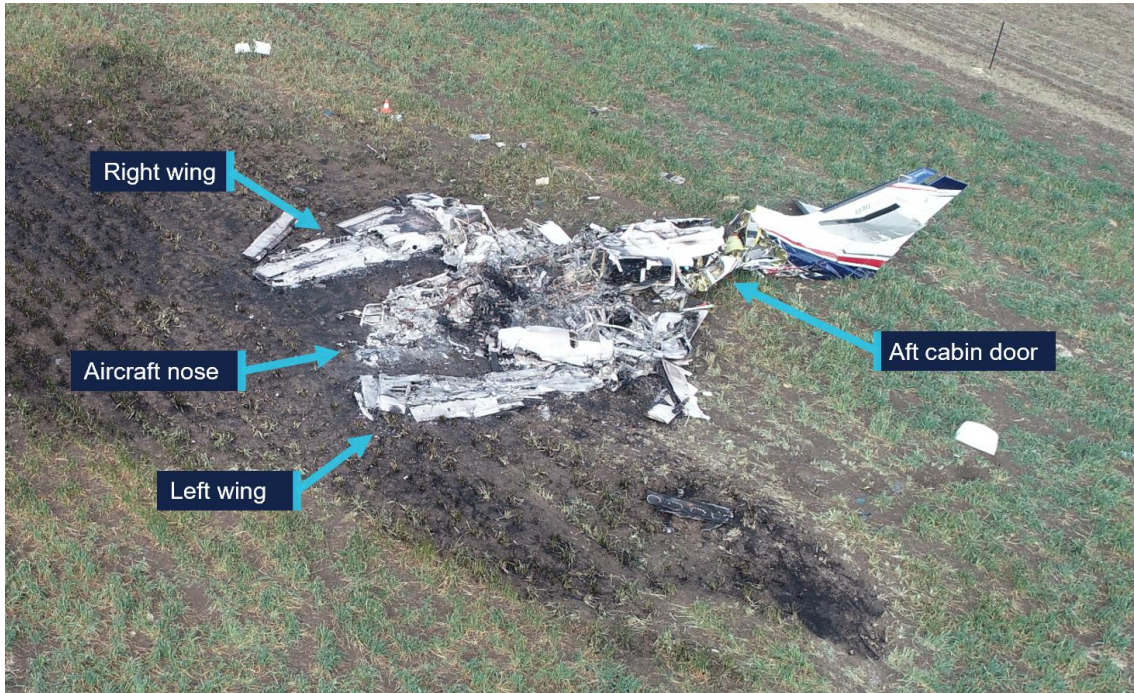
Figure 10: VH-EYQ wreckage

All major aircraft components were accounted for at the point of impact. A post-impact fire consumed the forward section of the aircraft to the aft cabin door (Figure 10). This damage limited the extent to which pre-impact defects could be identified.

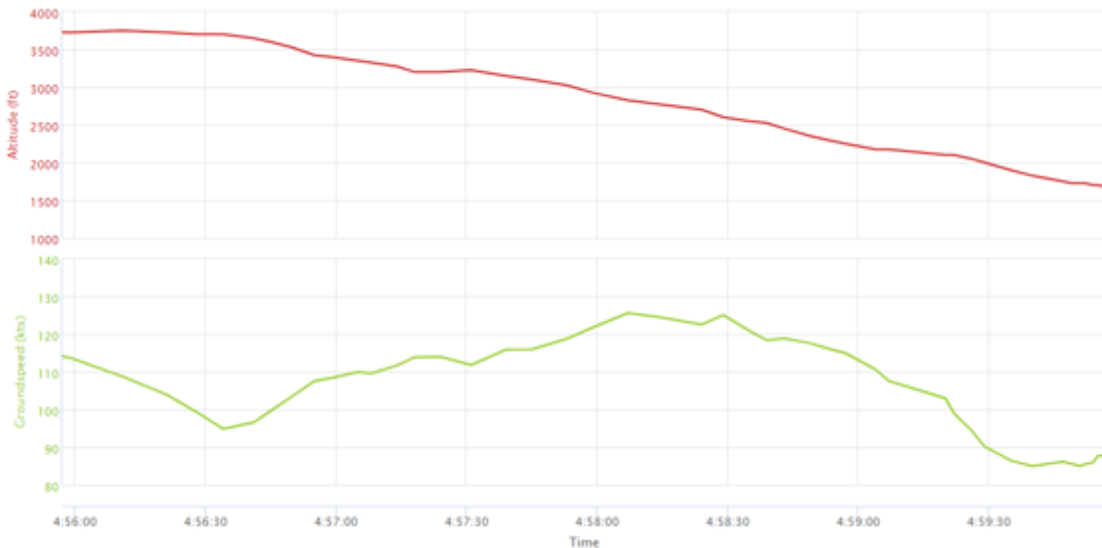
**Figure 12: VH-EYQ altitude and groundspeed during the Oakey Airport approach**

At about 1458:45, and an altitude of 2,500 ft, the aircraft began to descend below the glideslope. This was initially corrected, and the aircraft flew level at about 2,200 ft for 30 seconds. At 1459:25, the aircraft descended below the glideslope again, and the descent continued to an altitude of about 1,700 ft, which equated to a height of between 300–400 ft above ground level (AGL). During this period the aircraft's groundspeed began to decay. At 1459:39, the aircraft's groundspeed had reduced to 85 kt (see
