# In-flight fire involving Boeing 737, VH-YFY

56 km north-north-east of Hobart Airport, Tasmania, on 21 July 2025

Aviation Occurrence Investigation (Short)

AO-2025-043

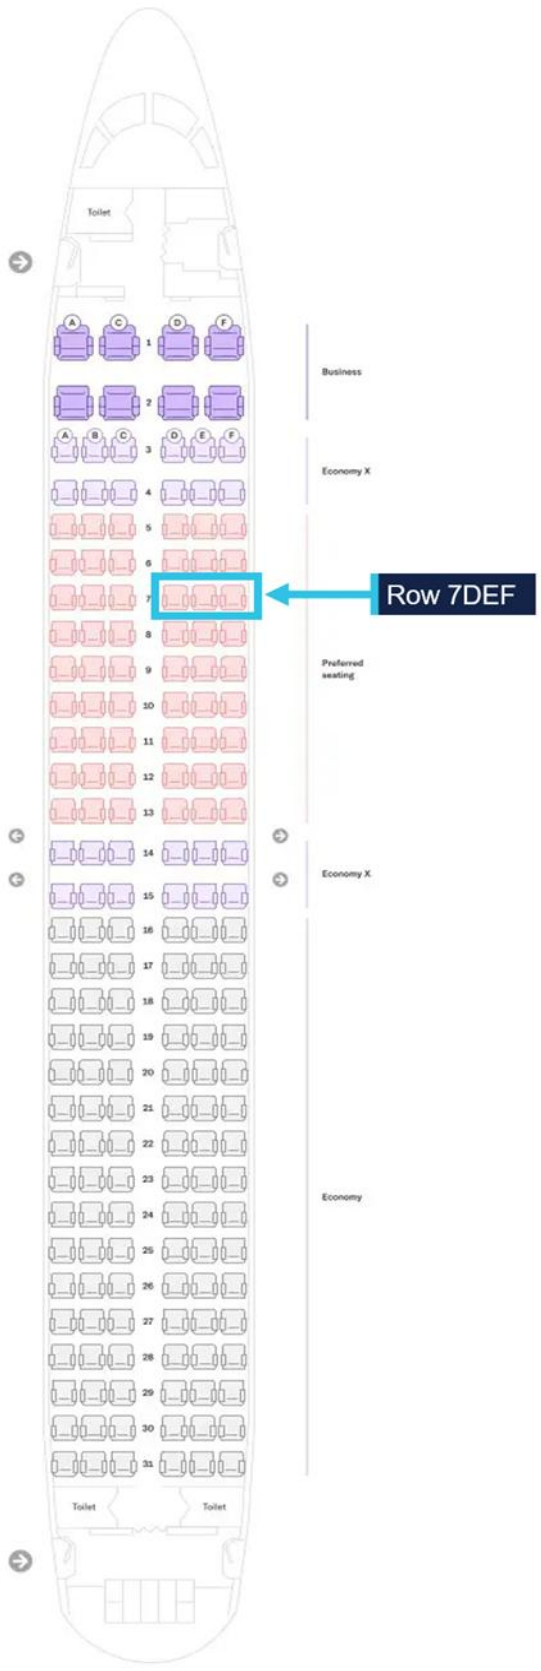
Figure 1: Aircraft seat plan showing the location of the overhead locker where flames and smoke were observed

When the overhead locker was opened, flames and smoke were observed emanating from a backpack. Although they could not see what was causing the fire, from their training, the cabin crew suspected it was from a portable electronic device overheating. The 1L discharged a fire extinguisher into the locker until the flames were extinguished. The 1L and 1R then poured water over the bag, with the assistance of the 2R and passengers. To reduce the risk of re-ignition, a second fire extinguisher was discharged into the locker. The cabin crew instructed passengers to keep their heads down and cover their nose and mouth to avoid inhaling smoke. They also asked the passengers who was the owner of the bag but did not receive a response at the time.

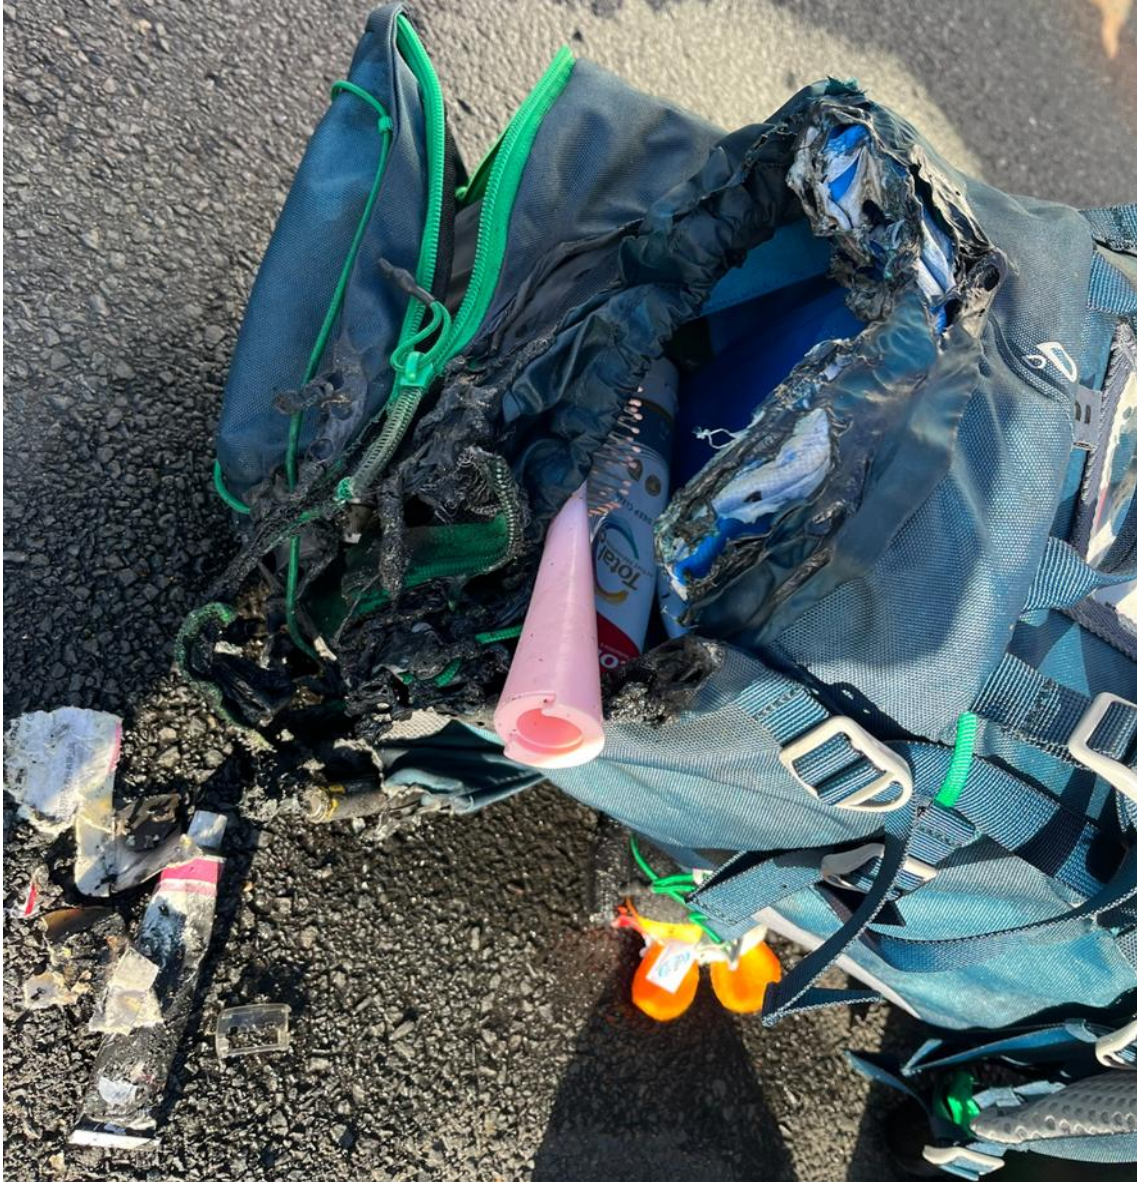
**Figure 3: Backpack containing the power bank**

The captain stopped the aircraft on the taxiway and exited the flight deck to speak to 1L and observed the cabin to determine whether an evacuation was required. As the fire appeared to be contained, the captain taxied the aircraft to the parking bay. At 0919, the aviation rescue and firefighting personnel boarded the aircraft and removed the backpack from the overhead locker. They confirmed the origin of the fire was a lithium power bank, stored in one of the backpack's front pockets (Figure 3).

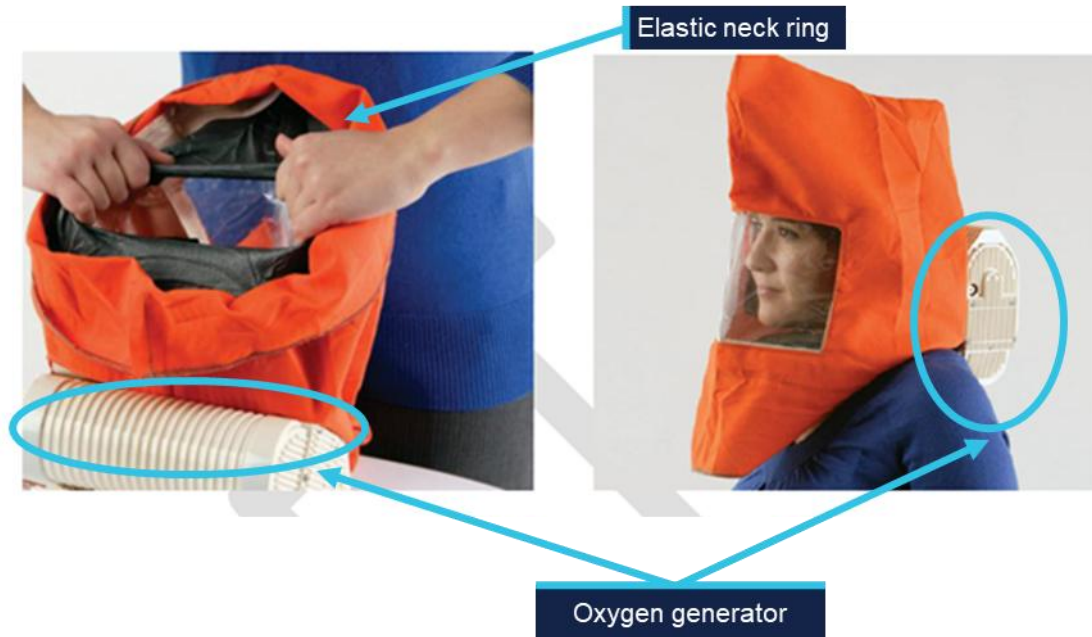
**Figure 4: Exemplar PBE, showing how to open the neck ring (left) and when donned (right)**

The 2 cabin crew who attempted to use the PBE stated that the equipment provided in training was much easier to don as the neck ring was stretched from repeated usage.

Protective breathing equipment (PBE) was available for cabin crew to use if deemed necessary in preparation to fight a fire, and all crew were trained in their use. Two of the cabin crew attempted to use the PBE, but did not find it effective due to fitment and communication/visibility issues. As the cabin crew were unable to use the PBE, they had no protection from the smoke and were placed at an increased risk of smoke inhalation. While these cabin crew did not experience any residual effects from the smoke, any protective equipment provided should be efficient to don and wear continuously while managing an emergency situation.

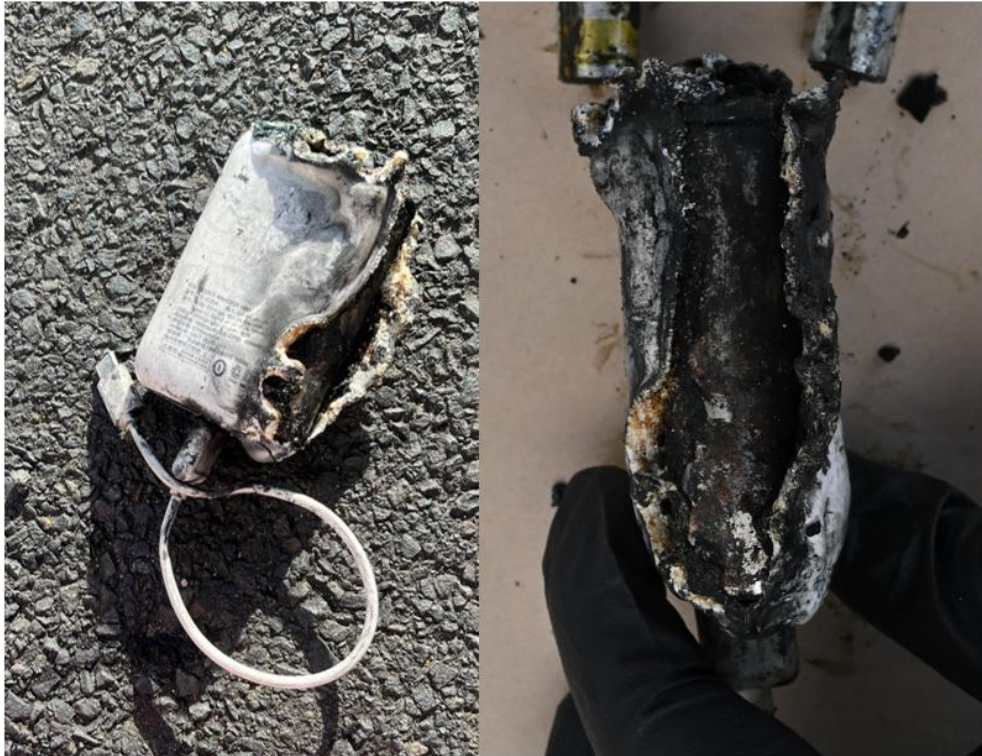
**Figure 6: Power bank showing damage from the back (left) and side view (right)**

The power bank had a rated output of 37 watt hours and had both USB-A and USB-C charging ports. It was not charging a device when the fire started, but there was a cable plugged into the USB-A charging port. When orientated with the manufacturer's label facing up, most of the damage was observed along the top and right side of the power bank. The damaged right end contained the USB-C charging port. External observations suggest that the power bank contained 2 internal cells, of which only 1 was affected by the thermal runaway by the time the fire was extinguished (Figure 6). The power bank was not protected from short circuits as it did not appear to have the terminals covered and was not separated from other items in the bag by being placed in a protective pouch or the original packaging. The backpack was reported by the operator to be substantially damaged by the fire.

For unknown reasons, one of the cells in a lithium-ion power bank stored in an overhead locker failed during the descent into Hobart. In this case, there was no reported pre-existing damage, or any other identified problems with this power bank prior to flight. However, the power bank was stored with a cable in it and the ports uncovered, both factors which can increase the risk of a fault.

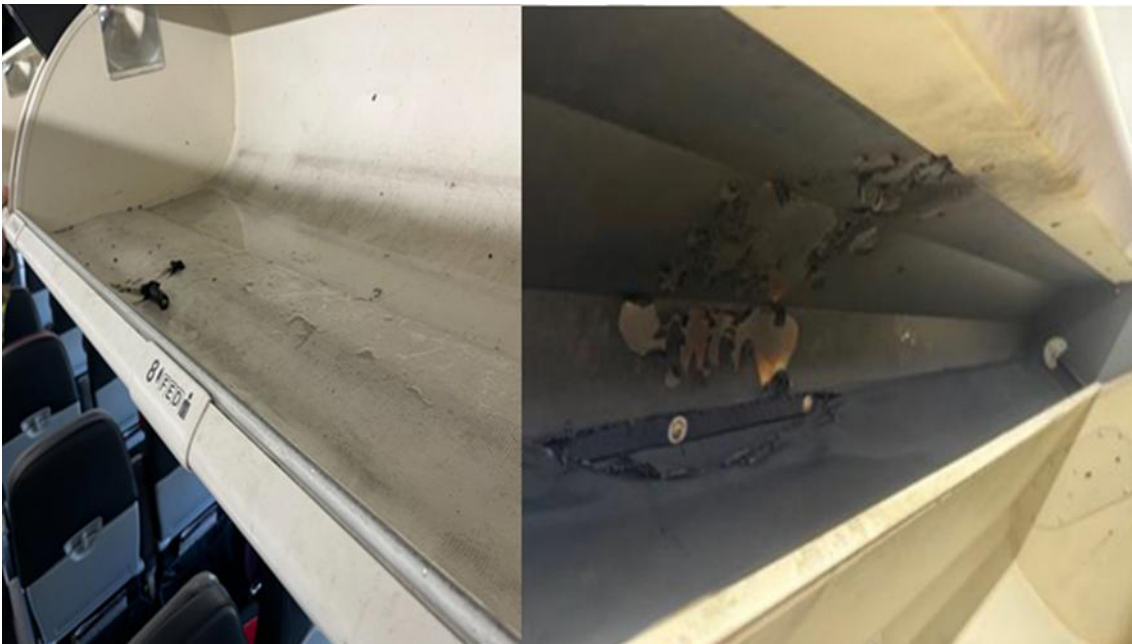
**Figure 7: Overhead locker above row 7DEF where the smoke and flames were observed (left) and area behind the overhead locker showing fire damage (right)**

An inspection of the aircraft found fire damage in the panels above and behind the overhead locker above row 7 and 8 DEF. The passenger service unit containing the reading lights, call bell and information signals under this locker also sustained fire and water damage. The overhead locker needed to be replaced post-fire (Figure 7).
