Premature parachute deployment involving Cessna 208, VH-DVS

over Tully Airport, Queensland, on 20 September 2025

ATSB Transport Safety Report

AO-2025-057

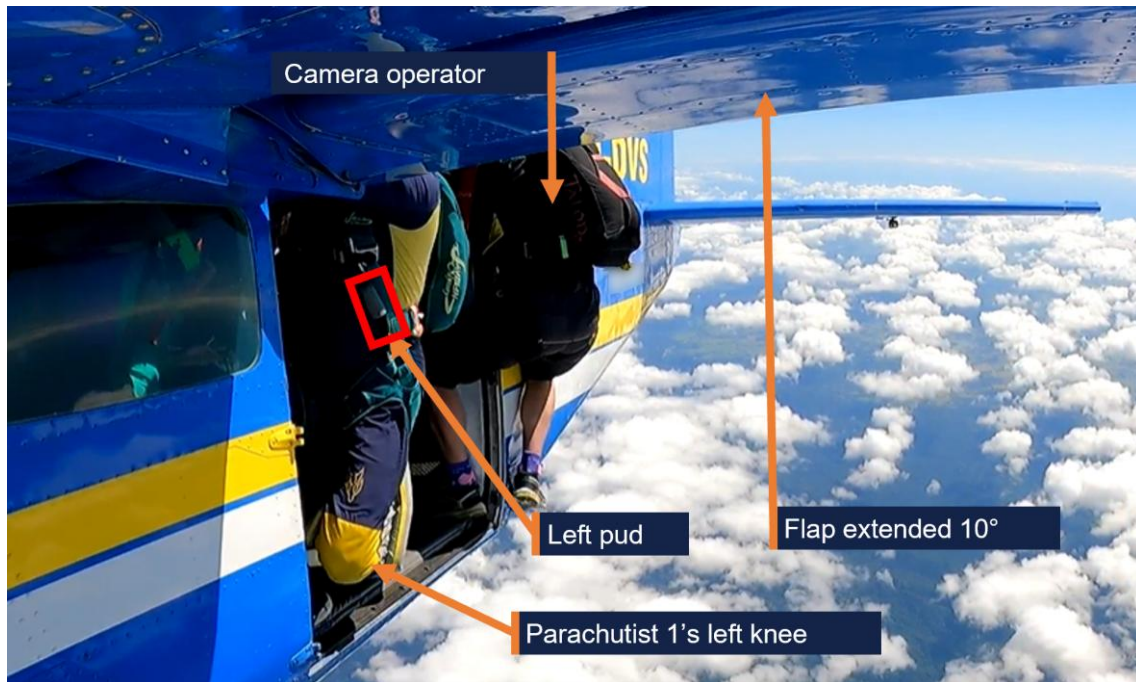
Figure 1: Parachutist 1 stepping out the door

Parachutist 1 then crouched down and stepped out at the front of the doorway facing forwards, into the 'front float' position, with their right foot in the front corner of the door frame and their left knee under the wing (Figure 1).

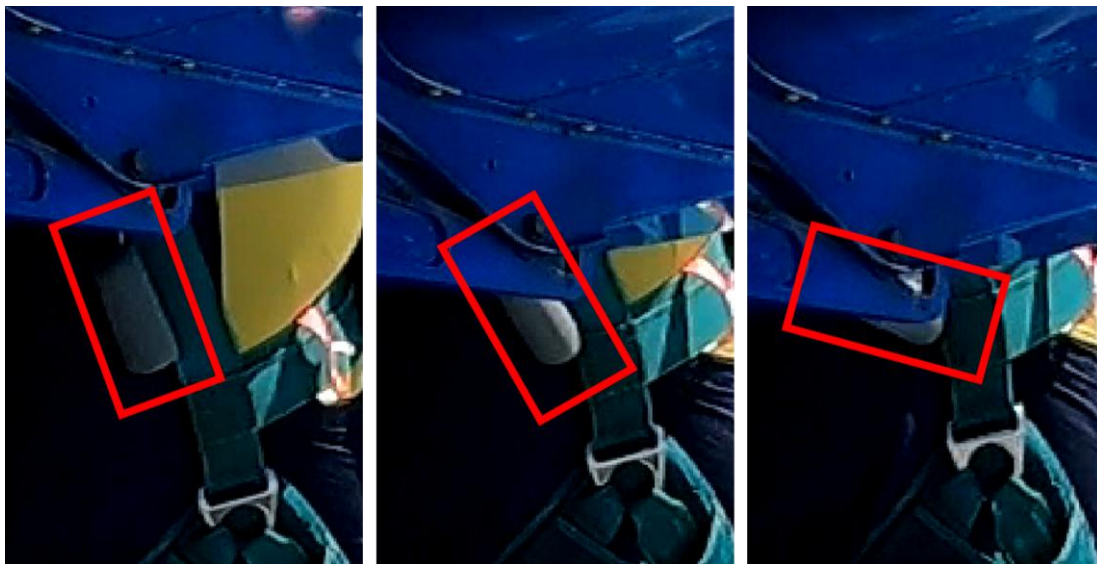
The ATSB found that as the first parachutist climbed out of the aircraft and into the front float position, their reserve handle snagged on the aircraft's flap, resulting in deployment of the reserve parachute. The parachute wrapped around the now-damaged tailplane, resulting in aircraft control difficulties.

Parachutist 1 then stood up outside the door, reaching for a small post on top of the fuselage with their left hand and lifting their left knee under the wing and flap. During this manoeuvre, P1's left handle (pud³) snagged on the wing flap and rotated (Figure 2).

Figure 2: Left pud (outlined in red) snagging on the flap and rotating

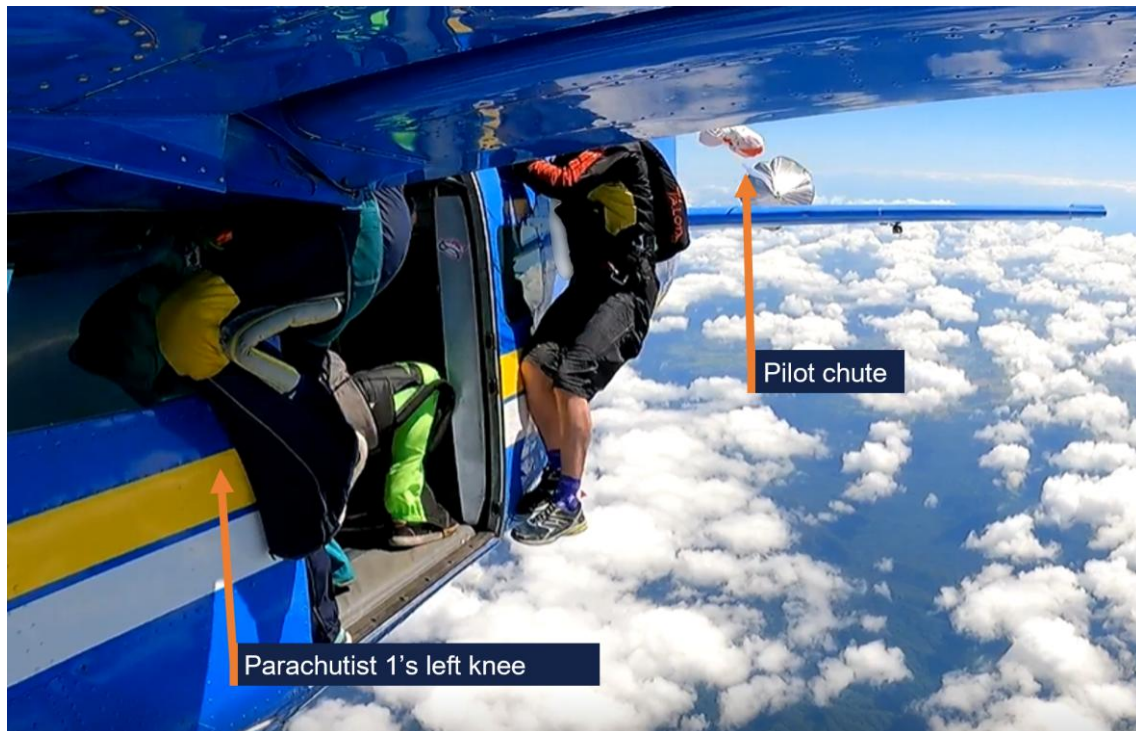
That movement dislodged the pud from the parachute container, deploying its reserve pilot chute (Figure 3).

Figure 3: Pilot chute deployment

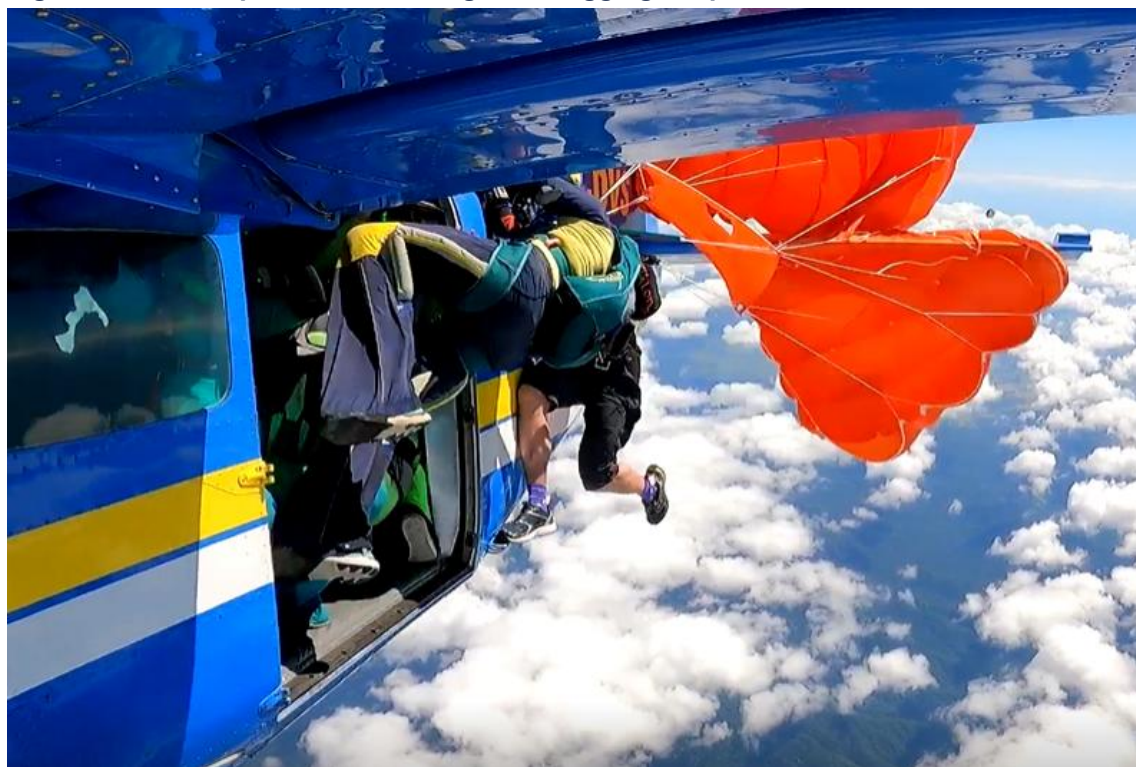
The pilot chute then pulled the reserve parachute and lines out of the container. As the reserve parachute inflated and the lines became taut, P1 was pulled off the side of the aircraft towards the tail, dislodging the camera operator into freefall (Figure 4 and 5).

Figure 4: Reserve parachute inflating and dragging the parachutist rearwards

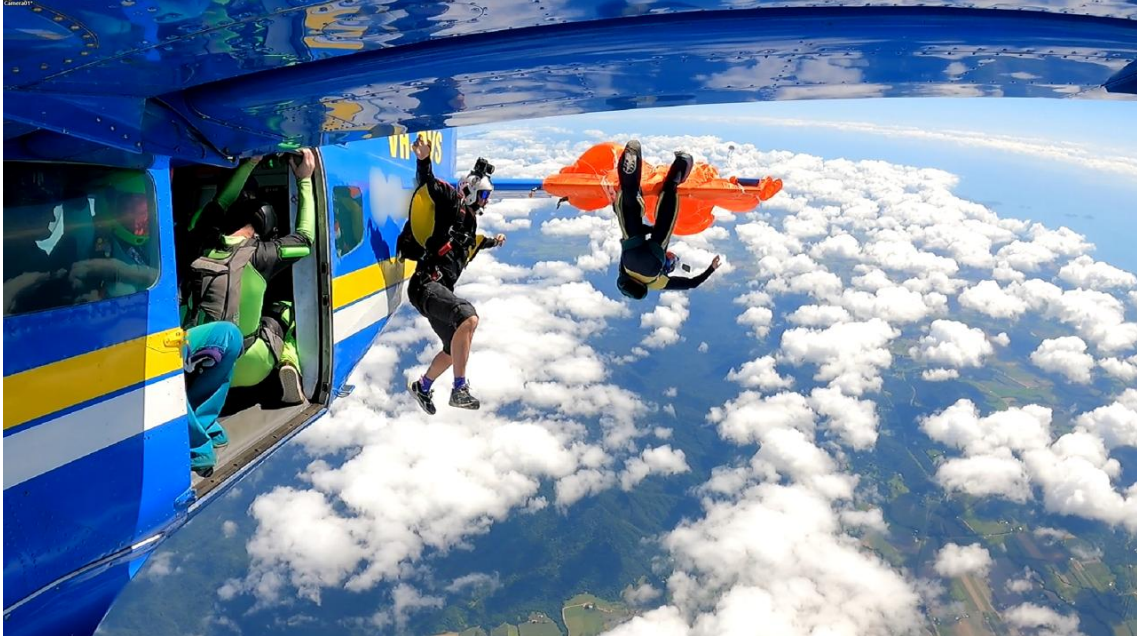
The reserve parachute wrapped around the left horizontal stabiliser and elevator and deflated as P1's lower legs struck the stabiliser (Figure 5). P1 was then suspended beneath the tailplane (Figure 6).

Figure 5: Parachutist 1 striking horizontal stabiliser as camera operator falls free

As the parachutist was pulled rearwards, they struck the camera operator, who was dislodged from the aircraft sustaining a minor shoulder injury. The parachutist's lower legs struck and damaged the leading edge of the horizontal stabiliser, which, combined with the parachute wrapped around the horizontal stabiliser and elevator, resulted in the pilot experiencing difficulties controlling the aircraft. Although not required to be carried, the parachutist had a hook knife, which enabled them to cut themselves free of the aircraft. Without access to the knife, separation from the aircraft may not have been possible. Additionally, although the pilot was wearing an emergency parachute and the roller door was clipped open to aid exiting if control was lost, the pilot was able to maintain sufficient control to land the aircraft without further incident.

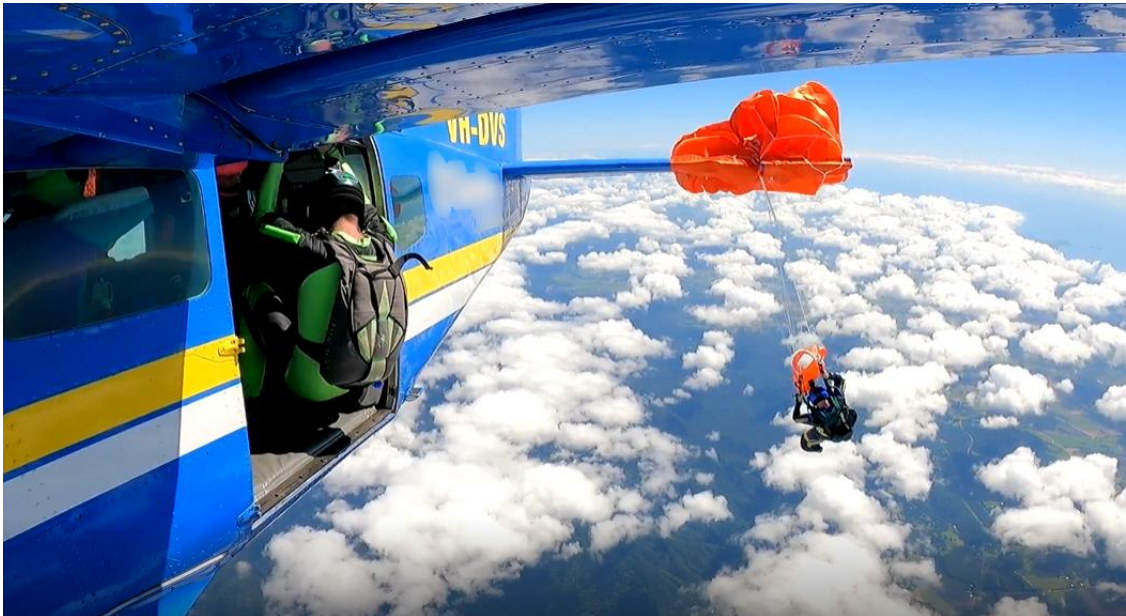
Figure 6: Reserve parachute wrapped around horizontal stabiliser with Parachutist 1 suspended beneath it

around the horizontal stabiliser, combined with damage from impact with the parachutist's legs, resulted in aircraft control difficulties.

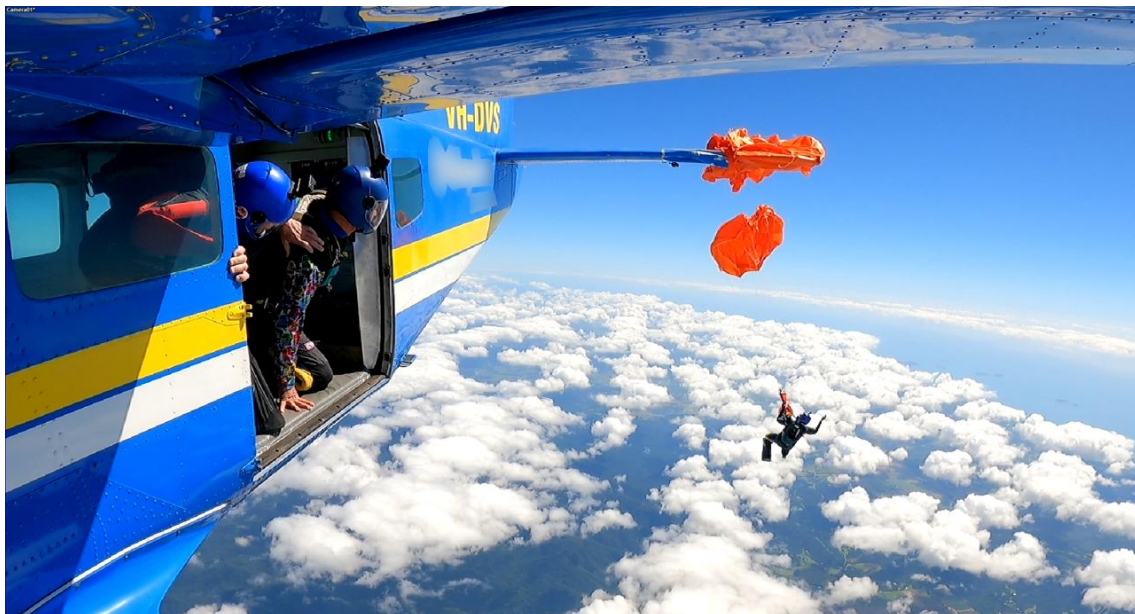
P1 reported that they found the lines harder to cut than expected but managed to cut 11 lines in 50 seconds. The reserve parachute then tore, releasing P1 from the aircraft with part of the reserve remaining on the aircraft's tail. The last 2 parachutists then exited the aircraft.

Figure 7: Reserve canopy torn and parachutist detached from aircraft

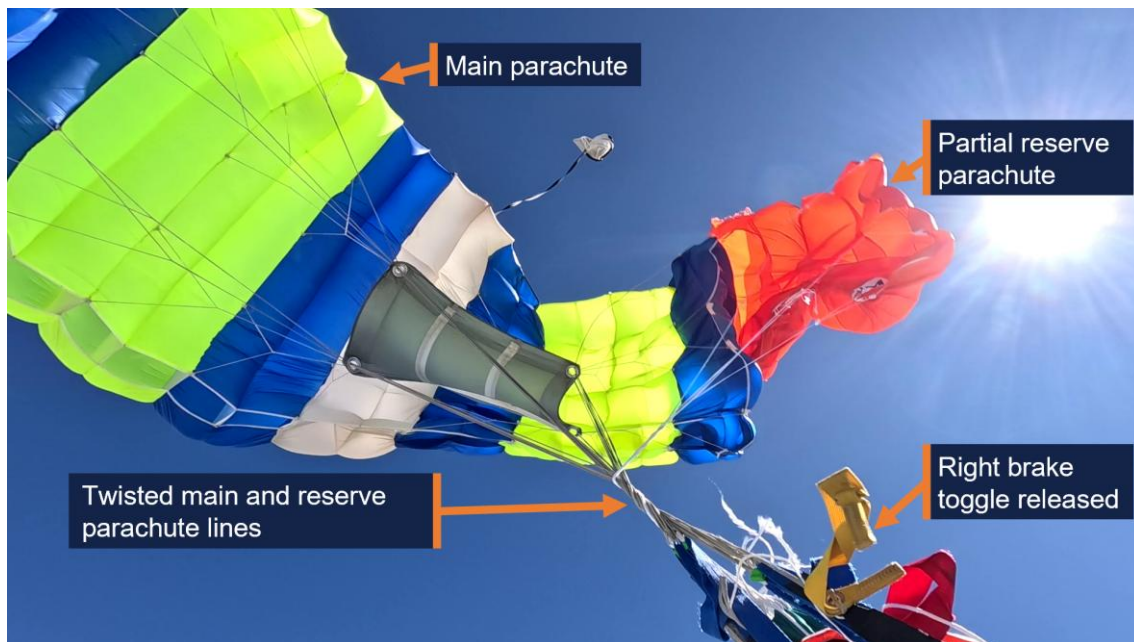
At 1003 while in freefall, P1 used their main pilot chute handle to release the pilot chute out into the airflow, deploying their main parachute. However, during the main parachute deployment, the remaining reserve parachute lines twisted around the main parachute lines. Additionally, during the opening sequence, the right brake toggle⁵ of the main parachute released (Figure 8).

Figure 8: Main parachute opening, left brake stowed and right brake toggle released, twisted main and reserve lines

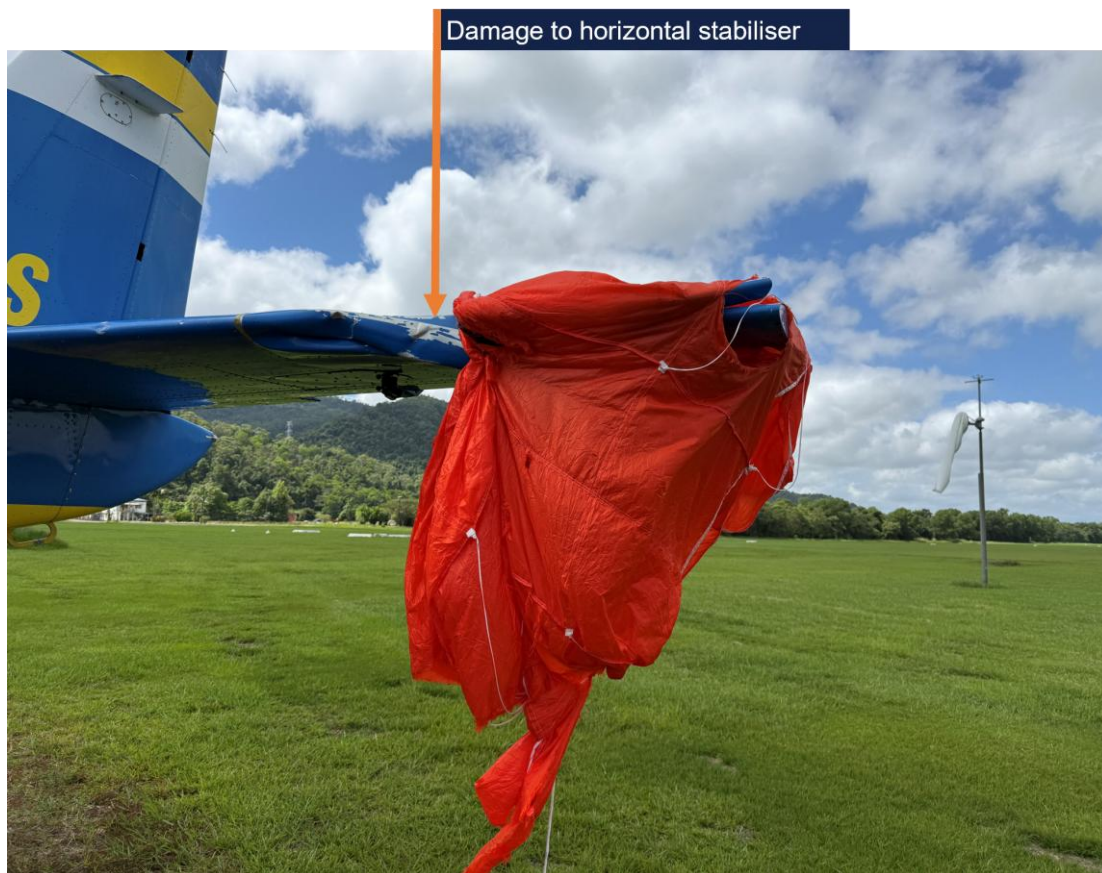
Despite control difficulties due to substantial damage to the horizontal stabiliser and part of the reserve parachute wrapped around the tail, the pilot safely landed the aircraft at Tully Airport.

Figure 9: VH-DVS after landing, showing damage to the horizontal stabiliser

- inspection of the fuselage to horizontal stabiliser attach fittings; no defects found
- inspection of the elevator control cable assembly; no defects found
- left and right elevator control surfaces replaced
- horizontal stabiliser assembly replaced.

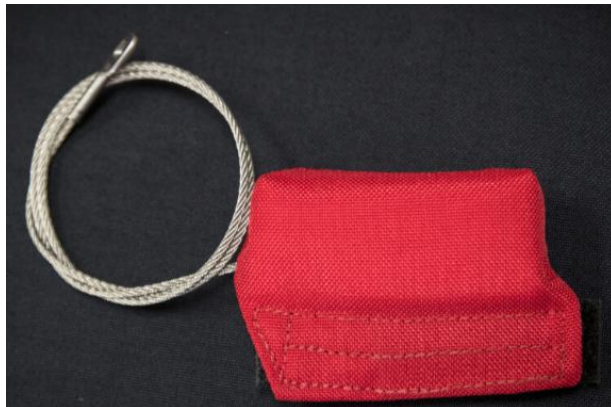
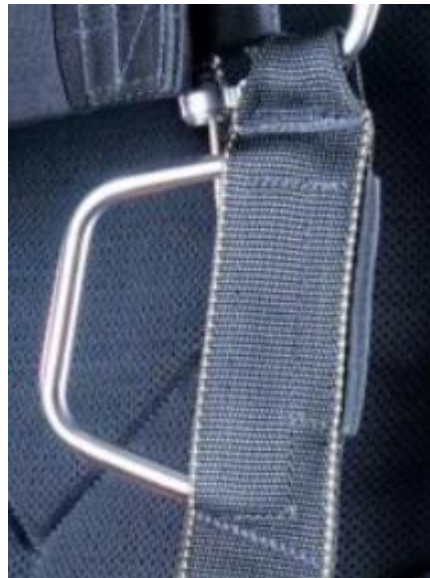
P1 used puds – soft handles held in place with Velcro – for their reserve deployment and main cutaway handles, in preference to ‘D’ handles, which they reported had previously been snag points (Figure 11). The reserve handle was a ‘Phat Daddy Tube Style’, described as ‘a soft handle with the bulk required to get a good grip in an emergency’. The APF assessed that the bulky handle design ‘may have increased the risk of snagging if not adequately protected’.

Figure 11: Pud ‘Phat Daddy’ soft reserve handle (left) and D handle (right)

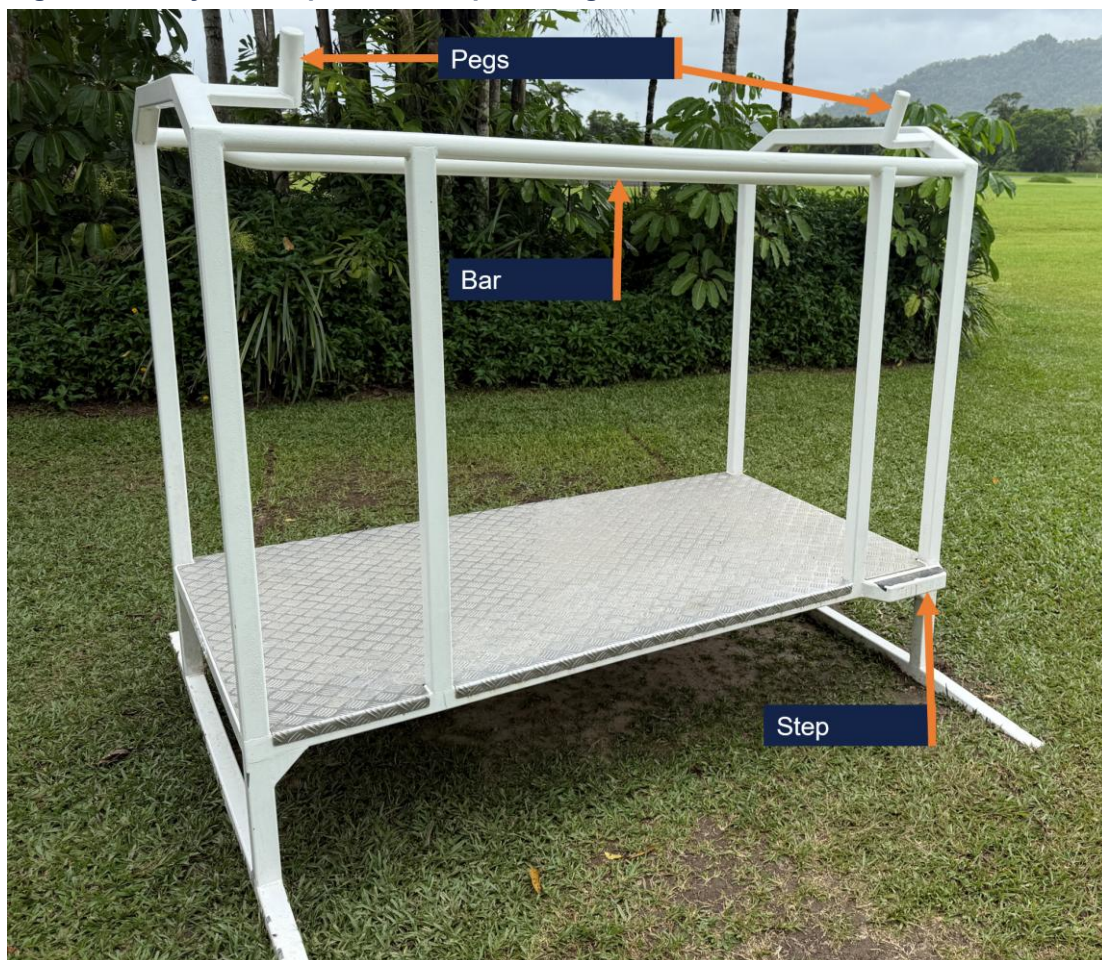
All the event jumps were practised first on the ground as a 'dirt dive' using a mock-up aircraft at the airport. The mock-up had outer pegs and inner bars, but not a wing or flap to simulate their position (Figure 12).

Figure 12: Tully mock-up aircraft for practising 'dirt dives'

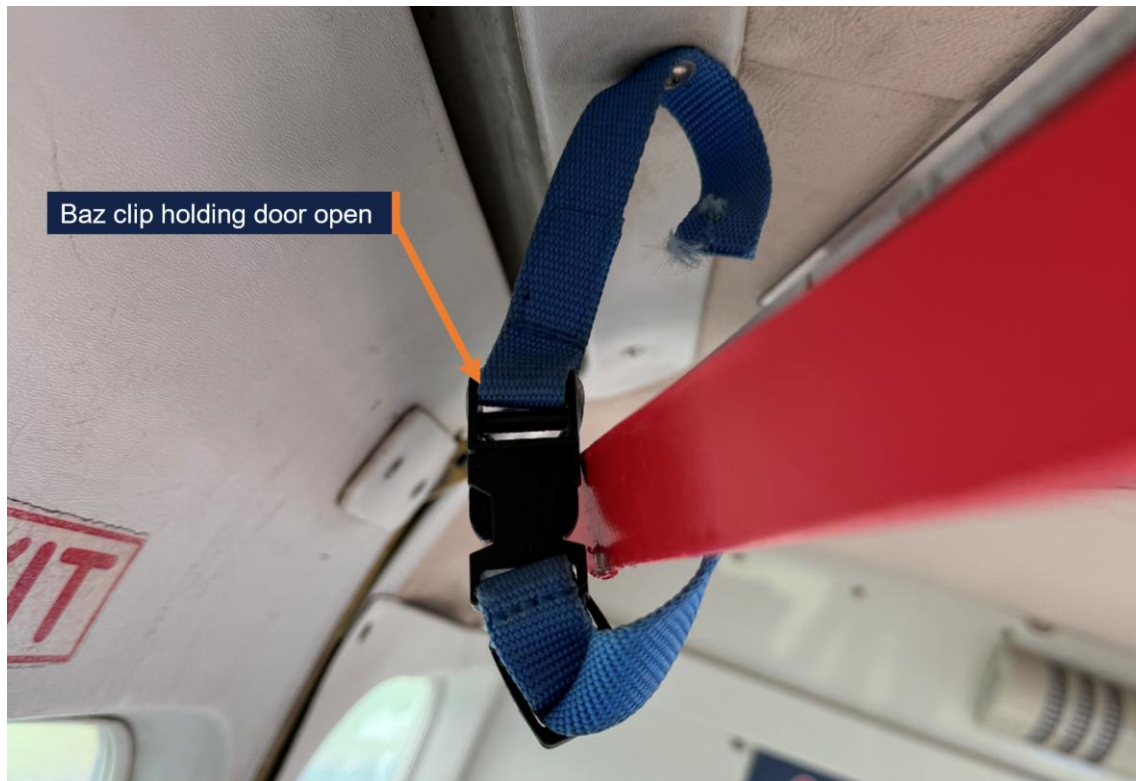
Furthermore, the ATSB found that the parachutists opened the roller door and clipped it open before exiting the aircraft. As a result, the roller door remained open during the descent, increasing the ease with which the pilot could have exited the aircraft if needed. Although not mandatory at the time of the accident, the parachutist had a hook knife attached to their chest strap, enabling them to cut enough reserve parachute lines for the parachute to tear free of the tailplane. Finally, in difficult circumstances, the pilot managed to control the aircraft and return to land safely.

Figure 13: Baz clip securing the roller door open
