Collision with terrain involving Robinson R22 Beta, VH-RDL

Bankstown Airport, New South Wales, on 3 October 2025

ATSB Transport Safety Report
Aviation Occurrence Investigation
AO-2025-059
Preliminary – 17 December 2025

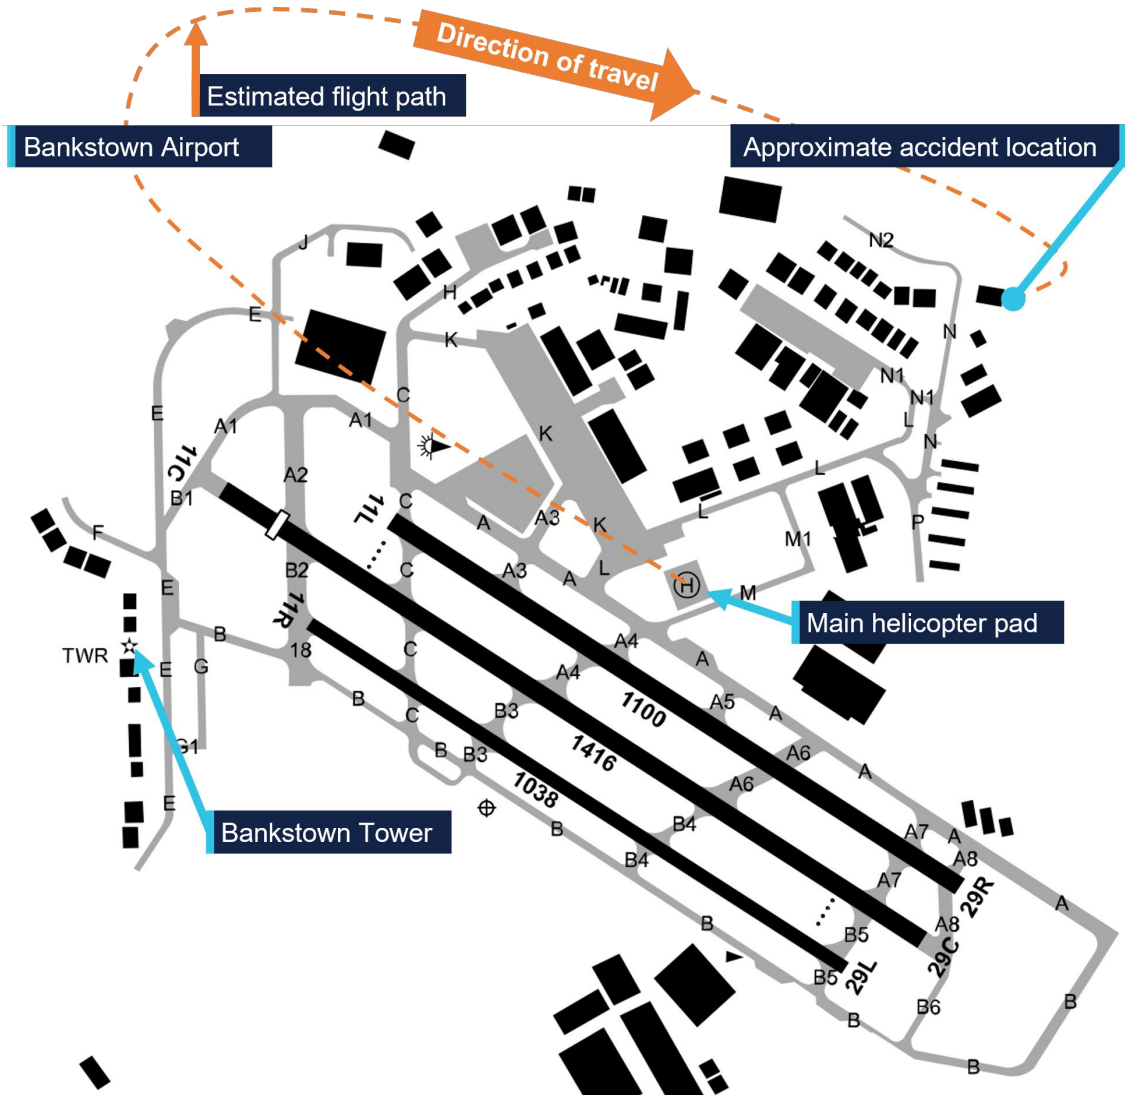
Figure 1: Estimated flight path

The helicopter departed the main helicopter pad (Figure 1) at about 1328 local time. The plan for the flight was to conduct circuits² on runway 29. The student pilot stated to the ATSB that they had planned and prepared to conduct a lesson on practice forced landings. However, due to the weather, the instructor changed the lesson to circuits. Due to the windy conditions on the day, the instructor demonstrated the first circuit, with the student pilot following them on the flight controls.³

At about 1329, the instructor made a downwind position radio broadcast and was cleared by Bankstown Tower air traffic control for a 'stop and go' on the main pad. In interview with the ATSB, the student pilot recalled that, during the downwind leg of the circuit, the helicopter dropped suddenly and they noticed the revolutions per minute (RPM) reduce but could not recall if this was engine or rotor RPM (see section *Helicopter information*). The student also recalled hearing a whistling noise prior to the RPM reduction. Following the sudden drop and RPM reduction, the student recalled that the instructor kept their hands on the controls and continued to fly the aircraft while attempting an autorotation,⁴ and they could not recall the instructor changing any switch positions.

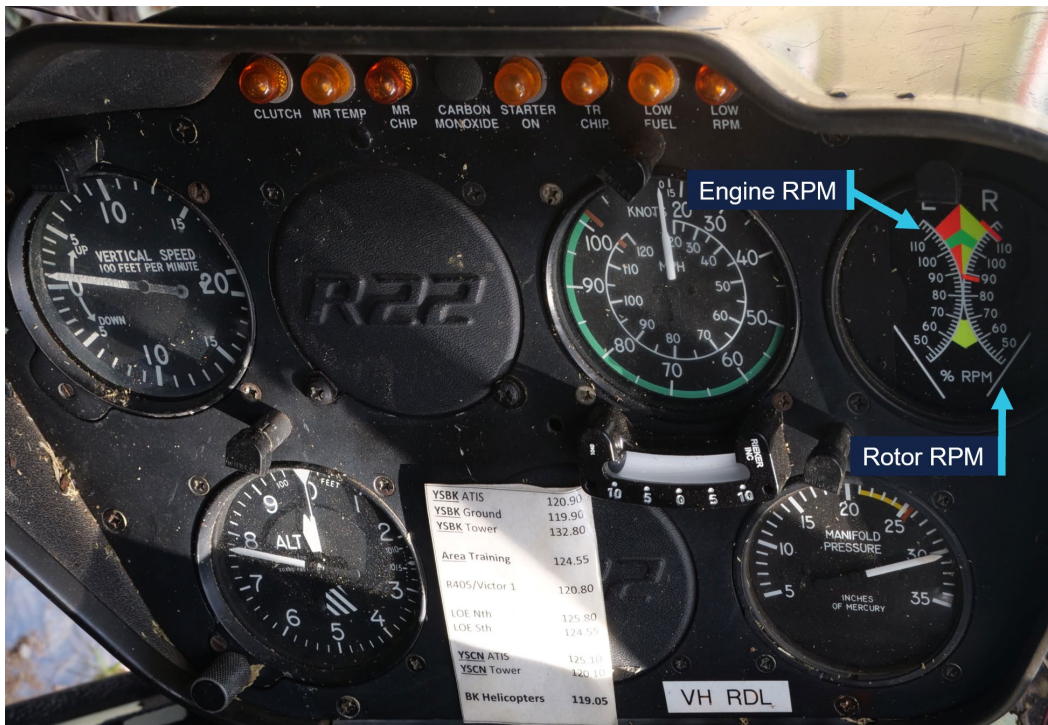
Figure 2: VH-RDL engine and rotor RPM tachometer

The helicopter had a combined engine and rotor RPM tachometer, which was positioned on the right side of the dashboard in front of the student pilot (Figure 2). The left side of the tachometer showed the engine RPM and the right side showed the rotor RPM. The position of the tachometer required the instructor to look across the dashboard to see the instrument.

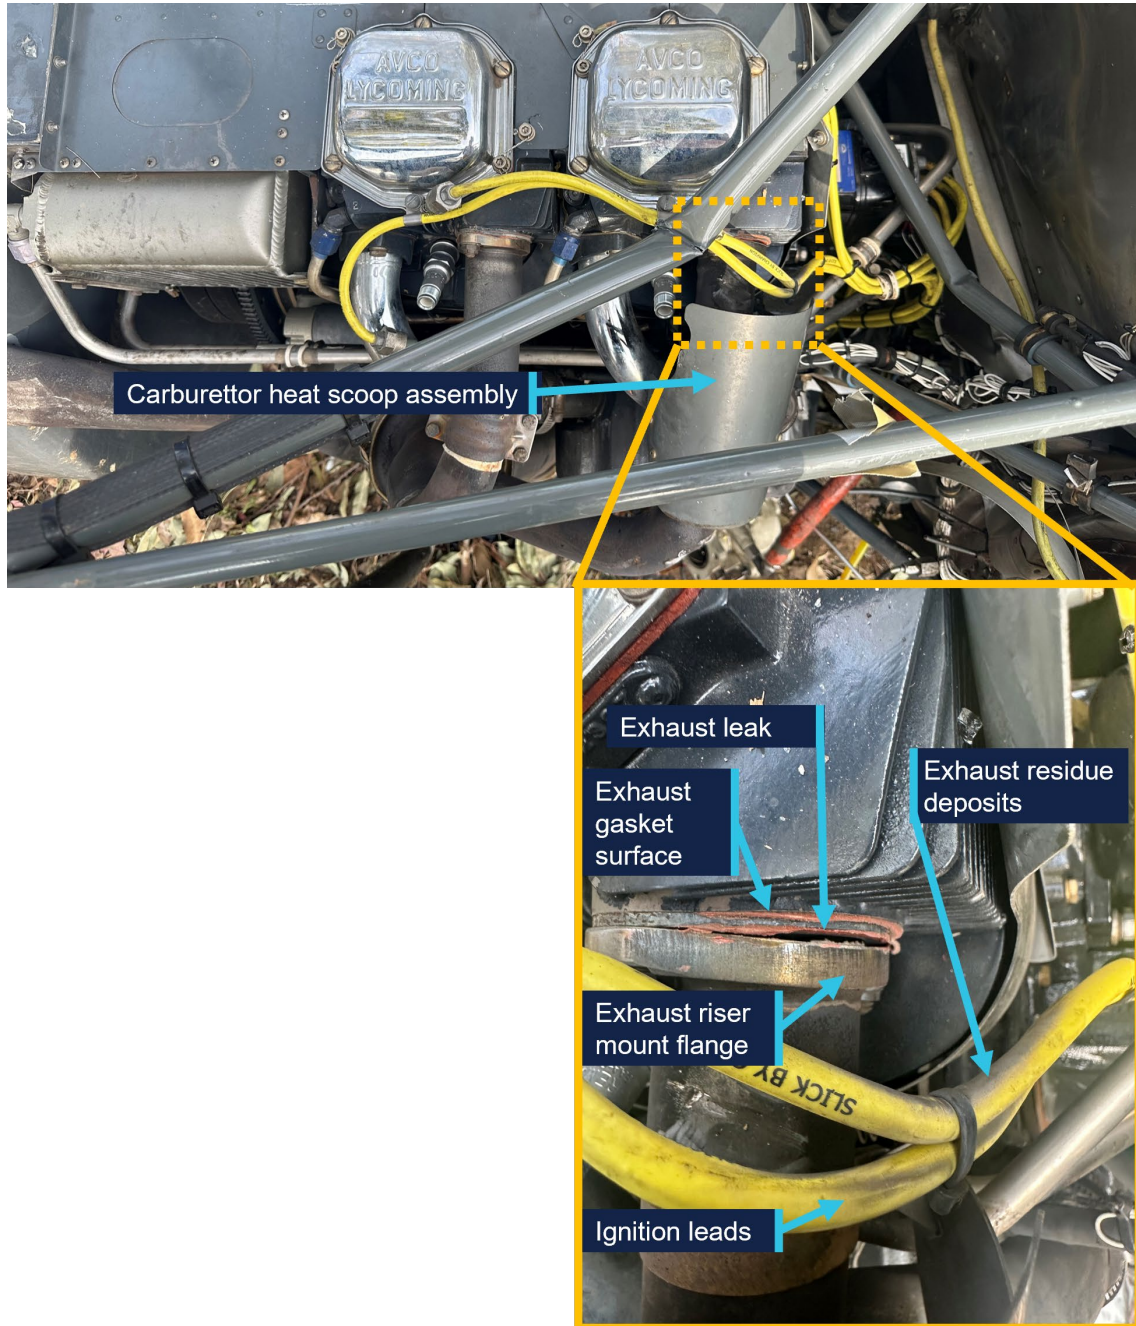
Figure 3: Exhaust leak found during the onsite inspection

It was determined by the ATSB that the engine was intact, and all components were present. Examination of the engine by the ATSB on site identified an absence of physical damage expected of an engine that was operating (rotating) at the time of impact with terrain. The engine examination also found:

- Evidence of an exhaust gas leak between the exhaust riser mount flange/exhaust gasket surfaces of the no 4 cylinder. The leak was attributed to deformation of the flange that created space between the flange and the gasket (Figure 3). This leak was located directly above the carburettor heat intake scoop opening.
- Deposits of exhaust gas products were present on the no 2 and no 4 cylinder ignition leads that were routed beside the no 4 cylinder exhaust riser.
