Exceedance of temporary speed restriction by XPT ST21

Merri-bek, Victoria, on 24 May 2022

ATSB Transport Safety Report
Rail Occurrence Investigation (Defined)
RO-2022-005
Final – 5 December 2025

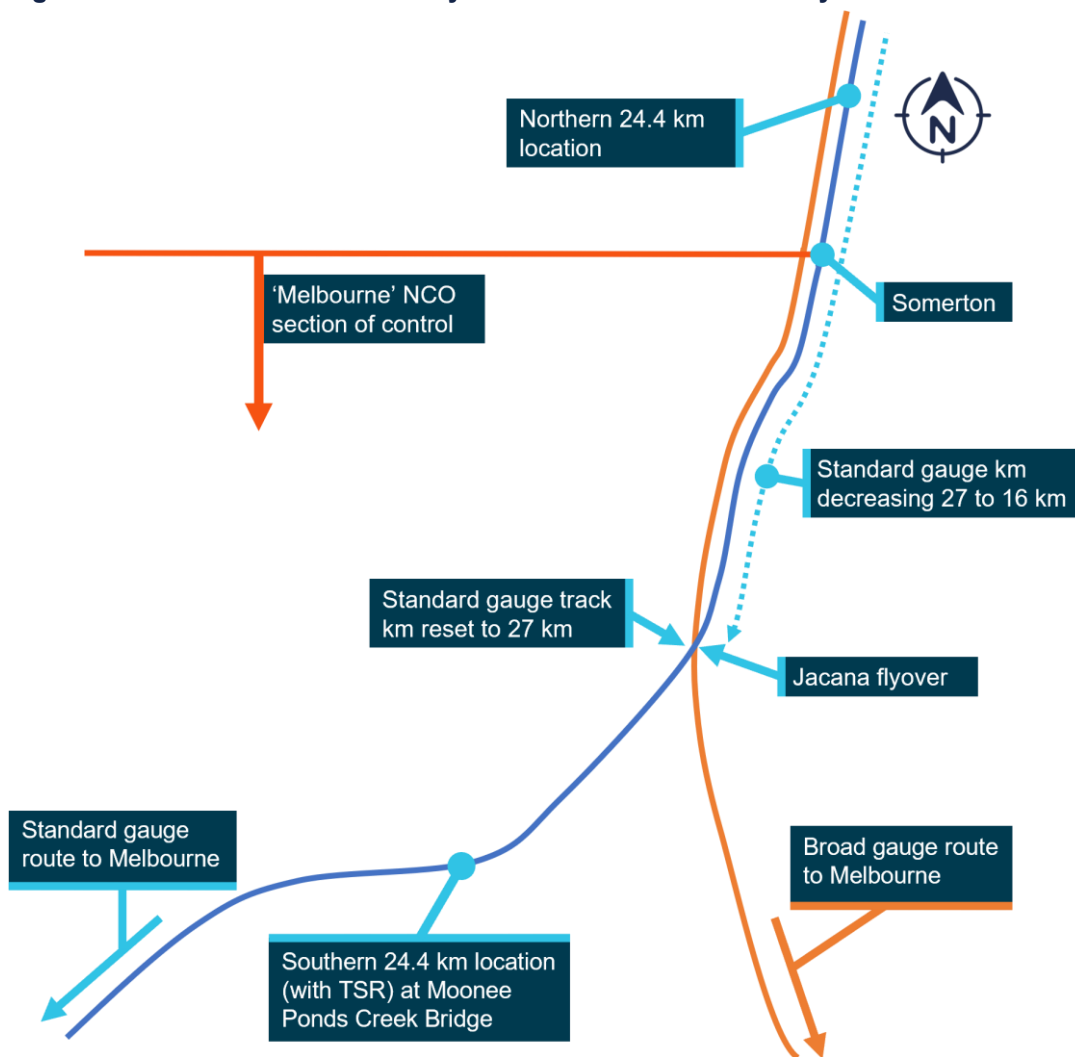
Figure 2: A schematic of the railway routes around the Jacana flyover

The TSR location was on the standard gauge track about 3 km south of a step change in track kilometres at the Jacana flyover (see *Location information*). The step change was due to the longer route of the standard gauge line to Melbourne after it diverged from the broad gauge line at the flyover. This step change resulted in there being two 24.4 km locations about 11 km apart, one either side of the change at the flyover (Figure 2).

The schematic shows the kilometre change at Jacana flyover, the northern and southern 24.4 km locations and the northern limit of the NCO's area of control. It is not drawn to scale.
 Source: Office of the Chief Investigator (OCI)

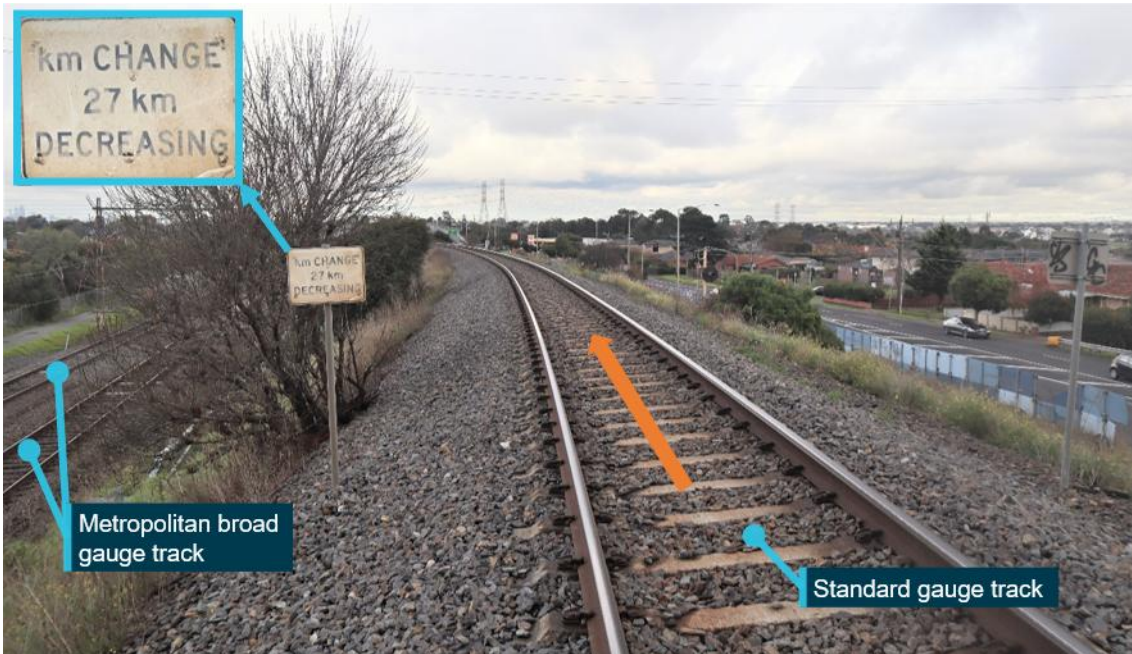
Figure 4: Kilometre change notification on the standard gauge track at Jacana flyover

North of the Jacana flyover, the same track kilometrage was used for the parallel broad gauge and standard gauge tracks. The kilometres on these parallel routes were based on the distance to Melbourne travelling on the broad gauge route. An adjustment was required on the standard gauge track to accommodate its longer route to Melbourne. This adjustment was made at the Jacana flyover at which point kilometrage changed from 16 km back up to 27 km in the direction of travel of ST21 towards Melbourne (Figure 4).

The figure shows the standard gauge track a short distance after it had passed over the broad gauge tracks at the Jacana flyover. The signage indicates a change (from 16 km) to 27 km and then kilometrage decreasing towards Melbourne.
Source: OCI

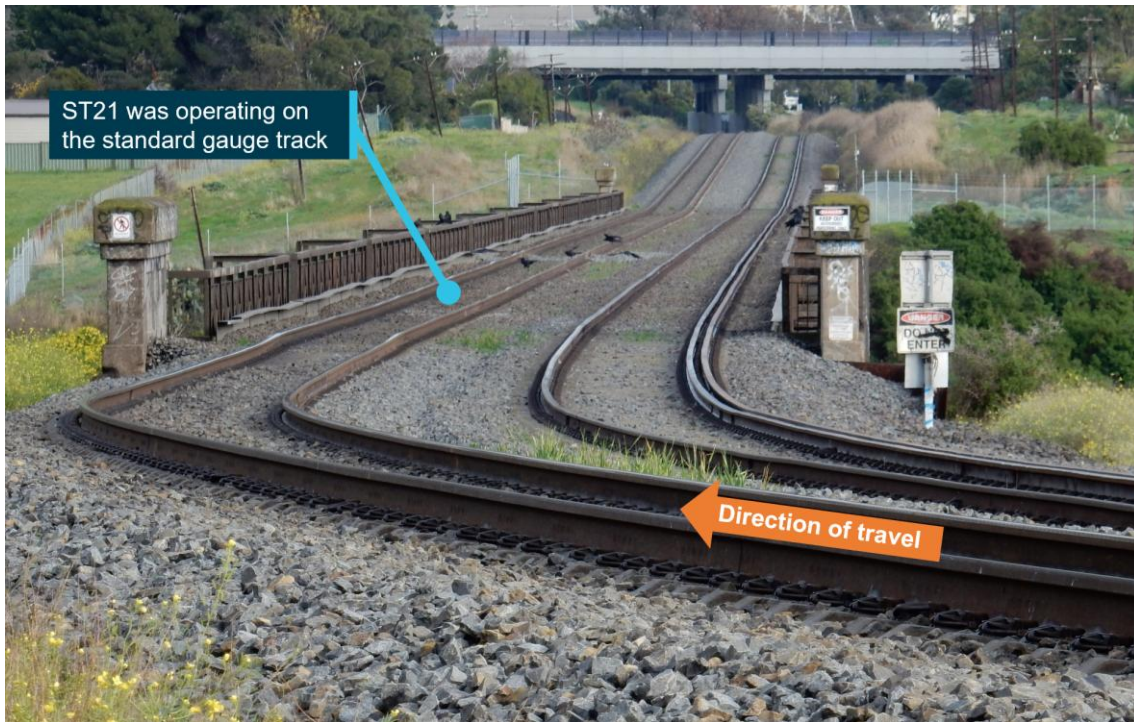
Figure 5: The location of the TSR at the Moonee Ponds Creek Bridge

The 40 km/h temporary speed restriction between 24.0 and 24.4 km encompassed the full length of the bridge (Figure 5). The normal speed for the standard gauge track in this location was 115 km/h. In the direction of travel of ST21, immediately prior to the bridge was a curve with a 95 km/h speed limit.

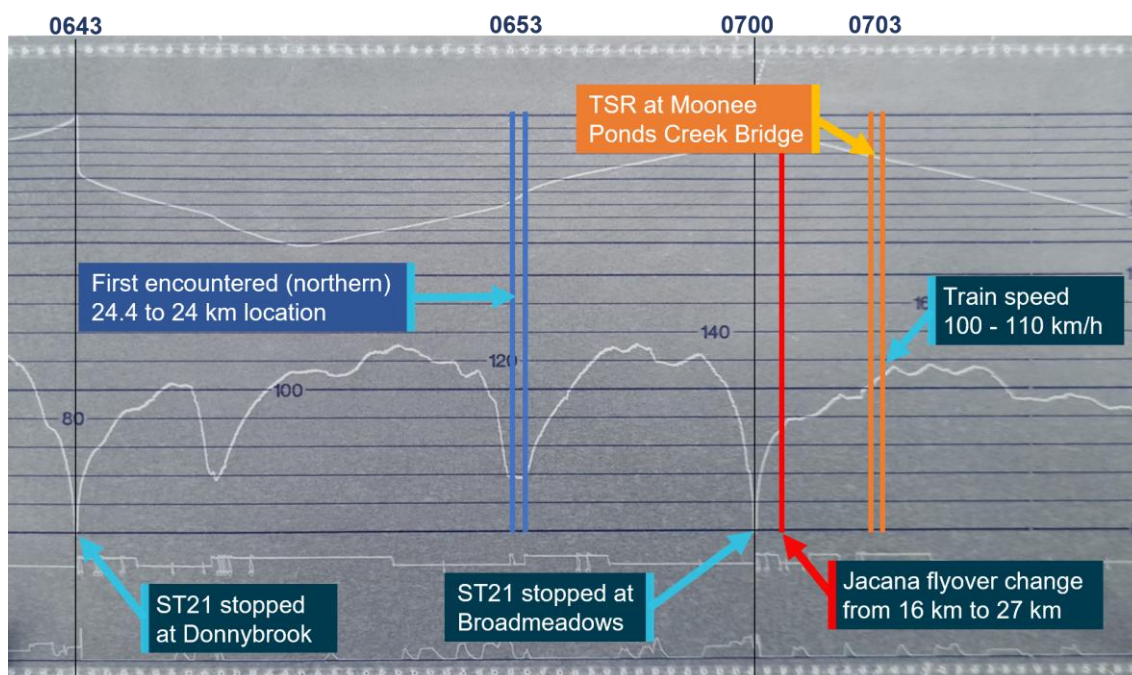
Figure 8: The tape recording from XP2003 showing train speed

This figure shows the approximate train speed after departing Donnybrook. The location where the train slowed to below 40 km/h (the northern location) is shown in blue, and the location of the TSR (the southern location) is shown in orange.
 Source: NSW Trains, annotated by OCI

ST21 slowed at the first 24.4 km location encountered (the northern location). After travelling over the Jacana flyover where the kilometrage reset to 27 km, it then passed the southern 24.4 km location, where the TSR started, travelling at between 100 km/h and 110 km/h. This was below the normal 115 km/h speed limit and consistent with ST21 accelerating out of a preceding curve that had a 95 km/h speed limit.

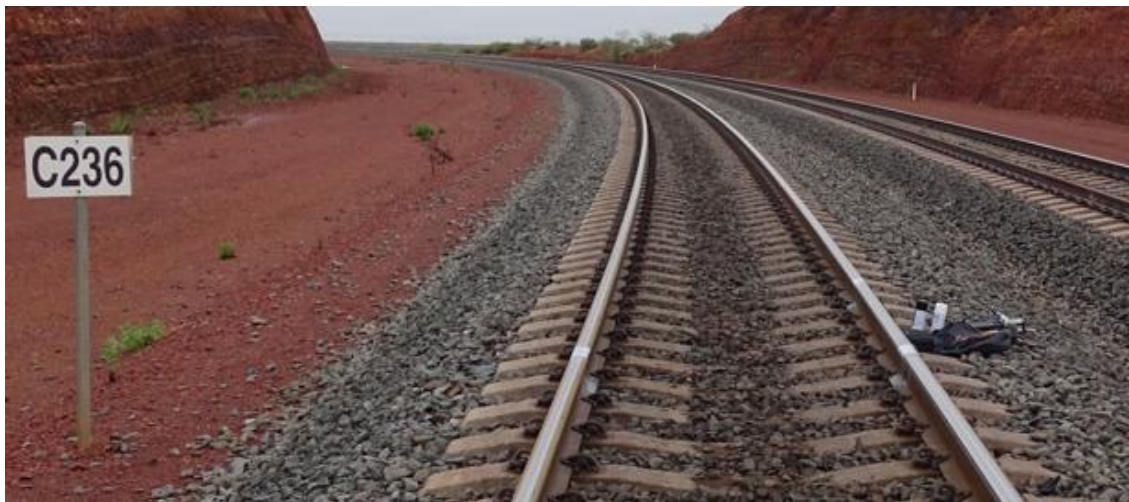
Figure 9: An example location marked using the ‘C’ prefix on an Australian railway

Some other railways have adopted kilometre identification processes that addressed this type of ambiguity. For example, a freight railway in the Pilbara region of West Australia used a prefix on kilometre markings that avoided duplication (Figure 9).
