Loss of control and collision with terrain involving a Morgan Cougar Mk1 aircraft, VH-LDV

19 km north-north-west of West Sale Airport, Victoria, on 16 November 2024

ATSB Transport Safety Report

AO-2024-058

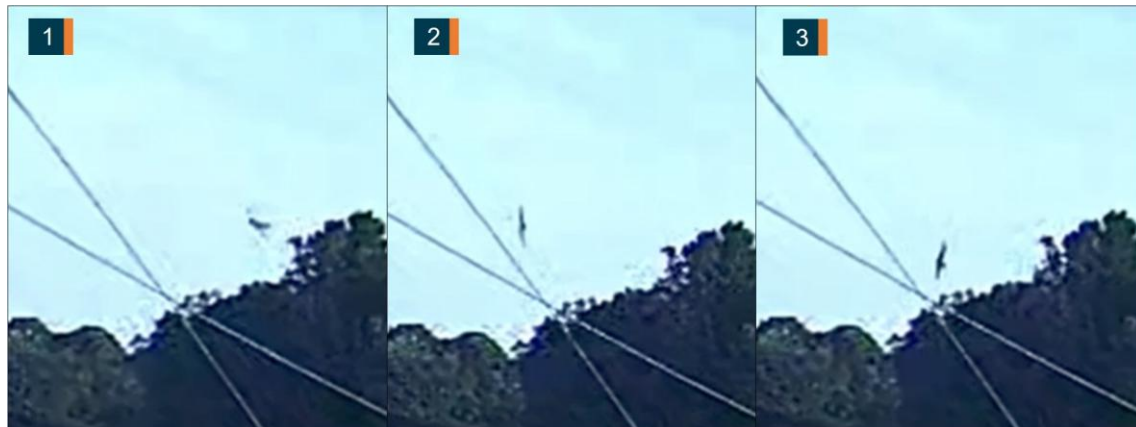
Figure 3: CCTV footage of final turn

A closed-circuit television (CCTV) camera, located about 700 m north-north-east of the accident site, captured the aircraft entering a left turn towards the camera on its third orbit (Figure 3 [1]). During the turn the angle of bank increased to a steep turn attitude (Figure 3 [2]) before the nose of the aircraft pitched down and the aircraft descended in the left turn behind trees (Figure 3 [3]).

One of the witnesses reported that, as the aircraft approached them for a third pass, it did a hard left turn and then appeared to be falling and not gliding towards the ground, as though it did not have enough speed. They reported that the wings levelled after the turn and it landed very hard on its belly and immediately caught fire. The second witness saw it bank hard left and fall out of the sky but did not see the collision. The 3 occupants were fatally injured, and the aircraft was destroyed.

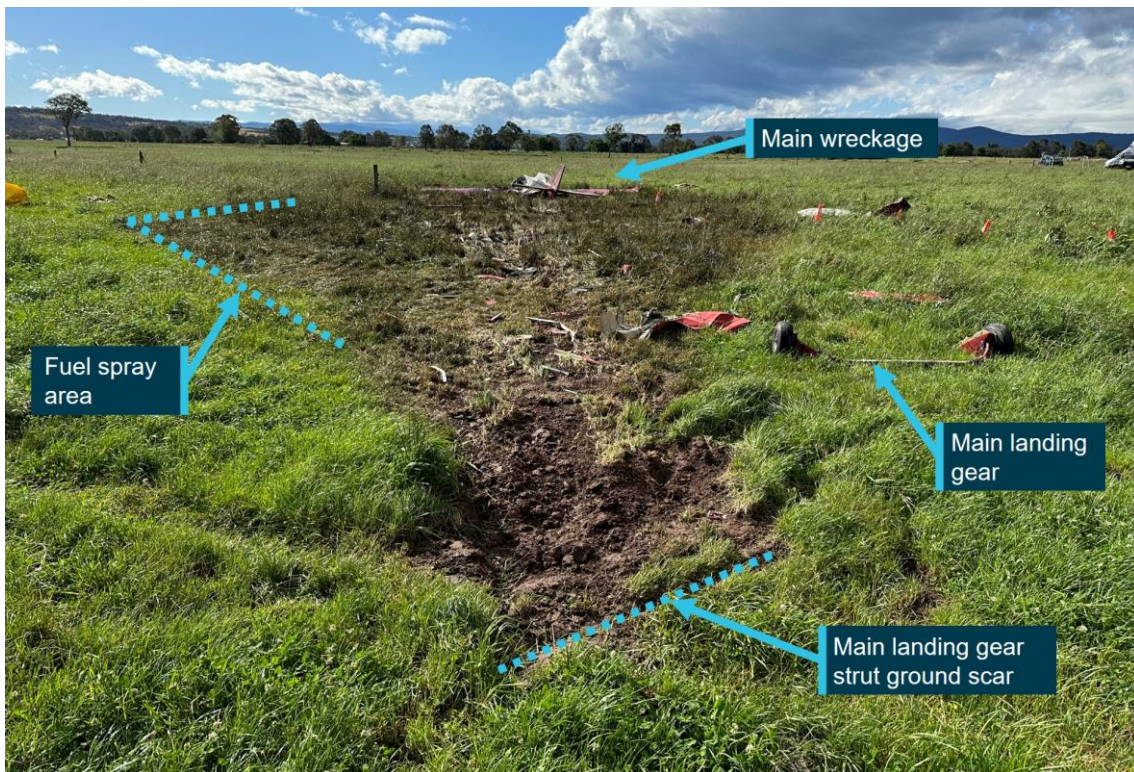
Figure 4: Accident site

The aircraft impacted flat and open terrain at an elevation of about 130 ft and produced a ground scar on a track of 315° T (Figure 4). The length of the wreckage trail was 30.3 m from the first ground scar to the propeller spinner, with the fuselage resting on a heading of 303° T. Impact analysis indicated the aircraft struck the ground in a slight left wing low and close to level pitch attitude, which was consistent with the witness report of the collision.

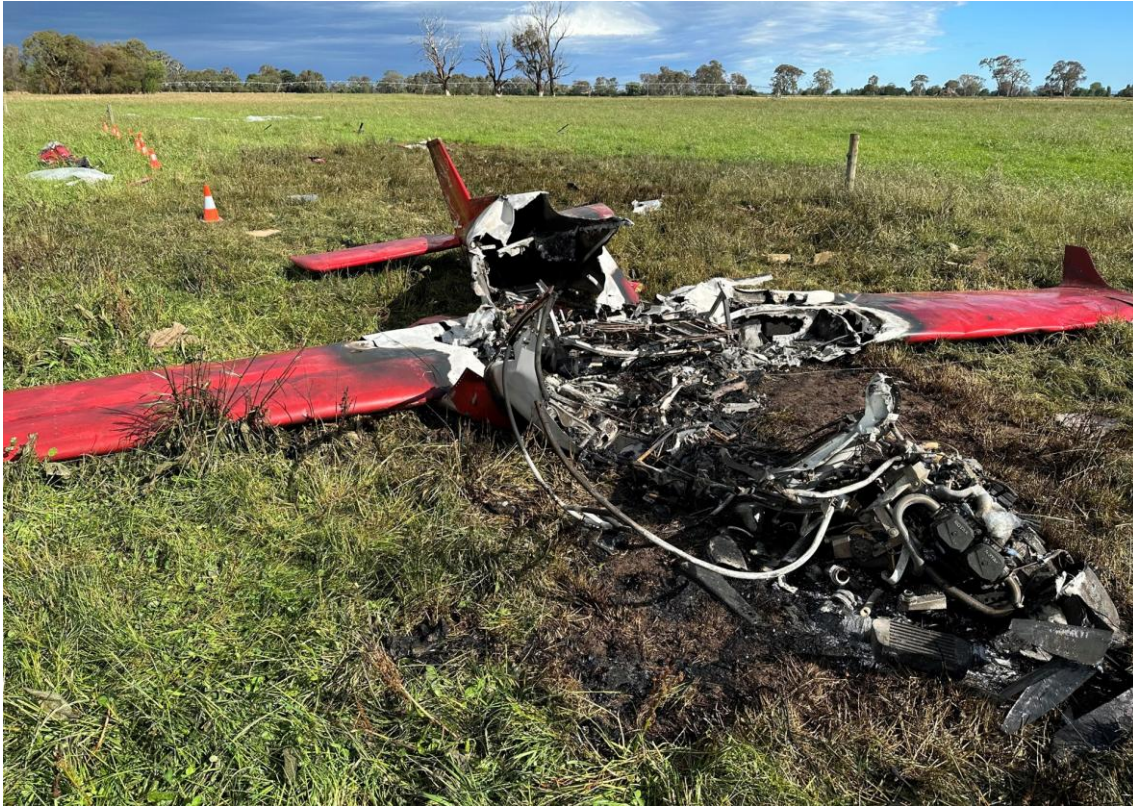
Figure 5: Fire damage to the aircraft

There was a delta-shaped fuel spray and debris pattern along the wreckage trail. A fuel-fed fire occurred after the ground impact, however, most of the fire damage to the aircraft was confined to the fuselage within the area bounded by the firewall,¹ aft bulkhead (behind rear seats) and the inboard sections of the wings (Figure 5). The engine and propeller were also affected by the post-impact fire, but to a lesser extent than the fuselage. The wings and tailplane (except the rudder) remained attached to the fuselage. The rudder was found in the wreckage trail.

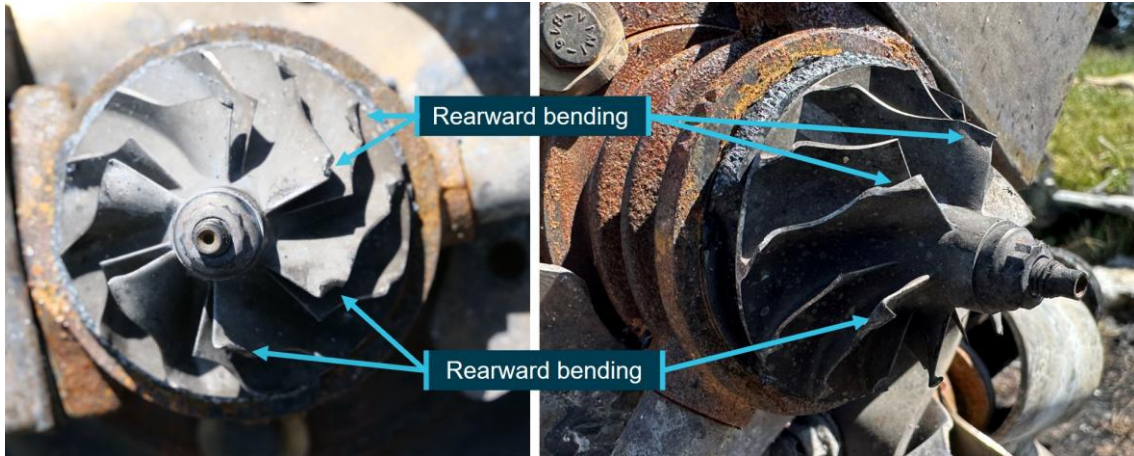
Figure 6: Rearward bending of turbocharger compressor vanes

The turbocharger compressor scroll was found separated from the turbocharger and directly below the turbocharger assembly. The scroll exhibited an overstress failure, with fracture surfaces but no scoring. Several turbocharger compressor vanes exhibited bending in the opposite direction of rotation, which indicated the compressor was running at impact (Figure 6).

The use of non-metallic propeller blades increased the uncertainty in the engine power assessment. However, in combination with the turbocharger compressor damage it was concluded that the engine was operating at impact, but the power level could not be determined.

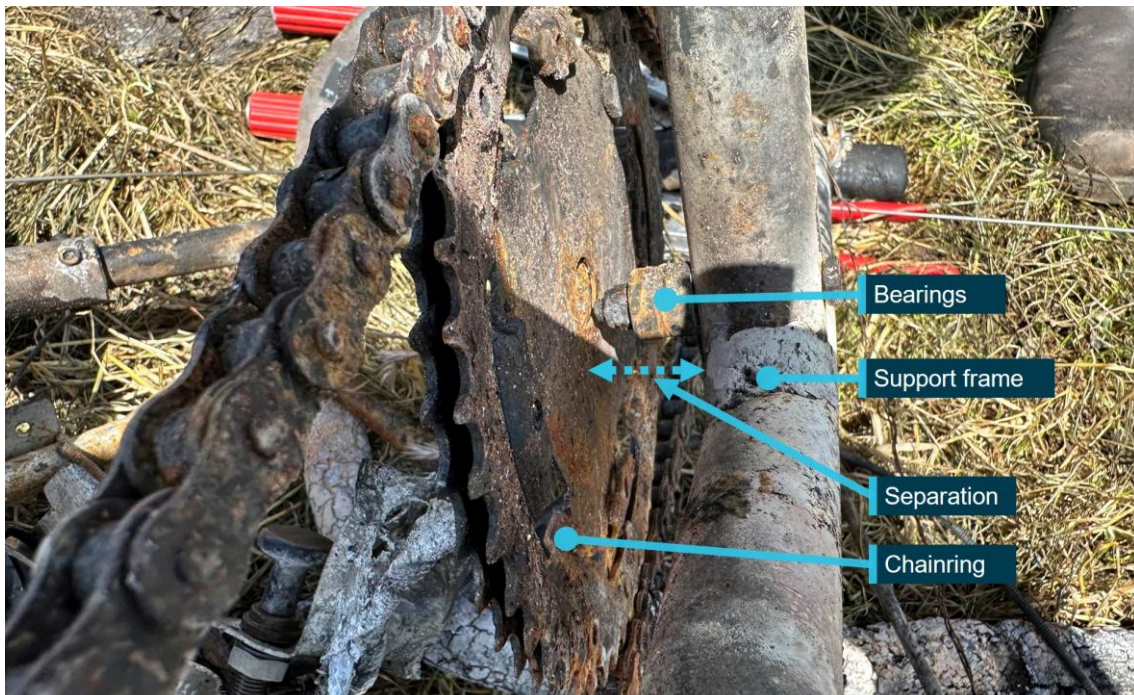
Figure 7: Chainring separation from bearings and support frame

While ATSB investigators were handling the yoke controls for inspection and photography, the chainring, which was part of the aileron control, separated under gravity from its bearings and support frame (Figure 7). However, given that they were not found separated, and that the aircraft attitude was recovered towards wings-level before the collision, it was concluded that the controls did not separate in-flight. The chainring and bearings were retained for further examination at the ATSB technical facility and details of that examination are provided in *Appendix A – Examination of the flight controls*.

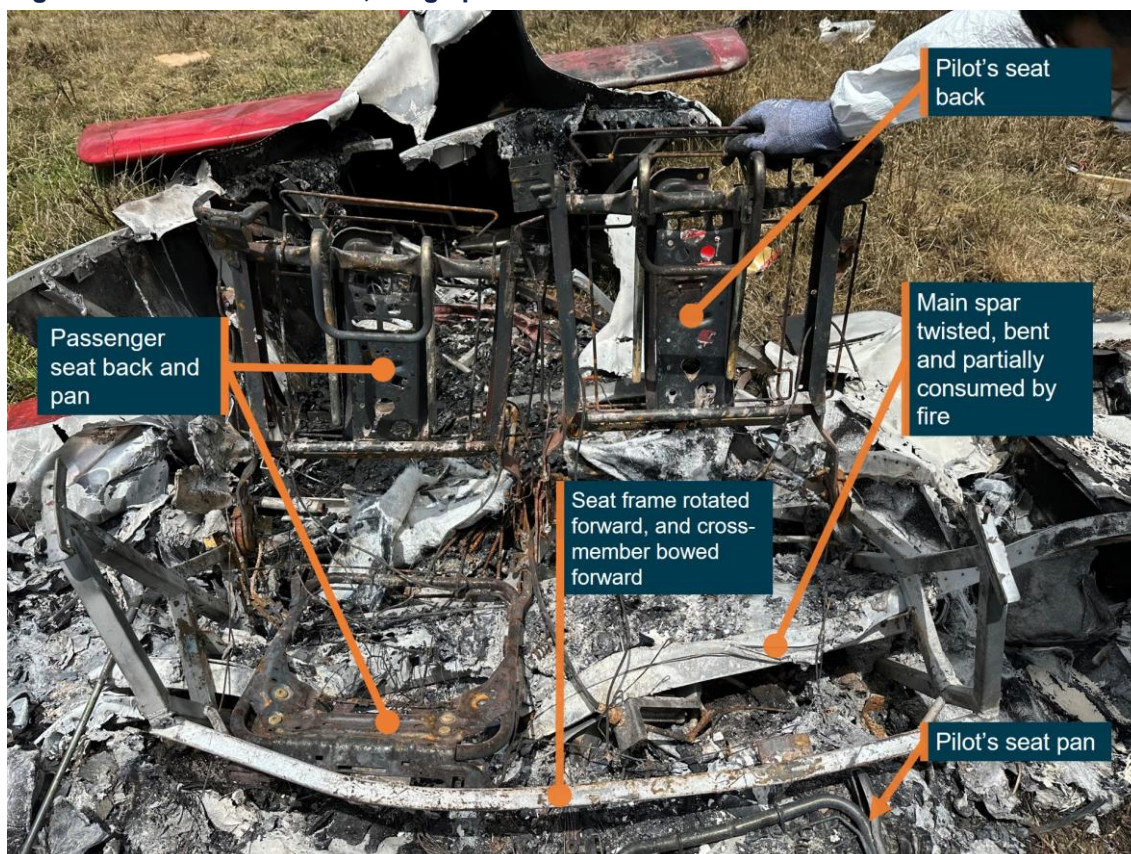
Figure 8: Aircraft seat frame, wing spar and seats

The aircraft was designed and built with 2 front seats and a 2-place rear bench-seat arrangement. The front seats were found in the wreckage, and their rear mountings were attached to the fuselage seat frame aluminium angle cross-member. The steel bolts used to mount the rear of the seats to the aluminium angle were present and fastened. The forward steel cross-member for the front seats was bowed forward (Figure 8). The right seat pan was retained by the seat back and appeared to have collapsed onto the main wing spar,² located underneath the front seats. The left front seat pan had separated from its seat back and was found in front of the seat frame forward cross-member.

The rear seats were upholstered 4 mm plywood mounted to the cross-members. The front seats were car seats, which were attached to cross-members and had the main wing spar underneath them. The front right seat pan was found collapsed onto the wing spar and the left seat pan had separated and was found forward of the front seat frame structure. None of the seats incorporated any recognisable form of energy attenuation.

However, poorly designed seats can produce spinal fracture in impacts as low as 8-10G. Typically, spinal fractures in low to moderate velocity crashes are caused by mounting seats above rigid panels or other non-frangible objects such as batteries and from mounting relatively rigid seats directly on bulkheads or over beams. In the first case, seats collapse onto unyielding objects causing the occupants to experience excessive vertical accelerations. In the latter case, rigid bulkheads or structural members transmit excessive forces from the ground directly to the seat occupants.

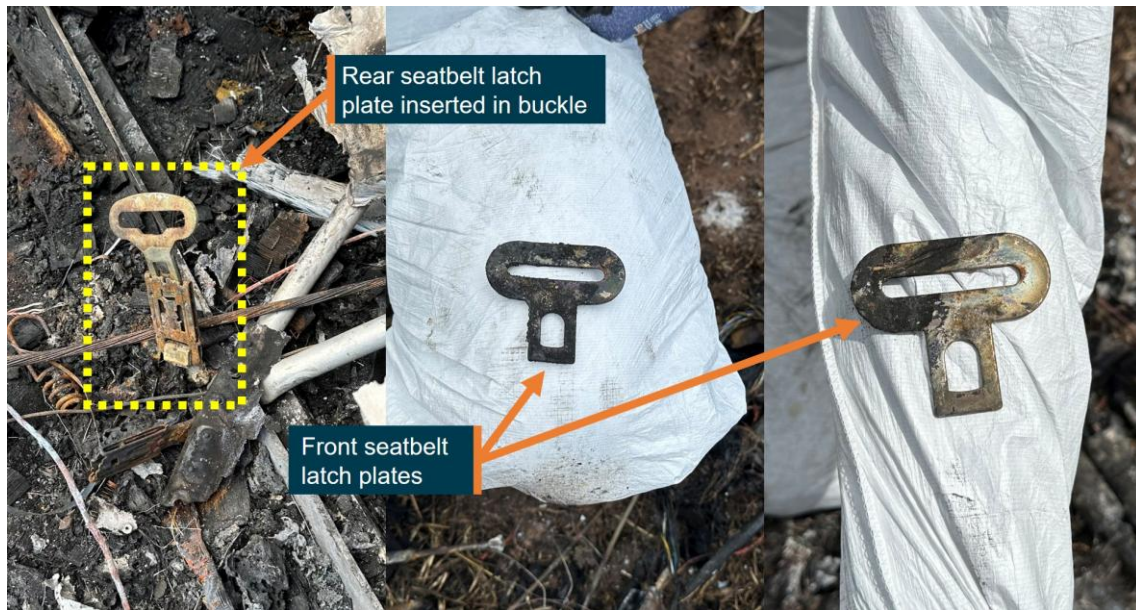
Figure 9: Aircraft seatbelt latch plates

it was likely that car seatbelts were fitted and the front seatbelts failed in the accident, which resulted in the front seat occupants being ejected from their seats.

Both front seatbelt latch plates were found separated from their buckles and their associated harnesses were destroyed by the fire (Figure 9). The rear seats and seatbelts were destroyed by the post-impact fire. However, the seatbelt latch plate for the rear seat occupant was found in its buckle.

The pilot and front right seat passenger were ejected from their seats during the accident, and their seatbelt latch plates were found separated from their respective buckles. The rear seat occupant appeared to have remained restrained and was found in the rear right seat location with their seatbelt latch plate attached to the buckle. The pilot was seen wearing a 3-point harness in videos taken during the accident flight. Therefore, it was considered very likely that all 3 occupants were wearing their seatbelts.

It is strongly recommended that US [United States] FAA [Federal Aviation Administration] Technical Standard Order (TSO) approved or equivalent seat belts be installed along with approved shoulder harnesses.

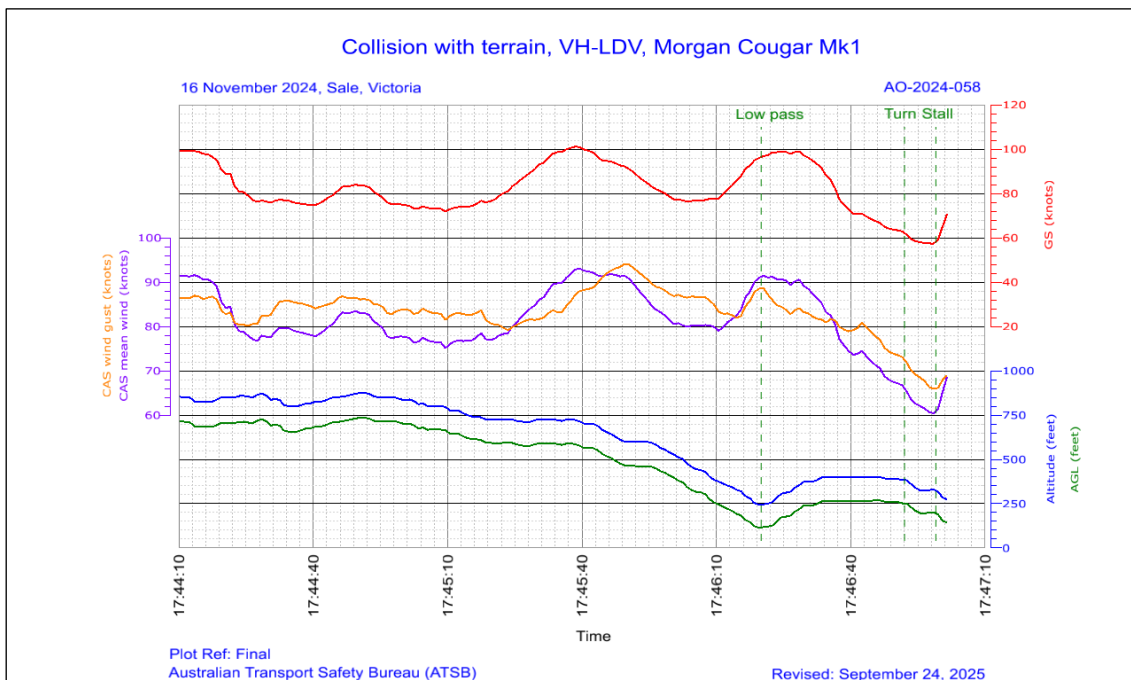
Figure 10: Plot of ADS-B data and CAS calculations

The final turn started at 1746:52 at 64 kt (67–74 kt CAS) and 269 ft AGL. The nose drop observed in the CCTV footage during the final turn, followed by a rapid descent, was indicative of an aerodynamic stall⁴ in a steep turn. The stall likely occurred at 1746:59 at 56 kt (59–65 kt CAS) and 221 ft AGL. After the stall there was an abrupt reduction in altitude and increase in speed, consistent with initiation of a stall recovery (Figure 10).

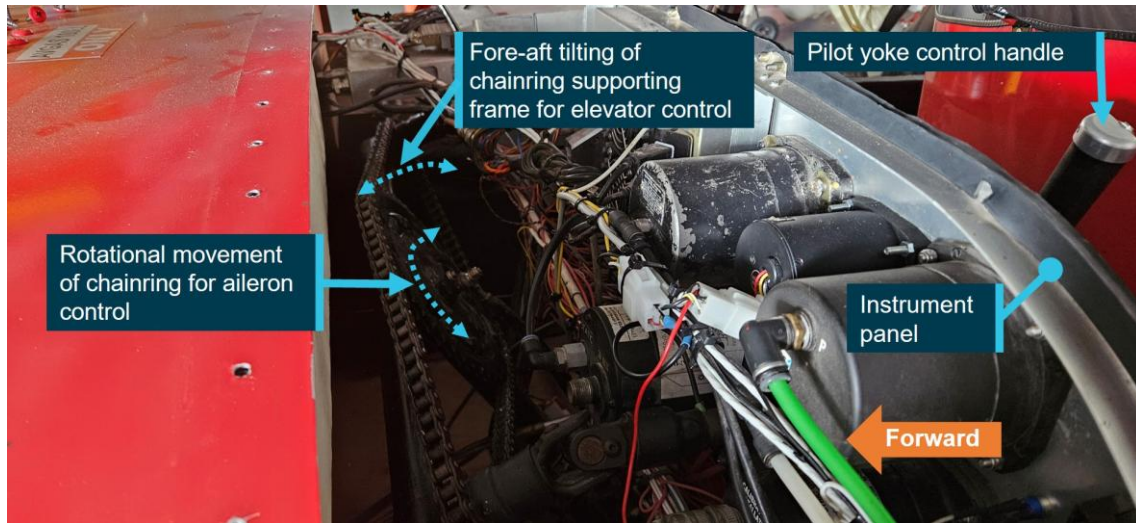
Figure 12: Location and movement of chainring

Examination of the flight control system chainring and bearings included a photographic review of the chainring at the wreckage site and as installed in the aircraft pre-accident, which was behind the instrument panel (Figure 12).

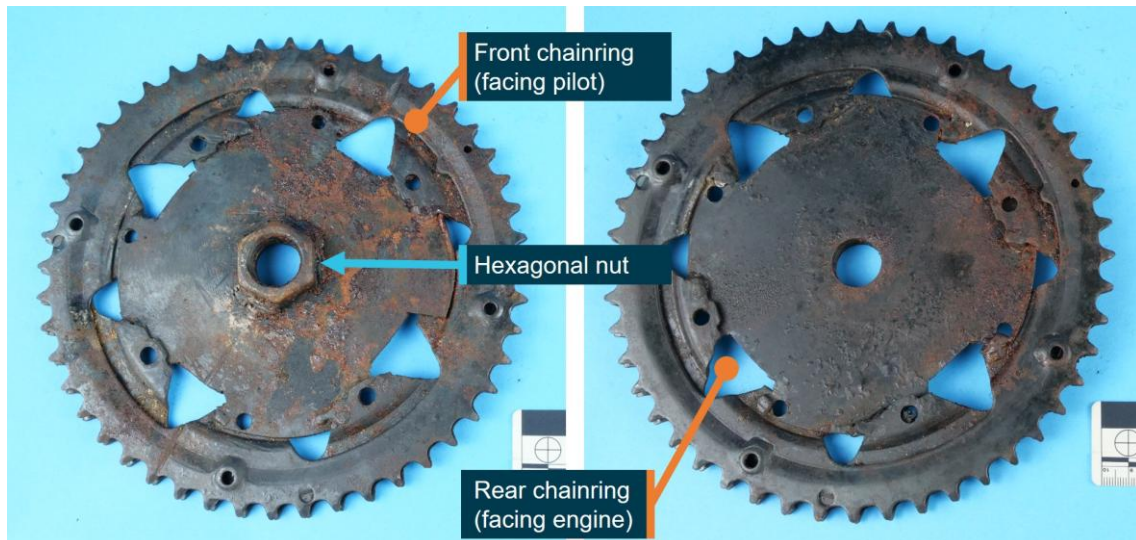
Figure 13: Front chainring facing pilot (left) and rear chainring facing engine (right)

The part that transmitted roll control from either yoke to the ailerons consisted of 2 chainrings welded together around a hexagonal nut to form one part, hereafter referred to as the 'chainring' (Figure 13). The chainring was supported by an inner and outer bearing attached to a support frame. Two grub screws located in threaded holes through the nut were present to secure the chainring to a bearing.

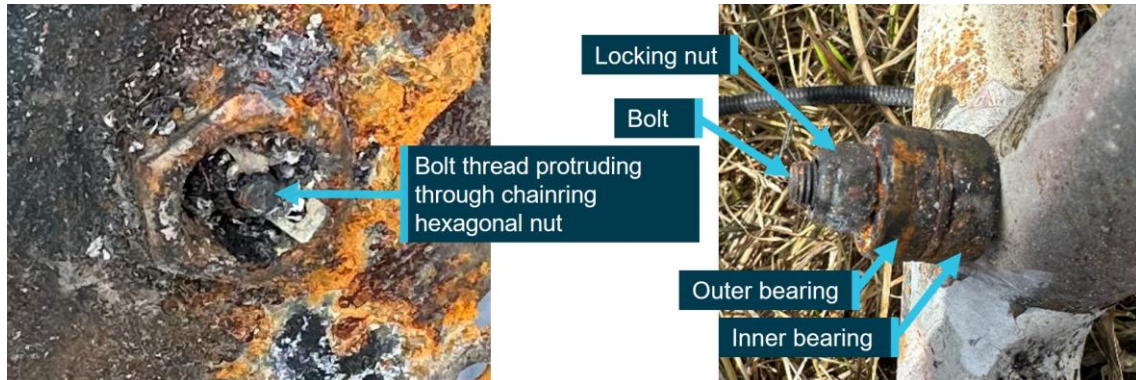
Figure 14: Location of bolt relative to hexagonal nut (left) and bearings (right)

It was noted that the chainring hexagonal nut appeared to be centrally located on the bearings (Figure 14 left) before the controls were disturbed for onsite examination and that the chainring only separated from the bearings when it was disturbed. Pre- and post-accident photographs of the flight controls and measurement of the clearance between the chainring and the support frame indicated that the 2 grub screws could only have engaged with the outer bearing (Figure 14 right).

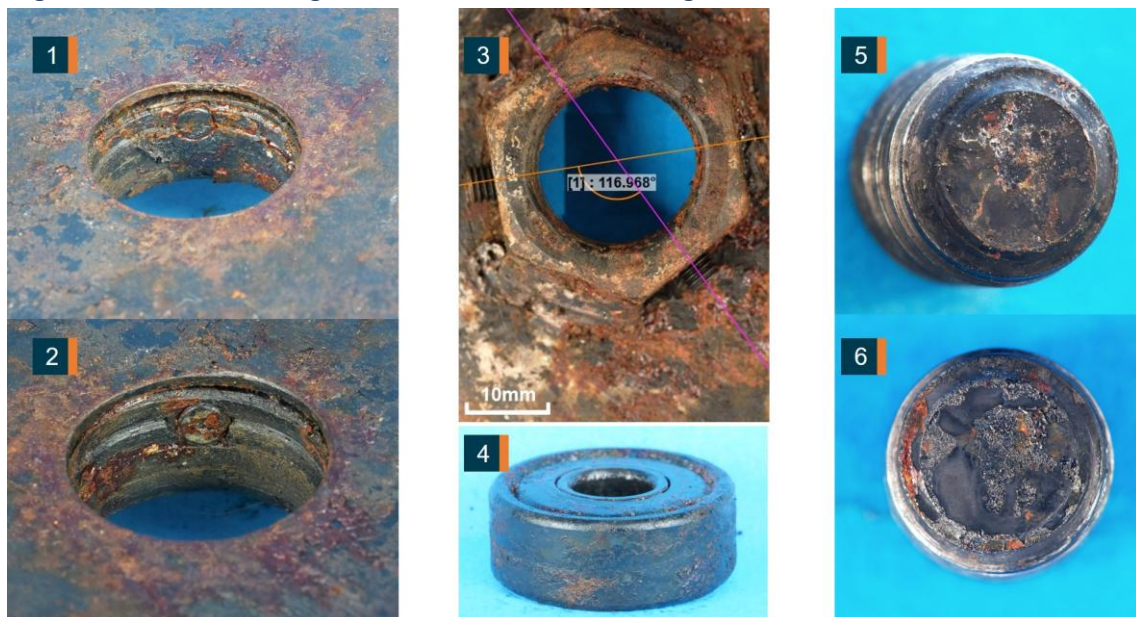
Figure 15: Condition of grub screws and outer bearing

The examination found that the 2 grub screws were not proud of the hexagonal nut inner diameter (Figure 15 [1, 2]) and they had an angular separation of 117° (Figure 15 [3]). The inner bearing and the outer bearing (Figure 15 [4]) were examined, cleaned and re-examined. No witness marks from the grub screws were identified. The grub screws (Figure 15 [5, 6]) were examined, cleaned and re-examined and no bearing witness marks were identified. Therefore, ATSB examination could not confirm that the grub screws retained the chainring to either bearing.
