# VFR into IMC involving Piper PA-28, VH-BTN

12 km north-west of Bankstown Airport, New South Wales, on 15 January 2025

**ATSB Transport Safety Report**  
Aviation Occurrence Investigation (Defined)  
AO-2025-003  
Final – 29 January 2026

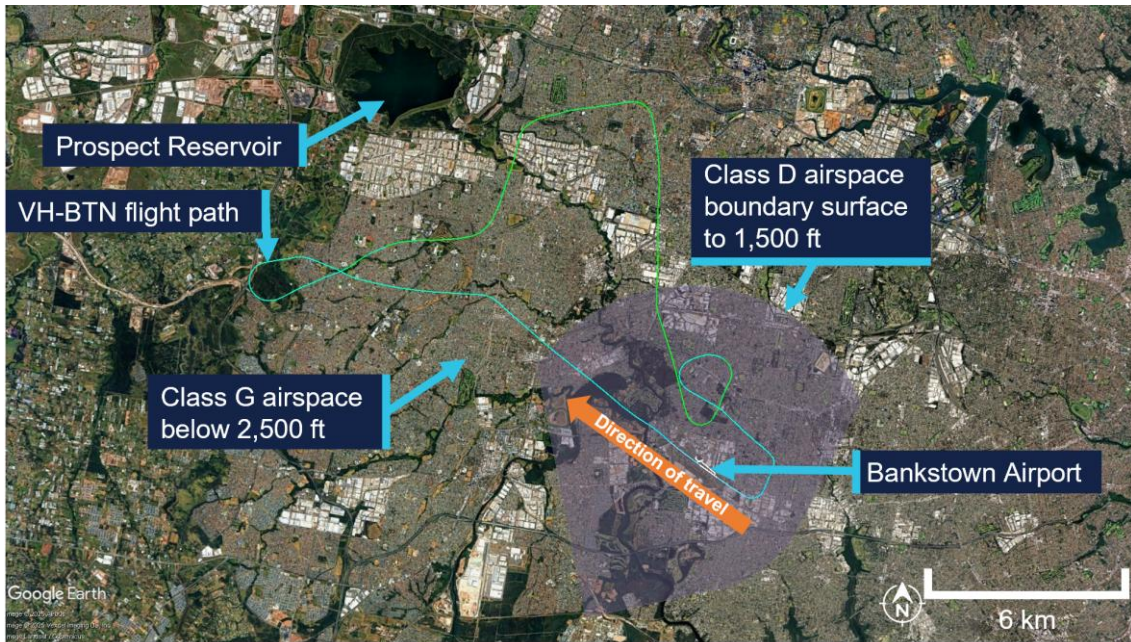
Figure 1: VH-BTN flight path

At 0843 the pilot was cleared for take-off and departure under special VFR (see the section titled *Visual flight rules*). At 0846 the pilot communicated to Bankstown Tower that they were leaving the Bankstown airspace. At approximately 0848, flying at 1,500 ft above mean sea level (AMSL), the pilot made a left turn to fly between a gap in the clouds. As they passed through the gap, the gap closed and visual reference of both the horizon and ground were lost.

Finding themselves in cloud, the pilot did as they had been previously trained for such circumstances and focused on their instruments to conduct a 180° turn in an attempt to return to visual conditions. However, the turn completed by the pilot exceeded 180° and the aircraft did not return to VMC (Figure 1). The pilot later reported to the ATSB that, while operating in cloud, they believed the aircraft was in a safe position and under control thanks to their training.

At 0850, the pilot advised the Bankstown Tower controller that they were in IMC just outside the controlled area. At this time, the controller advised the pilot of an instrument flight rules (IFR)<sup>6</sup> aircraft that had departed Bankstown and was 1.5 NM (2.8 km) east of their position, tracking west bound and climbing through their altitude. The pilot of VH-BTN replied that they were unable to see anything.

VH-BTN entered cloud at approximately 1,500 ft AMSL in an area where the lowest safe altitude was 2,500 ft AMSL (see the section titled *Lowest safe altitudes*). Once traffic separation was assured, the Bankstown Tower controller advised the pilot to climb above the cloud and the lowest safe altitude. The pilot responded they were climbing above the cloud and, a short time later, the controller suggested the pilot should climb to 2,500 ft. At 0851 the pilot reported that they were now above the cloud. The tower controller provided the pilot with suggested tracking to return to Bankstown and advised that there was a gap in the cloud over the airport sufficient to descend through.
