Flight control event involving Embraer E190, VH-UZD

29 km south-east of Launceston Airport, Tasmania, on 15 April 2025

Aviation Occurrence Investigation (Short)

AO-2025-021

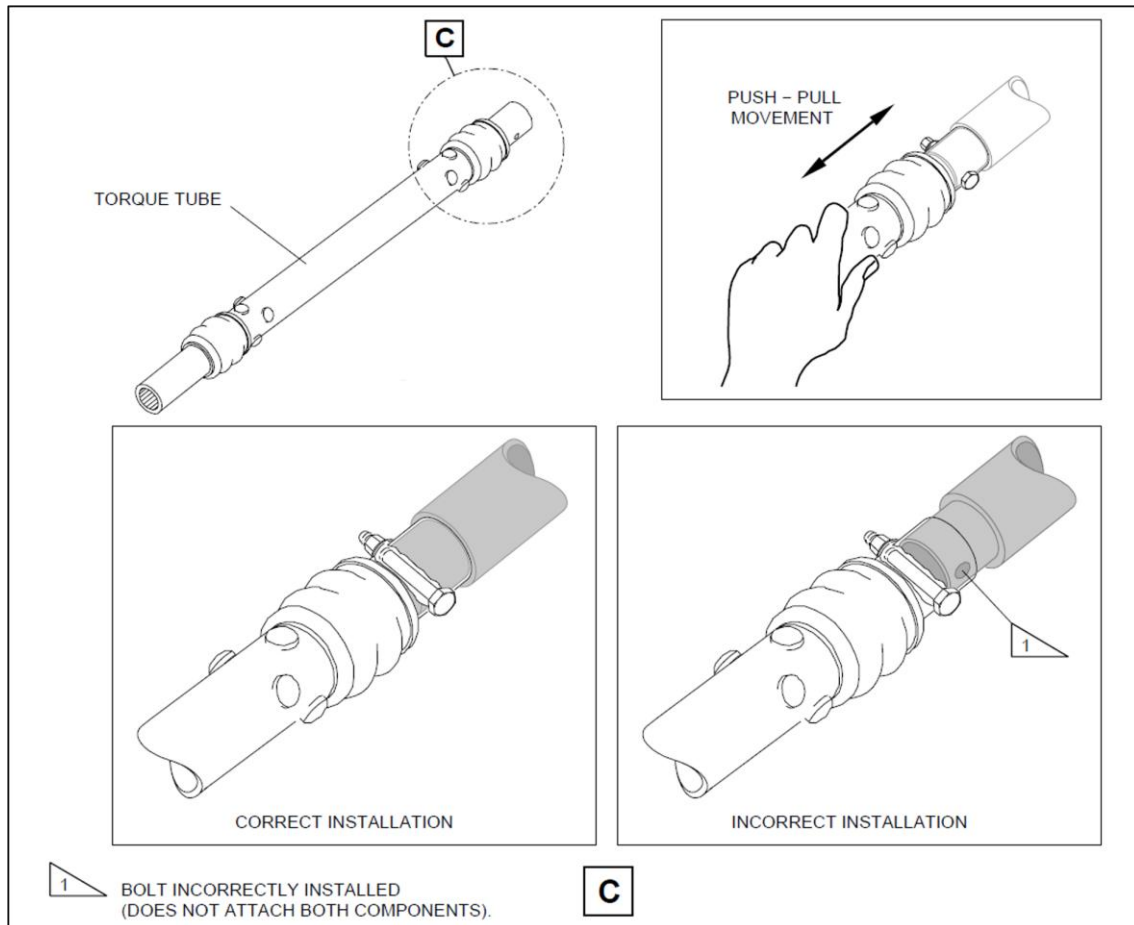
Figure 1: Aircraft maintenance manual torque tube installation illustration

The AMM describes and illustrates a ‘push-pull’ check to determine the locking bolt has been correctly installed and had showed representative examples of correct and incorrect installation (Figure 1).

In 2010 the AMM was amended to include the previously mentioned illustration (Figure 1) showing the correct and incorrect installation of slat and flap torque tubes along with the push-pull test. This revision also added the requirement to release the PDU brakes.

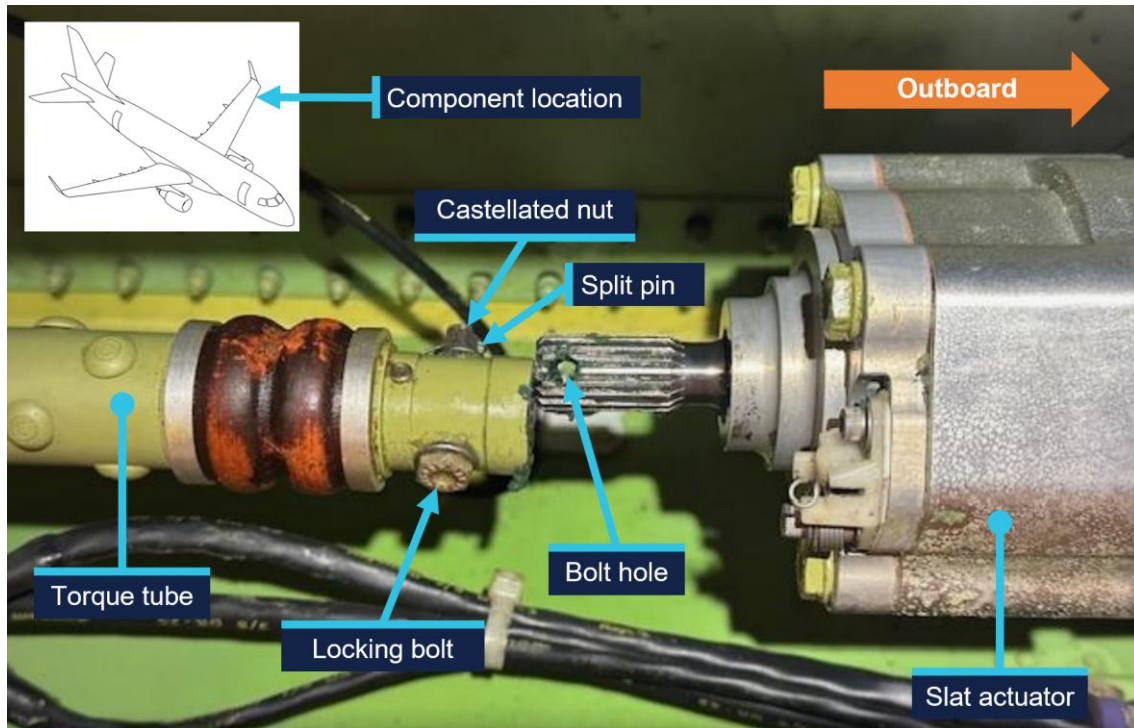
Post-flight inspection determined that the torque tube for the left wing slat number 4 outboard actuator had disconnected as the locking bolt fitted to the torque tube had not passed through the corresponding hole in the actuator's splined shaft when it was last refitted (Figure 2).

Figure 2: VH-UZD left wing outboard actuator for slat number 4 and torque tube, shown disconnected after the occurrence flight

When the torque tube for the left wing slat number 4 outboard actuator was refitted to VH-UZD in November 2024, it had not been positioned far enough onto the actuator's splined shaft for the locking bolt to secure it in place. After re-entering service and conducting 50 flights, the torque tube disengaged from the actuator, and the slat system failed. Protection systems ensured the safety of flight was minimally affected.

- During scheduled maintenance, the locking bolt for the left outboard slat torque tube was not passed through the hole in the actuator’s splined shaft as the torque tube had been incorrectly positioned. The aircraft was released from maintenance, and 50 flights later, the torque tube disconnected, causing the slat system to fail.
- Both licensed aircraft maintenance engineers inspecting the left outboard slat torque tube did not identify that it had been incorrectly assembled.

On 17 April 2025, Alliance Airlines issued a maintenance notice that detailed the flap torque tube disconnect affecting VH-UYB on 11 November 2024 and the slat torque tube disconnect affecting VH-UZD on 15 April 2025. This notice reiterated the aircraft maintenance manual information for the correct installation of flap and slat torque tubes.

The maintenance organisation added an additional task card that is automatically issued when work is scheduled on the E190 slat system torque tubes. This task card provides guidance in addition to the aircraft maintenance manual to highlight the possibility of hydraulic lock caused by lubricant and the importance of releasing the PDU brake. Additionally, this task details a dimensional check to confirm the correct installation of torque tubes on their splined shafts. A similar additional task card was being developed for the E190 flap system torque tubes.

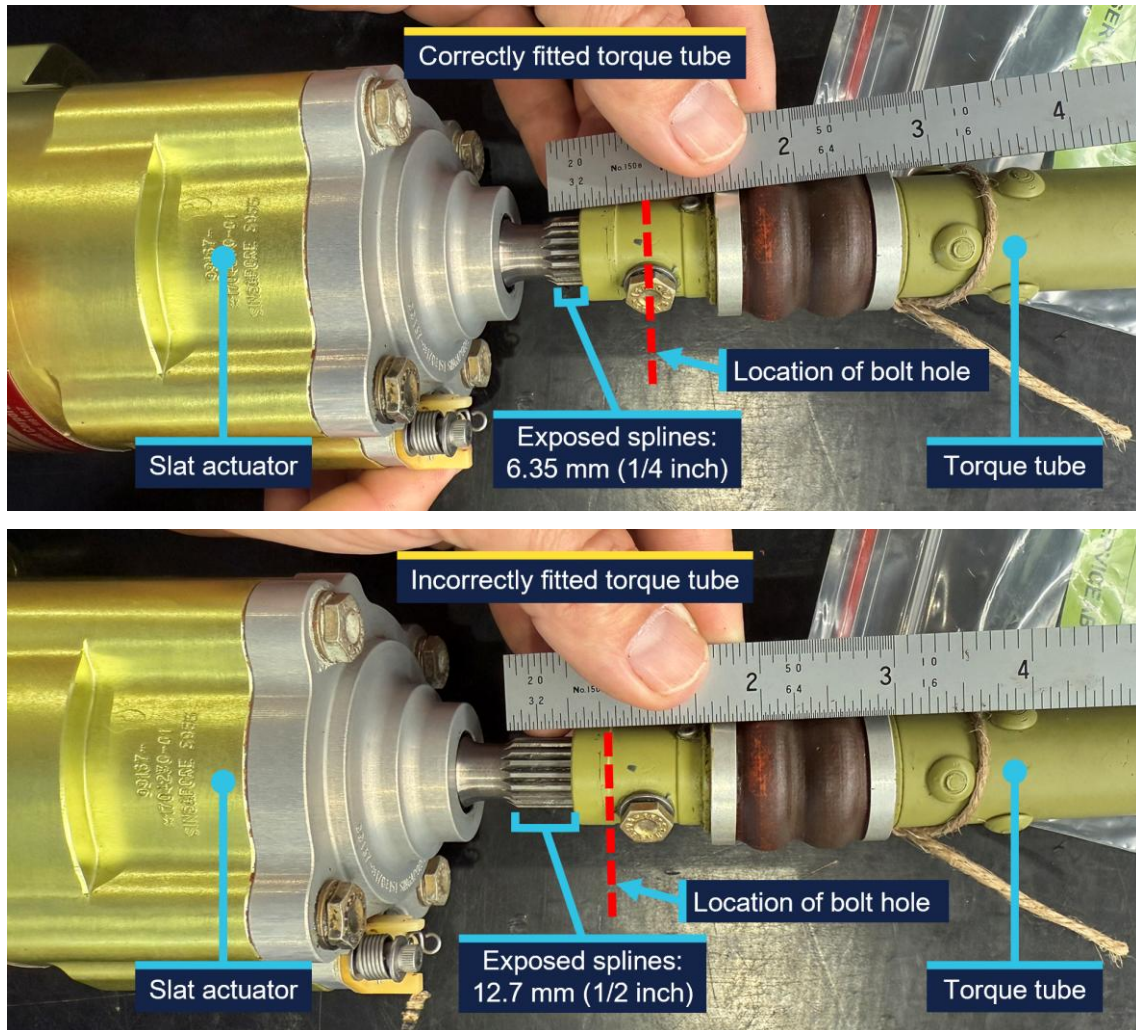
The torque tube locking bolts pass through holes close to the end of each actuator’s splined shaft. A correctly installed torque tube is visually apparent by less exposed splines (Figure 6). If a slat torque tube is incorrectly positioned⁹ on a slat actuator the locking bolt will not capture the splined shaft and can lead to the torque tube disconnecting and slat failures.

Figure 6: Exemplar slat torque tube correctly fitted (upper image) and incorrectly fitted (lower image) to a slat actuator

Ultimately, it is likely that not knowing the subtle difference in appearance of an incorrectly assembled slat torque tube (that is, as little as about 6.35 mm more of the actuator spline visible) contributed to the error not being detected by the 2 AMEs and the 2 LAMEs involved. Further, the remaining torque tubes in the slat drive system were correctly assembled, however their subtly different appearance did not trigger recognition that the original torque tube had been incorrectly assembled.

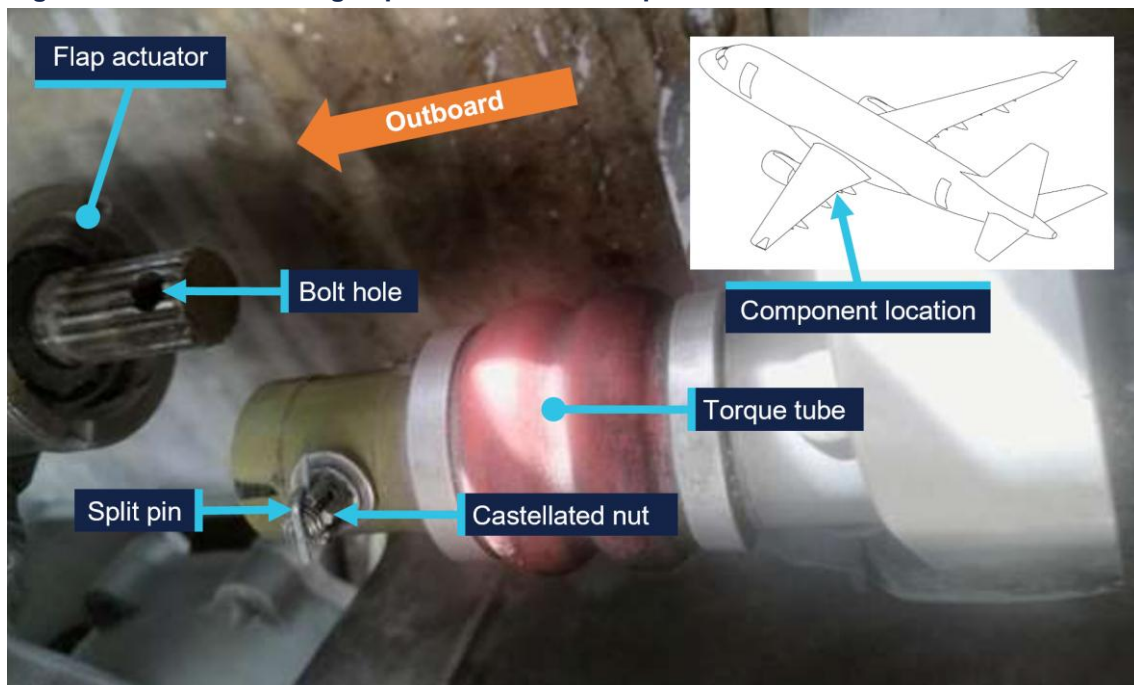
Engineering personnel later found that the locking bolt for the left wing flap actuator number 2 torque tube had not passed through the corresponding hole in the actuator splined shaft when it was last refitted (Figure 7).

Figure 7: VH-UYB left wing flap actuator 2 and torque tube

Similarly, when another E190, VH-UYB, was under heavy maintenance at a different facility at around the same time, the torque tube driving the left wing flap actuator number 2 was incorrectly assembled in that the locking bolt had not passed through the hole in the actuator's splined shaft. The torque tube disengaged 35 flights after the aircraft re-entered service and the flap system failed.
