# Control issues during landing and go-around involving Airbus A321, VH-OYF

Sydney Airport, New South Wales, on 26 June 2025

**ATSB Transport Safety Report**  
Aviation Occurrence Investigation (Short)  
AO-2025-036  
Final – 27 January 2026

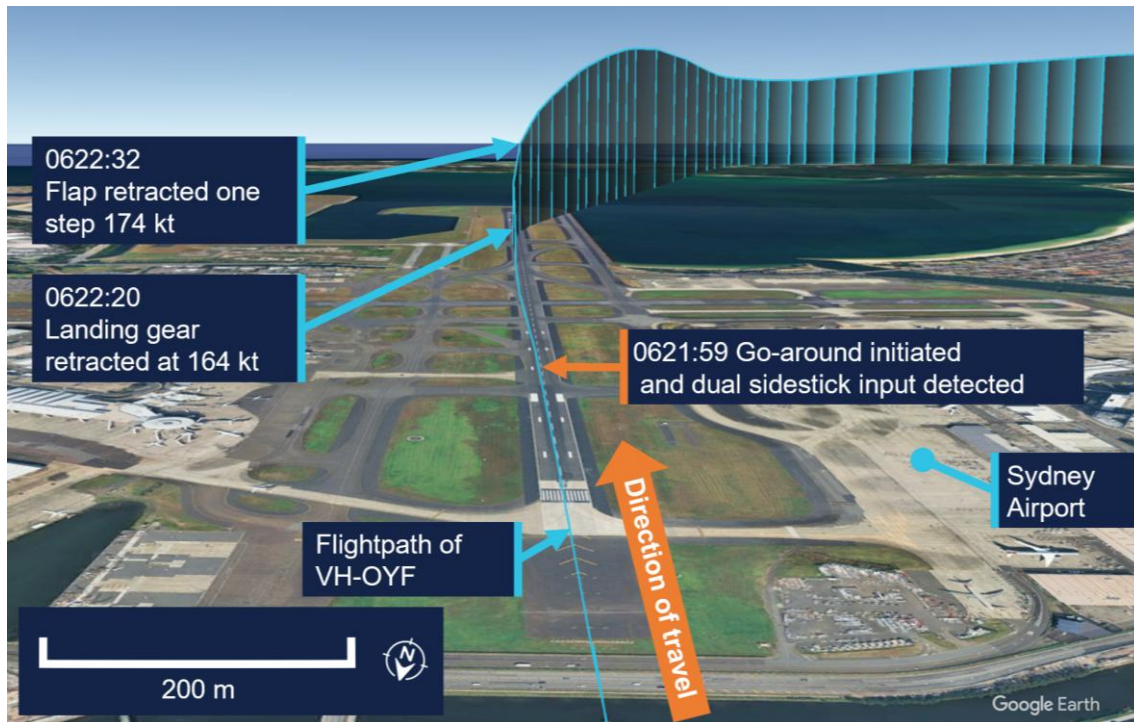
Figure 1: Overview of go-around

During the prolonged float, the aircraft was subjected to the crosswind conditions for a greater length of time. After observing the centreline deviation, the captain commanded a go-around approximately 600 m past the runway threshold, just prior to touchdown. The captain recalled they were ‘startled by the need to go around’ as the approach seemed ‘benign’ aside from the crosswind. They also reported a sudden stress response at this time as they had to rapidly transition from landing to commencing the go-around.

In response to the captain’s command, the first officer set take-off/go-around thrust at 0621:59 (Figure 1), which initiated the published missed approach procedure for the 16R GBAS landing system (GLS)<sup>8</sup> approach in the aircraft flight management system. The first officer also referenced their primary flight display (PFD) to command a target pitch attitude of 15° nose up.

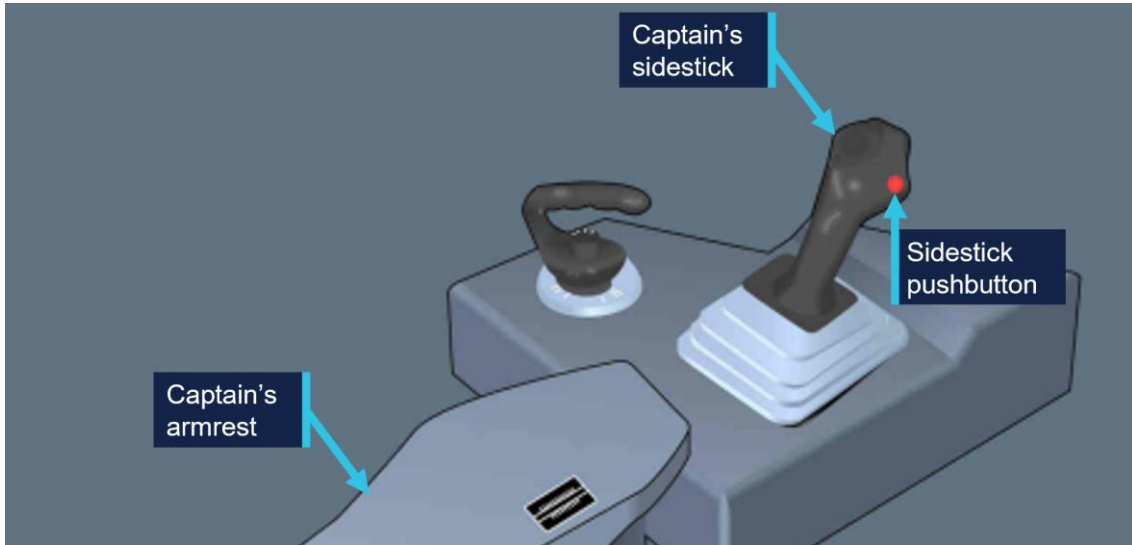
**Figure 2: Airbus A320/A321 captain's side sidestick and sidestick pushbutton**

At this point, the captain recalled they instinctively applied control inputs via their sidestick while the aircraft was just above the runway, and the crew were alerted to this by the aircraft’s ‘dual input’ voice message (see *Sidestick priority logic*).

The captain then engaged their sidestick pushbutton, and the first officer recalled hearing the ‘priority left’ voice message and the captain announce, ‘I have control.’ The captain subsequently took control of the thrust levers and the first officer relinquished control and became PM after the aircraft achieved a positive rate of climb. It was the role of the PM to retract the flap ‘one step’ at this point (see *Go-around procedure*).

A flight crewmember can deactivate the other sidestick and take full control, by pressing and keeping pressed the sidestick pb (Figure 2).

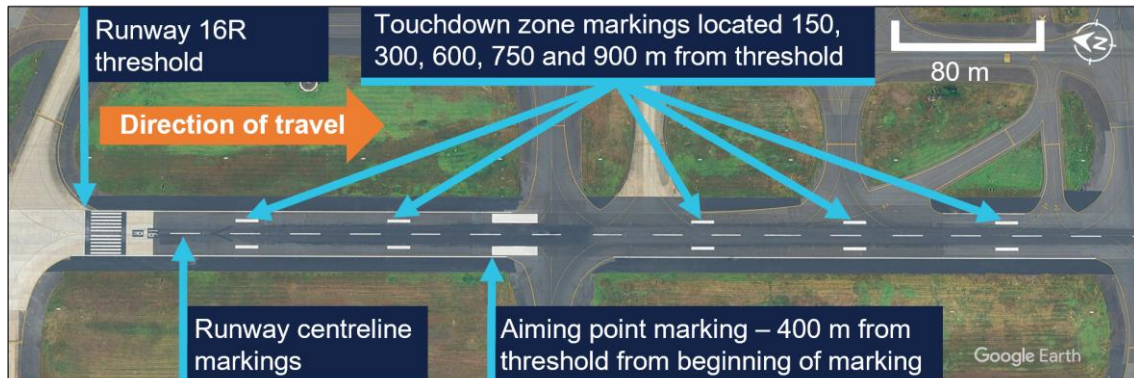
**Figure 3: Sydney Airport runway 16R markings**

For daytime operations, the runway centreline, aiming point and touchdown zone markings provide visual references to assist pilots with approach and landing (Figure 3).

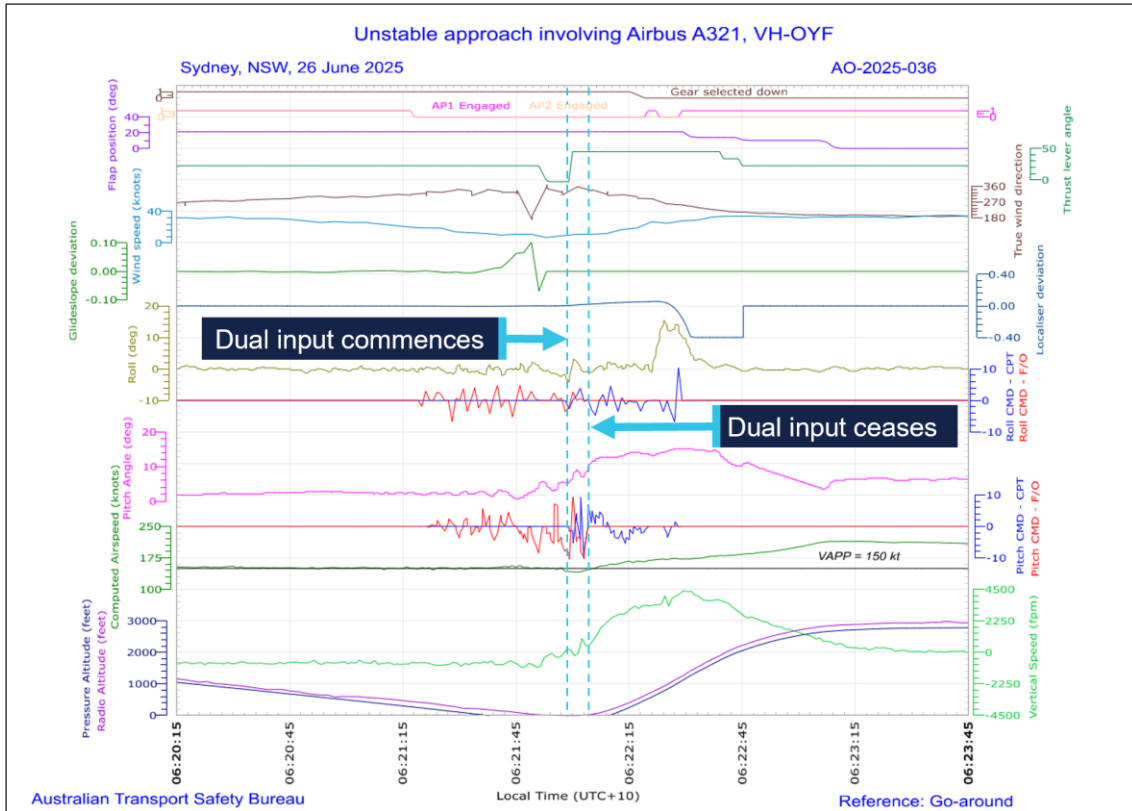
Figure 4: Graphical representation of the recorded quick access data

At 0621:59, the recorded data captured the captain's control inputs commencing concurrently with the initiation of the go-around, while the first officer was actively manipulating their sidestick control. Simultaneous control inputs lasted for a duration of 6 seconds (Figure 4), while the aircraft's pitch attitude remained below the aircraft's pitch limit of 11.5° until the aircraft had climbed through about 50 ft.

The recorded data further indicated that the wind direction and speed varied following the flare manoeuvre, however the crosswind component remained well below the first officer's operational limitation. The wind direction and speed was 315° at 13 kt with a crosswind component of 5 kt when the go-around was initiated.

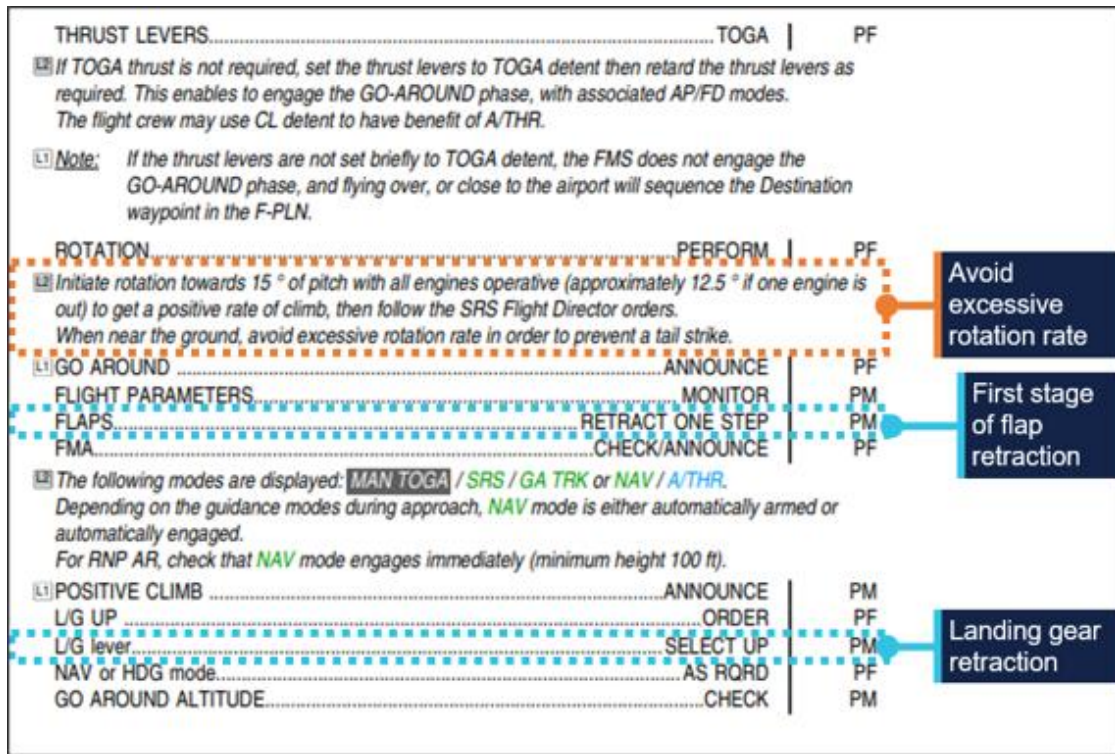
Figure 5: Jetstar Airway A320/A321 go-around procedure below acceleration altitude

The FCOM defined the go-around procedure for the A320/A321, which specified the task sequence, memory-based crew actions and applicable guidance relating to techniques and navigation (Figure 5).

Additionally, there was a further disruption (rapid task switching) associated with the first officer and captain exchanging pilot flying and pilot monitoring roles. As a result, some of the procedural items were completed out of sequence (flap 3 retraction occurred after gear retraction).
