Unreliable airspeed indication on take-off involving Fairchild SA227, VH-UZN

Townsville Airport, Queensland, on 10 February 2025

AO-2025-041

Final – 20 January 2026

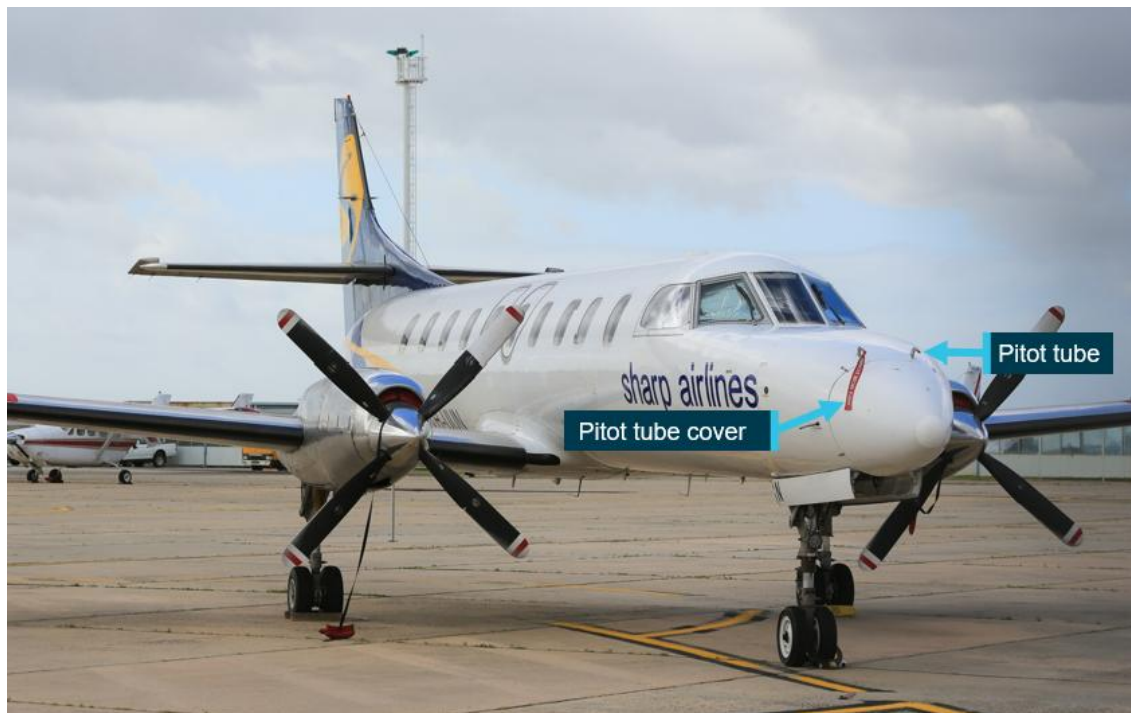
Figure 1: Pitot tubes on Fairchild SA227

During the initial climb, the FO heard a flapping noise coming from the front of the aircraft and identified that the pitot tube covers had been left installed on the pitot tubes, which they announced to the captain.

Following the post-flight inspection, the operator reported that the captain's side pitot cover was mostly intact, and heat fused to the pitot tube. The FO's side pitot cover had disintegrated, and the remnants of the cover had slid down to the rear of the pitot tube such that it did not obstruct normal operation.

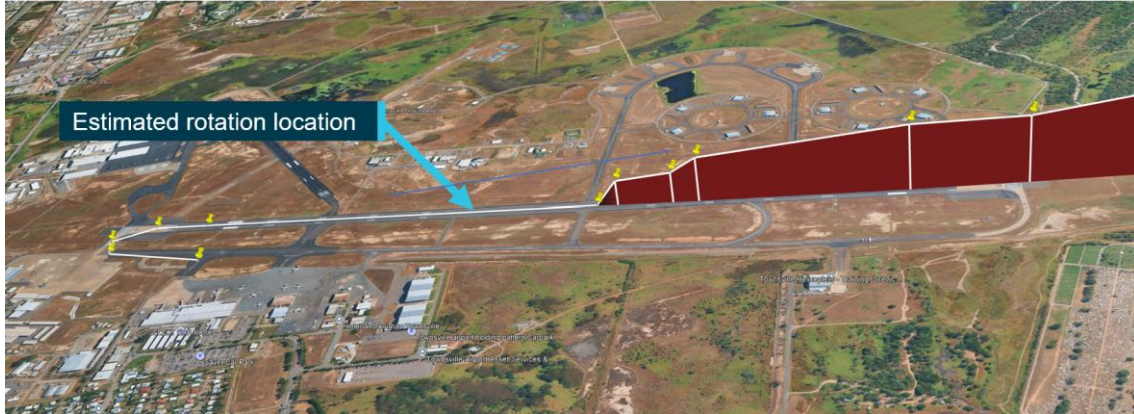
Figure 4: Estimated rotation location VH-UZN from historical flight analysis

This data was compared to historical recorded flight data of 19 take-offs of another SA227-DC aircraft from Townsville Airport runway 01. Comparing the pitch attitude and indicated airspeed parameters in the historical data against the available ADS-B parameters for the flight, the ATSB was able to identify an approximate rotation location on runway 01 during the incident flight (Figure 4).

The ATSB estimated that the rotation speed (V_R)² of VH-UZN, based on historical flights, was likely in the lower range of values between 112–130 kt.
